Profile/Photo Observation Report

Street:	HIGH ST & N KELLY ST	Flow Control:	Not Controlled
City:	Hobart, IN	Year Renewed:	
Location:	Other	Tape/Media #:	
Purpose:	Not Known	Dia/Height:	12"
Use:	Sanitary	Material:	VCP
Drain Area:	NA	Lining:	
Category:	NA		
Comment:

Location Details:		Direction of Survey:	Upstream
US MH:	M-803-046	DS MH:	M-804-056
		Total Length Surveyed (ft):	16.3

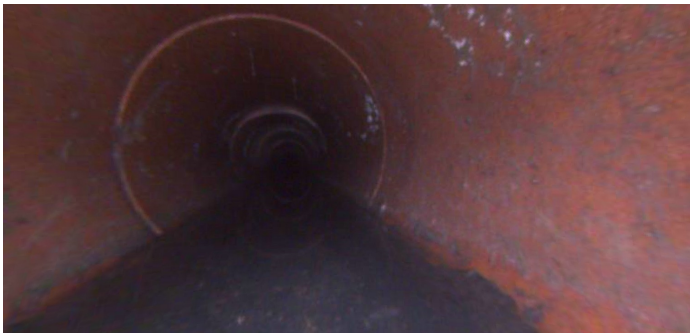
AMH

Manhole

.0

M-804-056

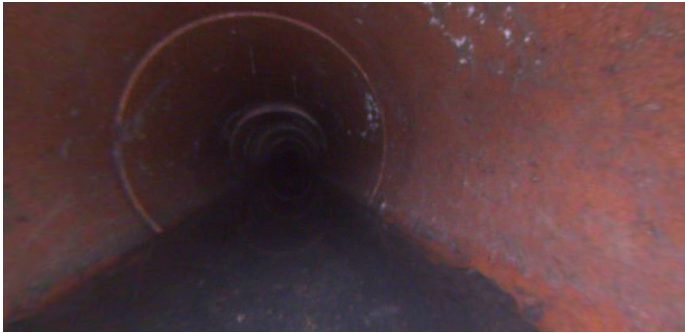
Code:	MWL
Description:	Water Level

Distance (ft):	.0
Structural Grade:	0
O&M Grade:	0
Clock Start/From:	
Clock To:	
1st Value:	
2nd Value:	
Value Percent:	10.000
Continuous Index:	
Within 8" of Joint:	NO
Remarks:

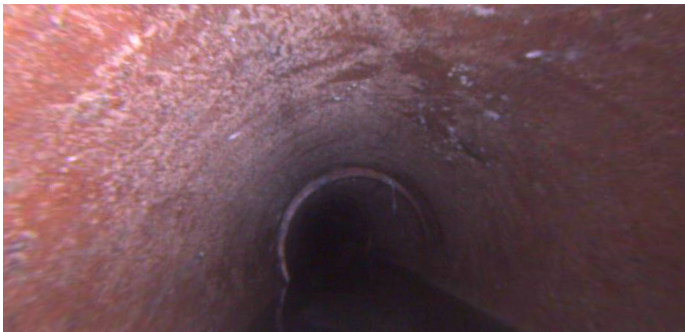
Code:	MSA
Description:	Abandoned Survey

Distance (ft):	16.3
Structural Grade:	0
O&M Grade:	0
Clock Start/From:	
Clock To:	
1st Value:	
2nd Value:	
Value Percent:	
Continuous Index:	
Within 8" of Joint:	NO
Remarks:	DEBRIS UNDER WATER
