Profile/Photo Observation Report

Street:	N Kelly Ave.	Flow Control:	Not Controlled
City:	Hobart, IN	Year Renewed:	
Location:	Other	Tape/Media #:	
Purpose:	Not Known	Dia/Height:	12"
Use:	Sanitary	Material:	VCP
Drain Area:	NA	Lining:	
Category:	NA		
Comment:

Location Details:		Direction of Survey:	Upstream
US MH:	M-803-046	DS MH:	M-804-056
		Total Length Surveyed (ft):	16.3

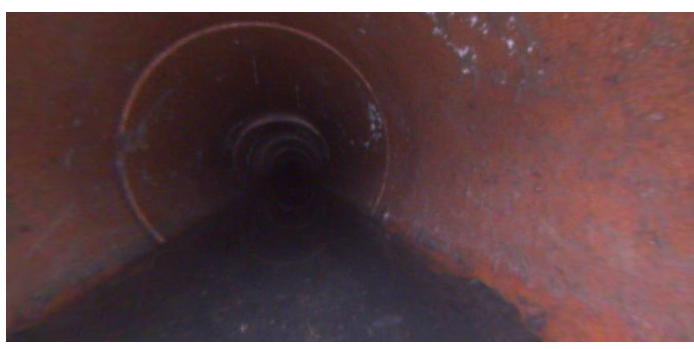
Code: **AMH**
Description: **Manhole**

Distance (ft): **.0**
Structural Grade: **0**
O&M Grade: **0**
Clock Start/From:
Clock To:
1st Value:
2nd Value:
Value Percent:
Continuous Index:
Within 8" of Joint: **NO**
Remarks: **M-804-056**

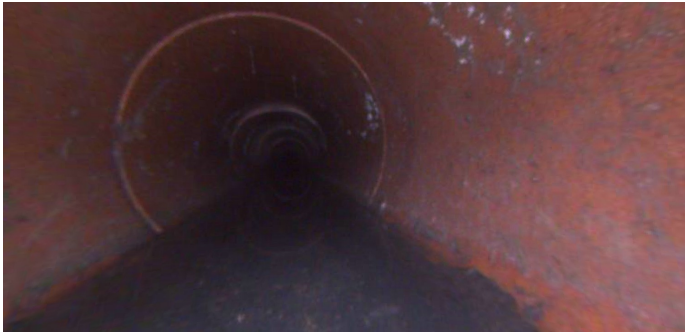
Code:	MWL
Description:	Water Level

Distance (ft):	.0
Structural Grade:	0
O&M Grade:	0
Clock Start/From:	
Clock To:	
1st Value:	
2nd Value:	
Value Percent:	10.000
Continuous Index:	
Within 8" of Joint:	NO
Remarks:

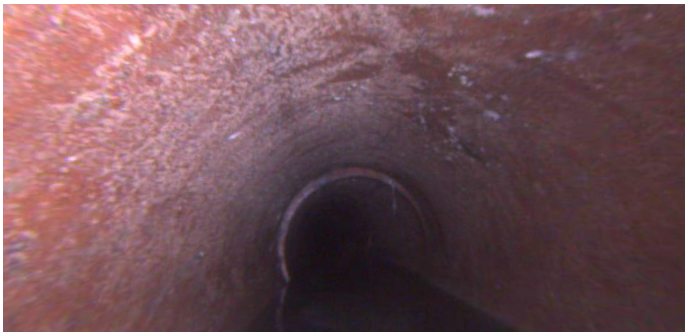
Code:	MSA
Description:	Abandoned Survey

Distance (ft):	16.3
Structural Grade:	0
O&M Grade:	0
Clock Start/From:	
Clock To:	
1st Value:	
2nd Value:	
Value Percent:	
Continuous Index:	
Within 8" of Joint:	NO
Remarks:	DEBRIS UNDER WATER
