# Profile/Photo Observation Report

Street:	<b>HIGH ST &amp; N KELLY ST</b>	Flow Control:	<b>Not Controlled</b>
City:	<b>Hobart, IN</b>	Year Renewed:	
Location:	<b>Light Highway</b>	Tape/Media #:	
Purpose:	<b>Routine Assessment</b>	Dia/Height:	<b>12"</b>
Use:	<b>Sanitary</b>	Material:	<b>VCP</b>
Drain Area:	<b>NA</b>	Lining:	
Category:	<b>NA</b>		
Comment:			
Location Details:		Direction of Survey:	<b>Downstream</b>
US MH:	<b>M-803-046</b>	DS MH:	<b>M-804-056</b>
		Total Length Surveyed (ft):	<b>225.6</b>

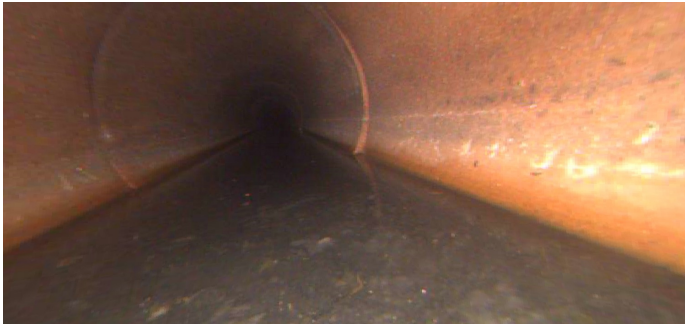
Code: **AMH**  
Description: **Manhole**

Distance (ft): **.0**  
Structural Grade: **0**  
O&M Grade: **0**  
Clock Start/From:  
Clock To:  
1st Value:  
2nd Value:  
Value Percent:  
Continuous Index:  
Within 8" of Joint: **NO**  
Remarks: **M-803-046**

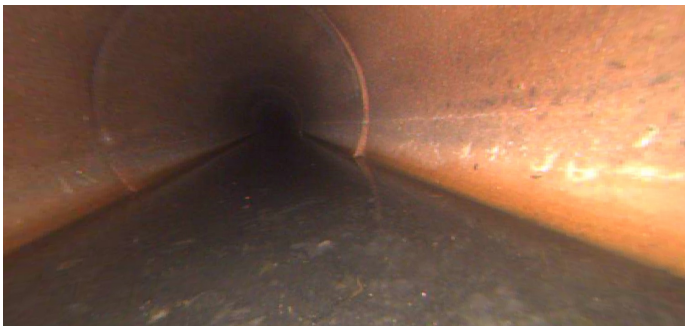
Code: **MWL**  
Description: **Water Level**

Distance (ft): **.0**  
Structural Grade: **0**  
O&M Grade: **0**  
Clock Start/From:  
Clock To:  
1st Value:  
2nd Value:  
Value Percent: **5.000**  
Continuous Index:  
Within 8" of Joint: **NO**  
Remarks:

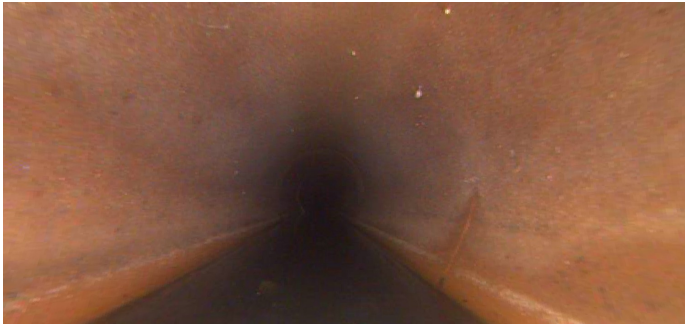
Code: **FS**  
Description: **Fracture Spiral**

Distance (ft): **7.3**  
Structural Grade: **3**  
O&M Grade: **0**  
Clock Start/From: **3**  
Clock To: **4**  
1st Value:  
2nd Value:  
Value Percent:  
Continuous Index:  
Within 8" of Joint:  
Remarks:

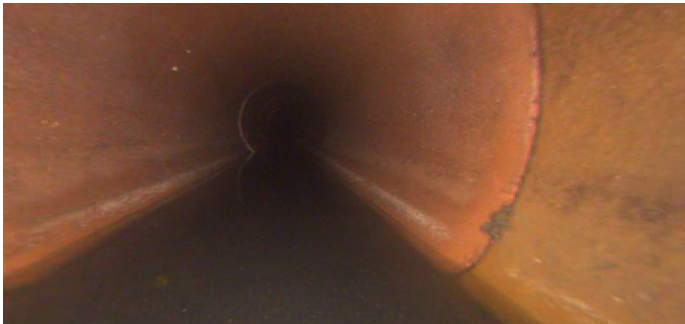
Code: **RFJ**  
Description: **Roots Fine Joint**

Distance (ft): **9.9**  
Structural Grade: **0**  
O&M Grade: **1**  
Clock Start/From: **4**  
Clock To:  
1st Value:  
2nd Value:  
Value Percent:  
Continuous Index:  
Within 8" of Joint: **YES**  
Remarks:

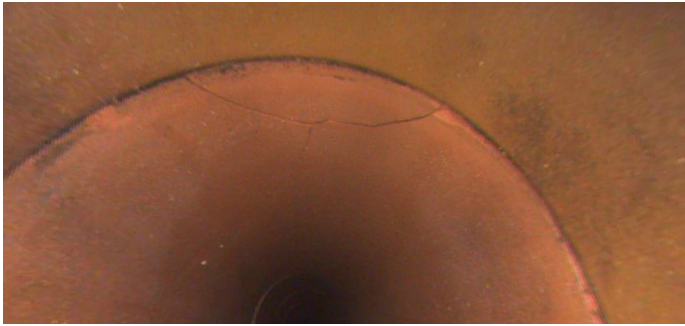
Code: **FC**  
Description: **Fracture Circumferential**

Distance (ft): **9.9**  
Structural Grade: **2**  
O&M Grade: **0**  
Clock Start/From: **11**  
Clock To: **1**  
1st Value:  
2nd Value:  
Value Percent:  
Continuous Index:  
Within 8" of Joint: **YES**  
Remarks:

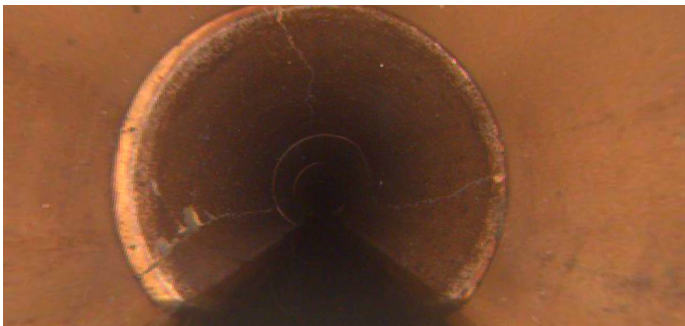
Code: **FM**  
Description: **Fracture Multiple**

Distance (ft): **12.5**  
Structural Grade: **4**  
O&M Grade: **0**  
Clock Start/From: **8**  
Clock To: **3**  
1st Value:  
2nd Value:  
Value Percent:  
Continuous Index: **S01**  
Within 8" of Joint: **YES**  
Remarks:

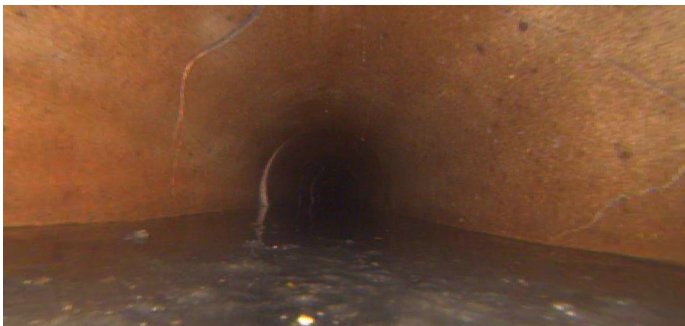
Code: **FM**  
Description: **Fracture Multiple**

Distance (ft): **41.1**  
Structural Grade: **4**  
O&M Grade: **0**  
Clock Start/From: **8**  
Clock To: **3**  
1st Value:  
2nd Value:  
Value Percent:  
Continuous Index: **F01**  
Within 8" of Joint: **YES**  
Remarks:

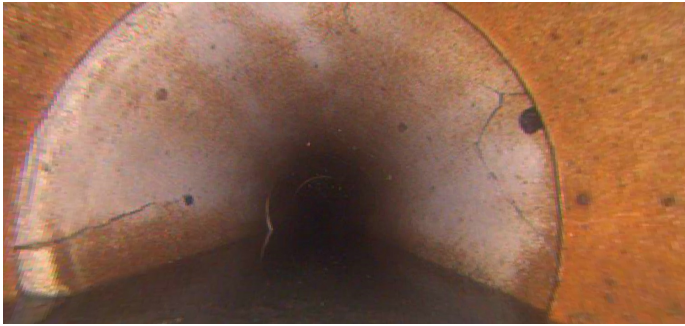
Code: **FM**  
Description: **Fracture Multiple**

Distance (ft): **46.8**  
Structural Grade: **4**  
O&M Grade: **0**  
Clock Start/From: **8**  
Clock To: **4**  
1st Value:  
2nd Value:  
Value Percent:  
Continuous Index:  
Within 8" of Joint: **YES**  
Remarks:

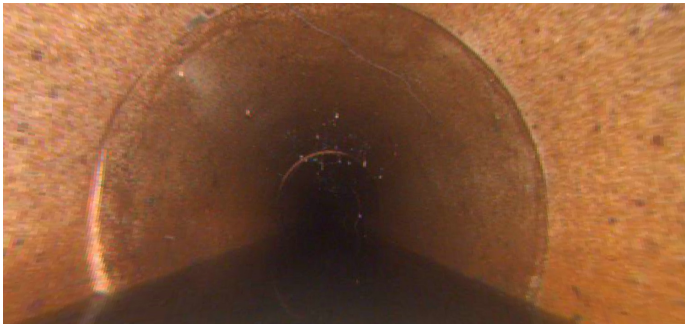
Code: **FC**  
Description: **Fracture Circumferential**

Distance (ft): **48.6**  
Structural Grade: **2**  
O&M Grade: **0**  
Clock Start/From: **12**  
Clock To: **3**  
1st Value:  
2nd Value:  
Value Percent:  
Continuous Index:  
Within 8" of Joint: **YES**  
Remarks:

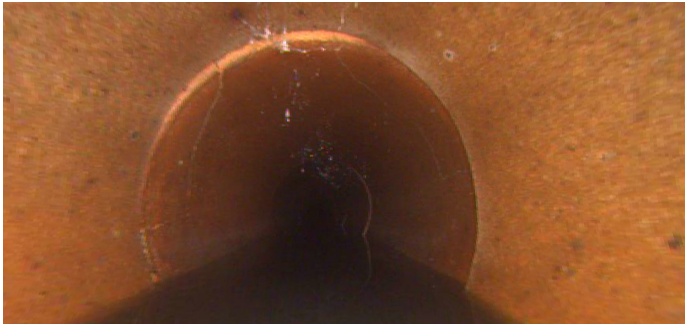
Code: **FM**  
Description: **Fracture Multiple**

Distance (ft): **50.4**  
Structural Grade: **4**  
O&M Grade: **0**  
Clock Start/From: **9**  
Clock To: **3**  
1st Value:  
2nd Value:  
Value Percent:  
Continuous Index:  
Within 8" of Joint: **YES**  
Remarks:

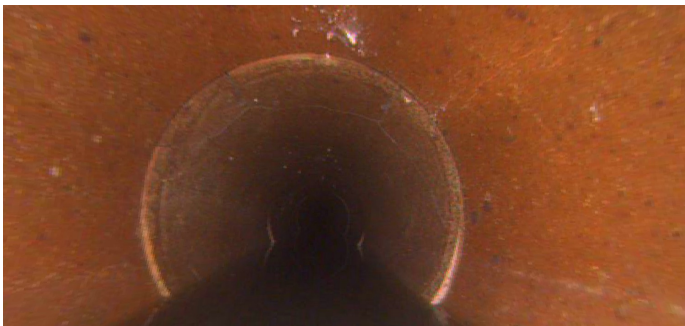
Code: **FM**  
Description: **Fracture Multiple**

Distance (ft): **54.3**  
Structural Grade: **4**  
O&M Grade: **0**  
Clock Start/From: **8**  
Clock To: **4**  
1st Value:  
2nd Value:  
Value Percent:  
Continuous Index:  
Within 8" of Joint: **YES**  
Remarks:

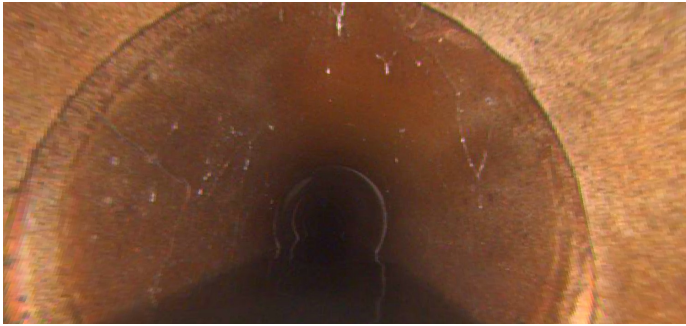
Code: **FM**  
Description: **Fracture Multiple**

Distance (ft): **56.7**  
Structural Grade: **4**  
O&M Grade: **0**  
Clock Start/From: **8**  
Clock To: **2**  
1st Value:  
2nd Value:  
Value Percent:  
Continuous Index:  
Within 8" of Joint: **YES**  
Remarks:

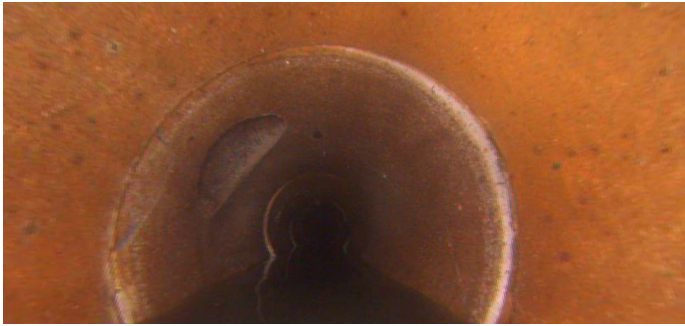
Code: **FS**  
Description: **Fracture Spiral**

Distance (ft): **58.5**  
Structural Grade: **3**  
O&M Grade: **0**  
Clock Start/From: **9**  
Clock To: **10**  
1st Value:  
2nd Value:  
Value Percent:  
Continuous Index:  
Within 8" of Joint: **YES**  
Remarks:

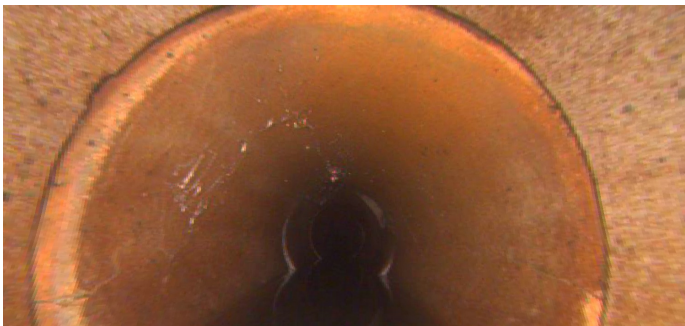
Code: **FM**  
Description: **Fracture Multiple**

Distance (ft): **60.7**  
Structural Grade: **4**  
O&M Grade: **0**  
Clock Start/From: **9**  
Clock To: **3**  
1st Value:  
2nd Value:  
Value Percent:  
Continuous Index:  
Within 8" of Joint: **YES**  
Remarks:

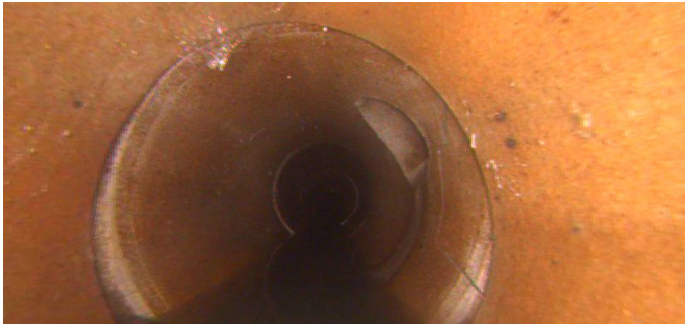
Code: **FC**  
Description: **Fracture Circumferential**

Distance (ft): **62.5**  
Structural Grade: **2**  
O&M Grade: **0**  
Clock Start/From: **8**  
Clock To: **4**  
1st Value:  
2nd Value:  
Value Percent:  
Continuous Index:  
Within 8" of Joint: **YES**  
Remarks:

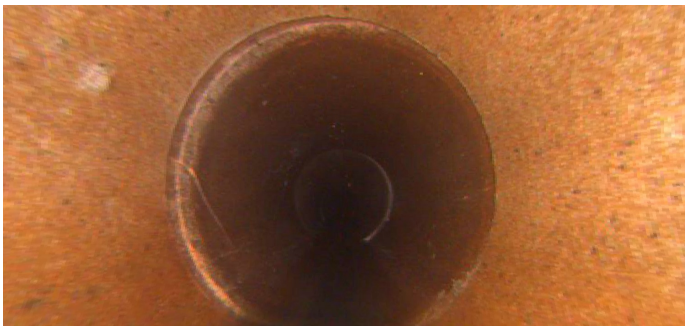
Code: **RFJ**  
Description: **Roots Fine Joint**

Distance (ft): **64.4**  
Structural Grade: **0**  
O&M Grade: **1**  
Clock Start/From: **4**  
Clock To: **5**  
1st Value:  
2nd Value:  
Value Percent:  
Continuous Index:  
Within 8" of Joint: **YES**  
Remarks:

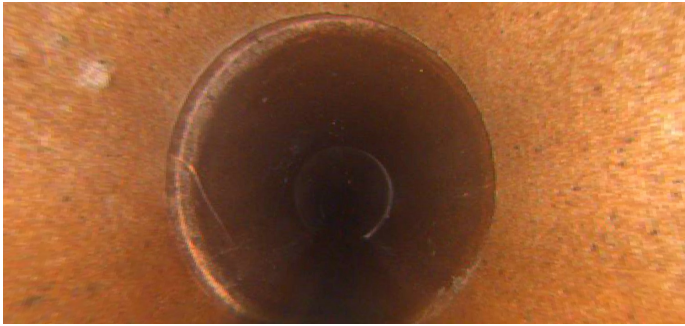
Code: **FM**  
Description: **Fracture Multiple**

Distance (ft): **64.4**  
Structural Grade: **4**  
O&M Grade: **0**  
Clock Start/From: **8**  
Clock To: **9**  
1st Value:  
2nd Value:  
Value Percent:  
Continuous Index:  
Within 8" of Joint: **YES**  
Remarks:

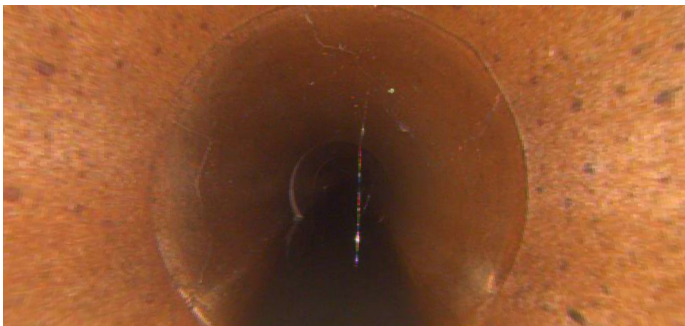
Code: **FS**  
Description: **Fracture Spiral**

Distance (ft): **68.4**  
Structural Grade: **3**  
O&M Grade: **0**  
Clock Start/From: **8**  
Clock To: **2**  
1st Value:  
2nd Value:  
Value Percent:  
Continuous Index:  
Within 8" of Joint: **YES**  
Remarks:

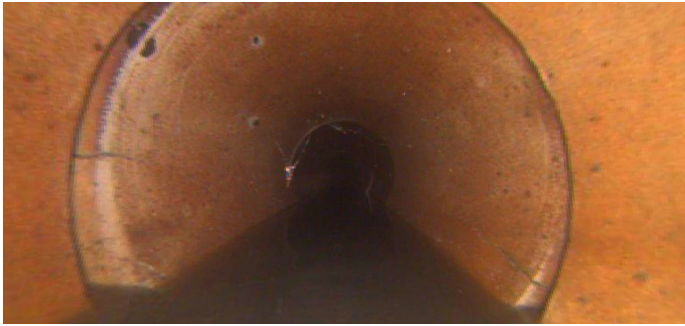
Code: **FL**  
Description: **Fracture Longitudinal**

Distance (ft): **70.7**  
Structural Grade: **3**  
O&M Grade: **0**  
Clock Start/From: **4**  
Clock To:  
1st Value:  
2nd Value:  
Value Percent:  
Continuous Index:  
Within 8" of Joint: **YES**  
Remarks:

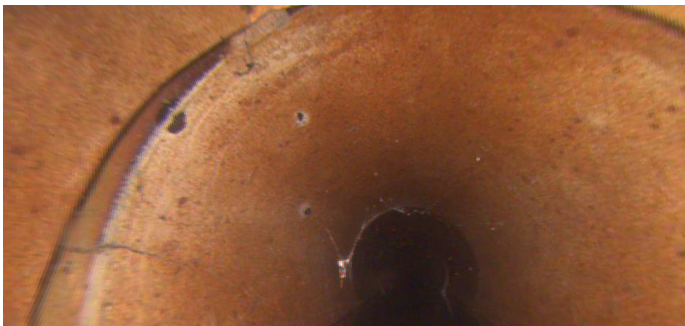
Code: **FM**  
Description: **Fracture Multiple**

Distance (ft): **70.9**  
Structural Grade: **4**  
O&M Grade: **0**  
Clock Start/From: **9**  
Clock To: **11**  
1st Value:  
2nd Value:  
Value Percent:  
Continuous Index:  
Within 8" of Joint: **YES**  
Remarks:

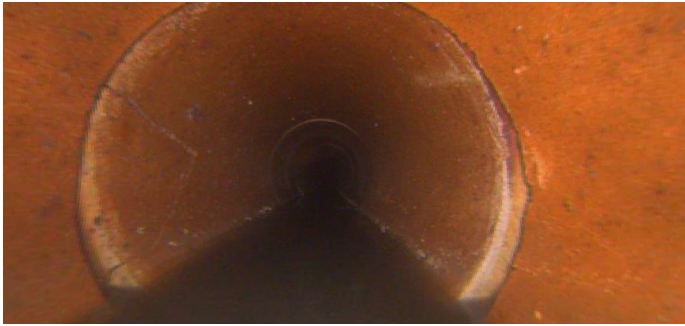
Code: **FS**  
Description: **Fracture Spiral**

Distance (ft): **74.6**  
Structural Grade: **3**  
O&M Grade: **0**  
Clock Start/From: **8**  
Clock To: **10**  
1st Value:  
2nd Value:  
Value Percent:  
Continuous Index:  
Within 8" of Joint: **YES**  
Remarks:

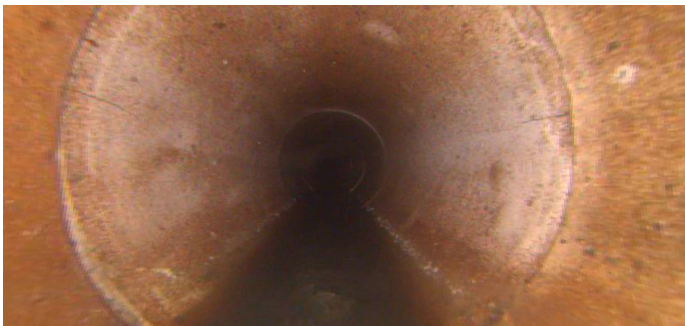
Code: **FL**  
Description: **Fracture Longitudinal**

Distance (ft): **78.7**  
Structural Grade: **3**  
O&M Grade: **0**  
Clock Start/From: **9**  
Clock To:  
1st Value:  
2nd Value:  
Value Percent:  
Continuous Index:  
Within 8" of Joint: **YES**  
Remarks:

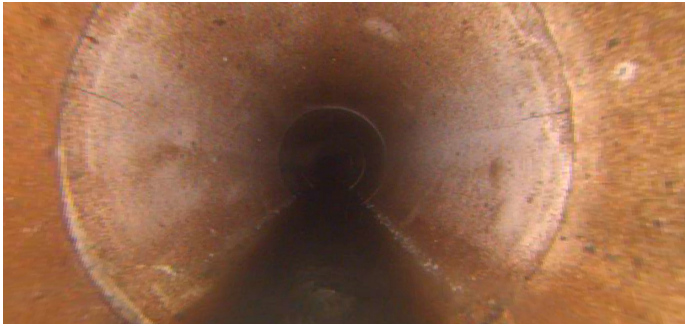
Code: **FL**  
Description: **Fracture Longitudinal**

Distance (ft): **78.7**  
Structural Grade: **3**  
O&M Grade: **0**  
Clock Start/From: **3**  
Clock To:  
1st Value:  
2nd Value:  
Value Percent:  
Continuous Index:  
Within 8" of Joint: **YES**  
Remarks:

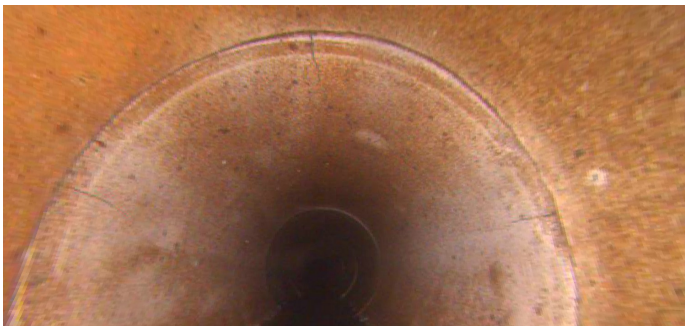
Code: **FL**  
Description: **Fracture Longitudinal**

Distance (ft): **78.7**  
Structural Grade: **3**  
O&M Grade: **0**  
Clock Start/From: **12**  
Clock To:  
1st Value:  
2nd Value:  
Value Percent:  
Continuous Index:  
Within 8" of Joint: **YES**  
Remarks:

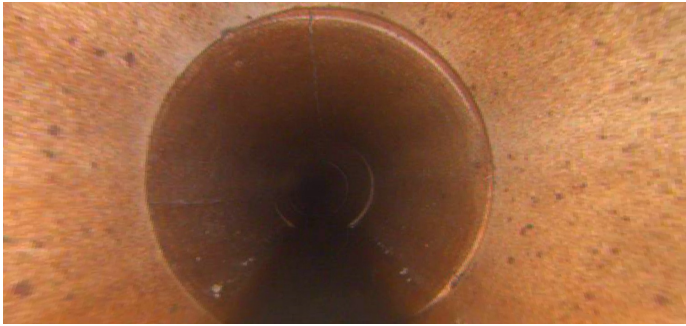
Code: **FL**  
Description: **Fracture Longitudinal**

Distance (ft): **80.4**  
Structural Grade: **3**  
O&M Grade: **0**  
Clock Start/From: **12**  
Clock To:  
1st Value:  
2nd Value:  
Value Percent:  
Continuous Index:  
Within 8" of Joint: **YES**  
Remarks:

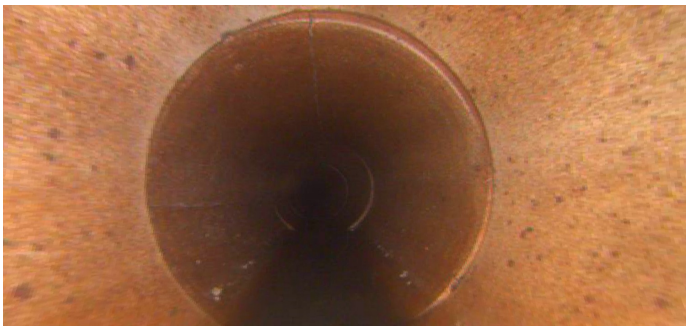
Code: **FL**  
Description: **Fracture Longitudinal**

Distance (ft): **80.4**  
Structural Grade: **3**  
O&M Grade: **0**  
Clock Start/From: **9**  
Clock To:  
1st Value:  
2nd Value:  
Value Percent:  
Continuous Index:  
Within 8" of Joint: **YES**  
Remarks:

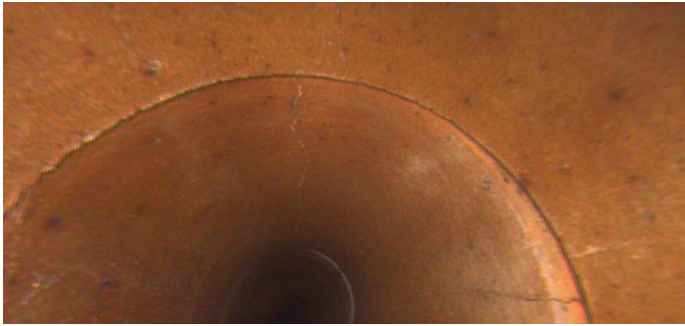
Code: **FL**  
Description: **Fracture Longitudinal**

Distance (ft): **82.7**  
Structural Grade: **3**  
O&M Grade: **0**  
Clock Start/From: **12**  
Clock To:  
1st Value:  
2nd Value:  
Value Percent:  
Continuous Index:  
Within 8" of Joint: **YES**  
Remarks:

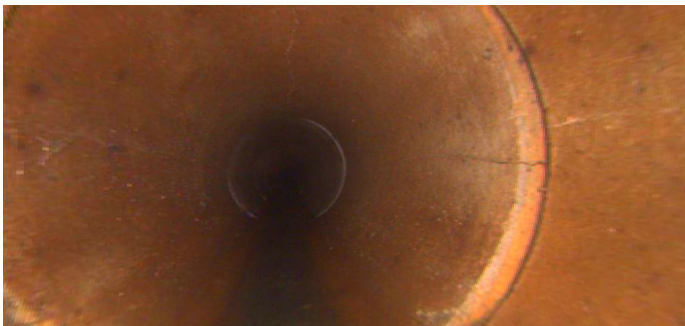
Code: **FL**  
Description: **Fracture Longitudinal**

Distance (ft): **82.7**  
Structural Grade: **3**  
O&M Grade: **0**  
Clock Start/From: **3**  
Clock To:  
1st Value:  
2nd Value:  
Value Percent:  
Continuous Index:  
Within 8" of Joint: **YES**  
Remarks:

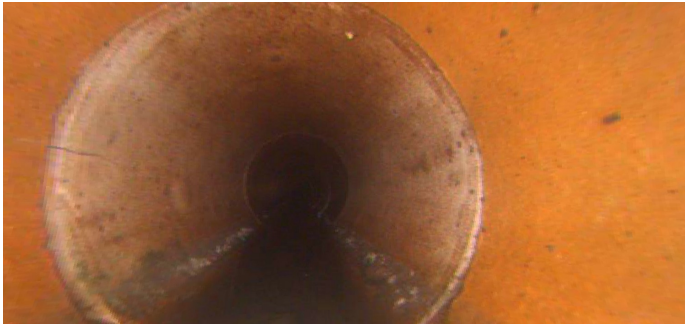
Code: **FL**  
Description: **Fracture Longitudinal**

Distance (ft): **88.5**  
Structural Grade: **3**  
O&M Grade: **0**  
Clock Start/From: **9**  
Clock To:  
1st Value:  
2nd Value:  
Value Percent:  
Continuous Index:  
Within 8" of Joint: **YES**  
Remarks:

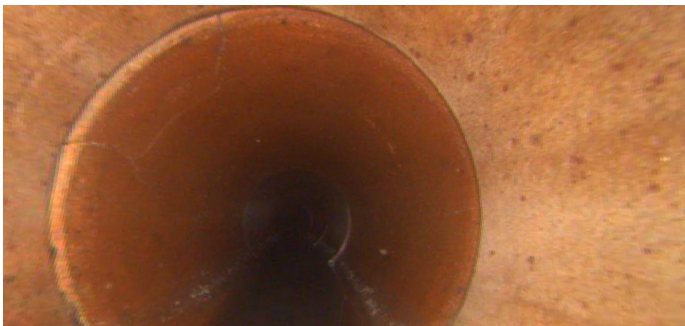
Code: **FS**  
Description: **Fracture Spiral**

Distance (ft): **90.4**  
Structural Grade: **3**  
O&M Grade: **0**  
Clock Start/From: **9**  
Clock To: **12**  
1st Value:  
2nd Value:  
Value Percent:  
Continuous Index:  
Within 8" of Joint: **YES**  
Remarks:

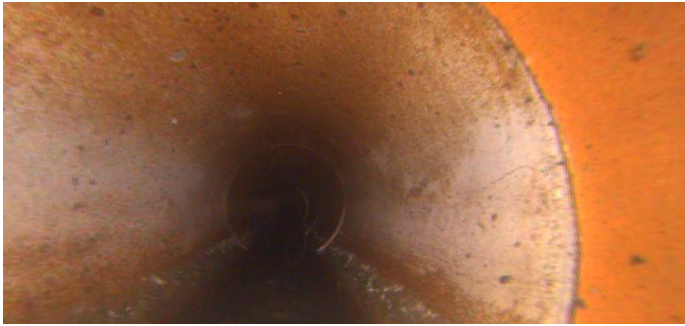
Code: **FL**  
Description: **Fracture Longitudinal**

Distance (ft): **92.7**  
Structural Grade: **3**  
O&M Grade: **0**  
Clock Start/From: **3**  
Clock To:  
1st Value:  
2nd Value:  
Value Percent:  
Continuous Index:  
Within 8" of Joint: **YES**  
Remarks:

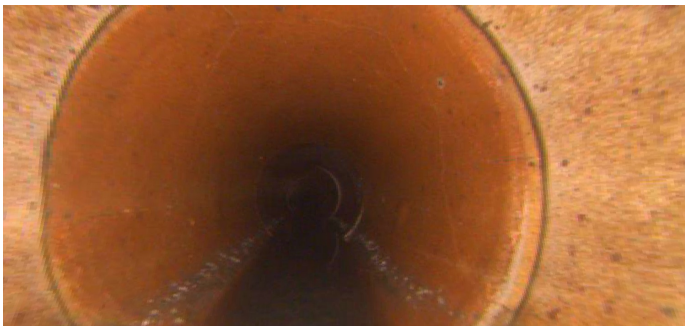
Code: **FC**  
Description: **Fracture Circumferential**

Distance (ft): **94.5**  
Structural Grade: **2**  
O&M Grade: **0**  
Clock Start/From: **9**  
Clock To: **4**  
1st Value:  
2nd Value:  
Value Percent:  
Continuous Index:  
Within 8" of Joint: **YES**  
Remarks:

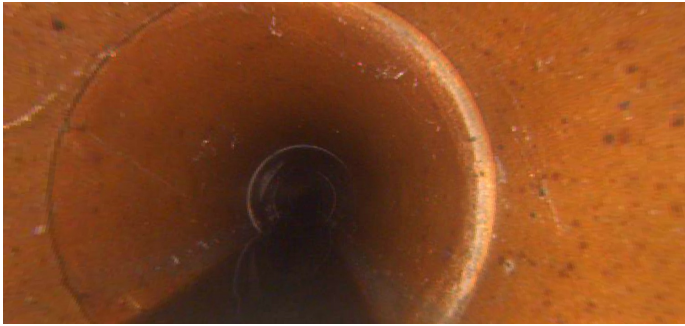
Code: **FL**  
Description: **Fracture Longitudinal**

Distance (ft): **98.4**  
Structural Grade: **3**  
O&M Grade: **0**  
Clock Start/From: **9**  
Clock To:  
1st Value:  
2nd Value:  
Value Percent:  
Continuous Index:  
Within 8" of Joint: **YES**  
Remarks:

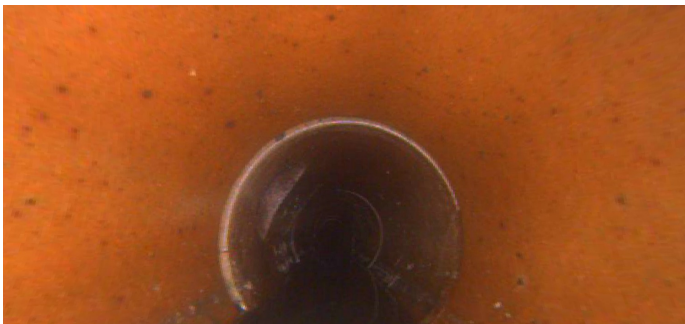
Code: **TF**  
Description: **Tap Factory**

Distance (ft): **99.9**  
Structural Grade: **0**  
O&M Grade: **0**  
Clock Start/From: **10**  
Clock To:  
1st Value: **4.000**  
2nd Value:  
Value Percent:  
Continuous Index:  
Within 8" of Joint:  
Remarks:

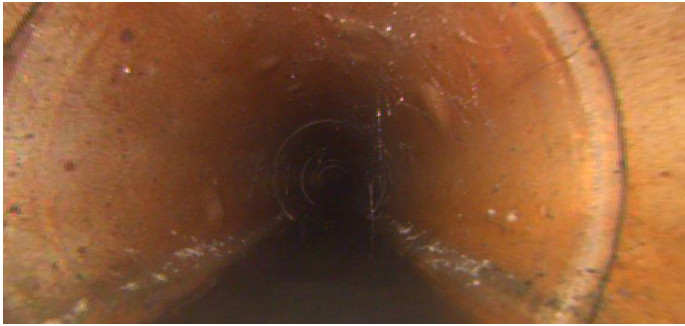
Code: **LFB**  
Description: **Lining Failure Blistered**

Distance (ft): **102.6**  
Structural Grade: **3**  
O&M Grade: **0**  
Clock Start/From: **7**  
Clock To: **5**  
1st Value:  
2nd Value:  
Value Percent:  
Continuous Index:  
Within 8" of Joint:  
Remarks:

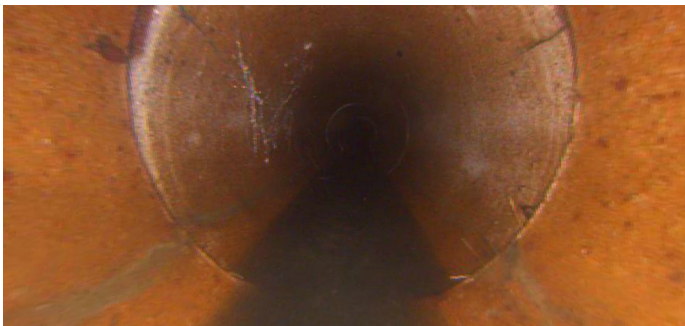
Code: **RFJ**  
Description: **Roots Fine Joint**

Distance (ft): **110.4**  
Structural Grade: **0**  
O&M Grade: **1**  
Clock Start/From: **4**  
Clock To: **5**  
1st Value:  
2nd Value:  
Value Percent:  
Continuous Index:  
Within 8" of Joint: **YES**  
Remarks:

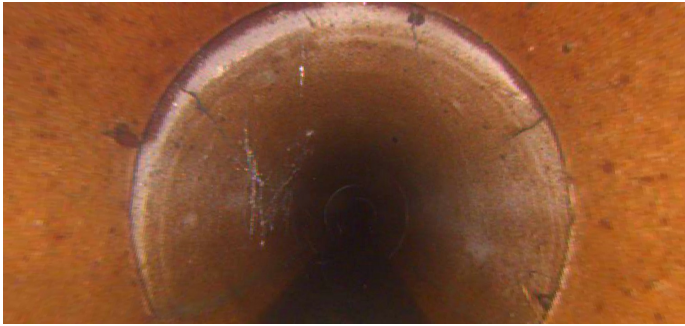
Code: **FL**  
Description: **Fracture Longitudinal**

Distance (ft): **110.4**  
Structural Grade: **3**  
O&M Grade: **0**  
Clock Start/From: **10**  
Clock To:  
1st Value:  
2nd Value:  
Value Percent:  
Continuous Index:  
Within 8" of Joint: **YES**  
Remarks:

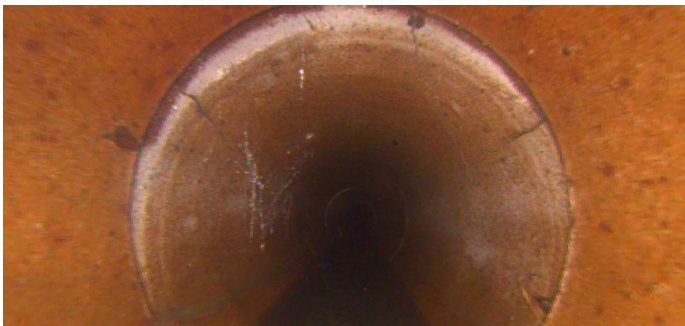
Code: **FL**  
Description: **Fracture Longitudinal**

Distance (ft): **110.4**  
Structural Grade: **3**  
O&M Grade: **0**  
Clock Start/From: **12**  
Clock To:  
1st Value:  
2nd Value:  
Value Percent:  
Continuous Index:  
Within 8" of Joint: **YES**  
Remarks:

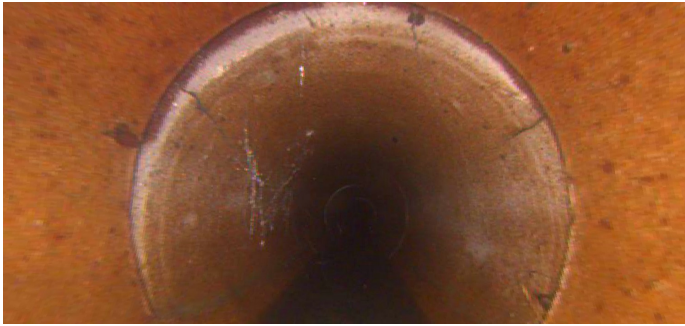
Code: **FL**  
Description: **Fracture Longitudinal**

Distance (ft): **110.4**  
Structural Grade: **3**  
O&M Grade: **0**  
Clock Start/From: **2**  
Clock To:  
1st Value:  
2nd Value:  
Value Percent:  
Continuous Index:  
Within 8" of Joint: **YES**  
Remarks:

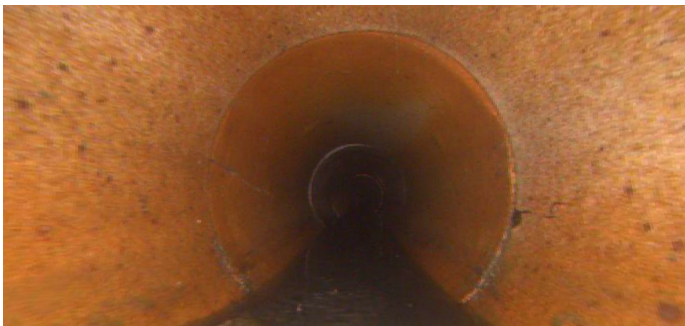
Code: **FL**  
Description: **Fracture Longitudinal**

Distance (ft): **112.1**  
Structural Grade: **3**  
O&M Grade: **0**  
Clock Start/From: **9**  
Clock To:  
1st Value:  
2nd Value:  
Value Percent:  
Continuous Index:  
Within 8" of Joint: **YES**  
Remarks:

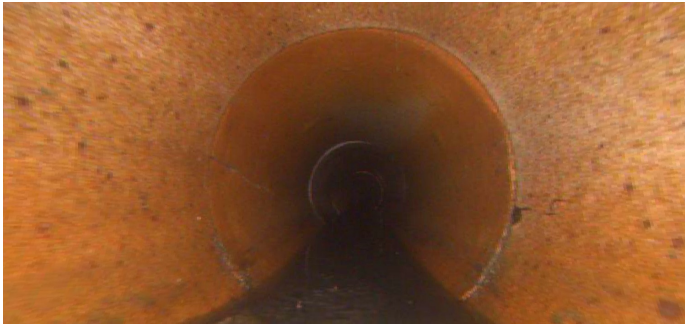
Code: **FL**  
Description: **Fracture Longitudinal**

Distance (ft): **112.1**  
Structural Grade: **3**  
O&M Grade: **0**  
Clock Start/From: **3**  
Clock To:  
1st Value:  
2nd Value:  
Value Percent:  
Continuous Index:  
Within 8" of Joint: **YES**  
Remarks:

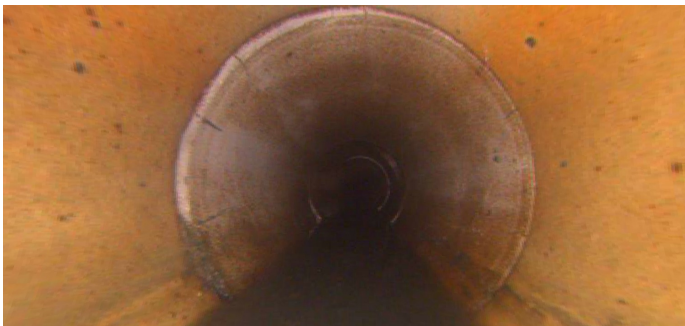
Code: **FL**  
Description: **Fracture Longitudinal**

Distance (ft): **114.2**  
Structural Grade: **3**  
O&M Grade: **0**  
Clock Start/From: **10**  
Clock To:  
1st Value:  
2nd Value:  
Value Percent:  
Continuous Index:  
Within 8" of Joint: **YES**  
Remarks:

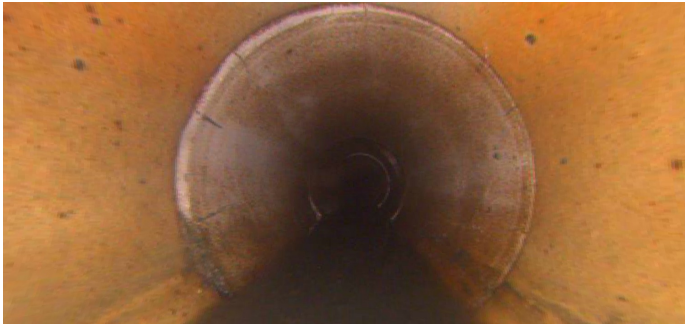
Code: **FL**  
Description: **Fracture Longitudinal**

Distance (ft): **114.2**  
Structural Grade: **3**  
O&M Grade: **0**  
Clock Start/From: **11**  
Clock To:  
1st Value:  
2nd Value:  
Value Percent:  
Continuous Index:  
Within 8" of Joint: **YES**  
Remarks:

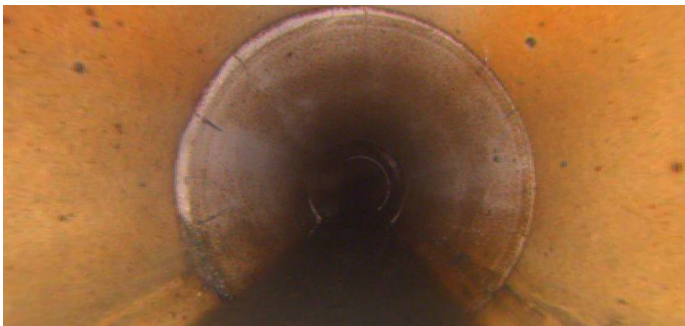
Code: **FL**  
Description: **Fracture Longitudinal**

Distance (ft): **114.2**  
Structural Grade: **3**  
O&M Grade: **0**  
Clock Start/From: **12**  
Clock To:  
1st Value:  
2nd Value:  
Value Percent:  
Continuous Index:  
Within 8" of Joint: **YES**  
Remarks:

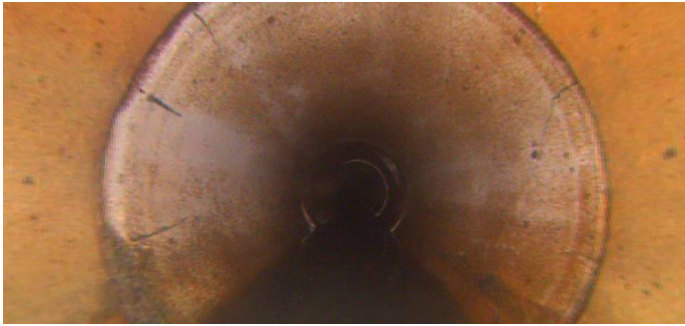
Code: **FL**  
Description: **Fracture Longitudinal**

Distance (ft): **114.5**  
Structural Grade: **3**  
O&M Grade: **0**  
Clock Start/From: **2**  
Clock To:  
1st Value:  
2nd Value:  
Value Percent:  
Continuous Index:  
Within 8" of Joint: **YES**  
Remarks:

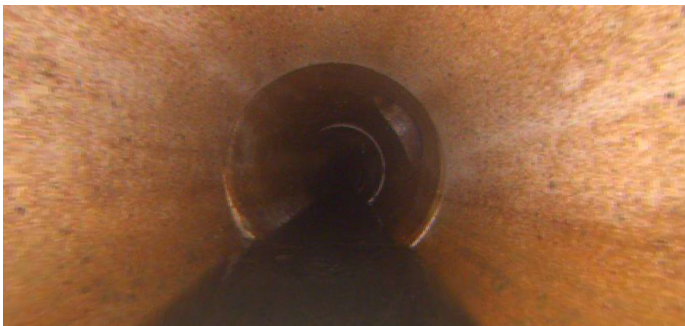
Code: **TF**  
Description: **Tap Factory**

Distance (ft): **115.8**  
Structural Grade: **0**  
O&M Grade: **0**  
Clock Start/From: **2**  
Clock To:  
1st Value: **4.000**  
2nd Value:  
Value Percent:  
Continuous Index:  
Within 8" of Joint:  
Remarks:

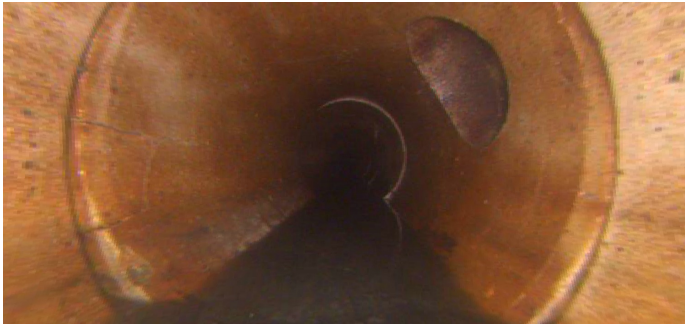
Code: **FM**  
Description: **Fracture Multiple**

Distance (ft): **116.5**  
Structural Grade: **4**  
O&M Grade: **0**  
Clock Start/From: **8**  
Clock To: **3**  
1st Value:  
2nd Value:  
Value Percent:  
Continuous Index:  
Within 8" of Joint: **YES**  
Remarks:

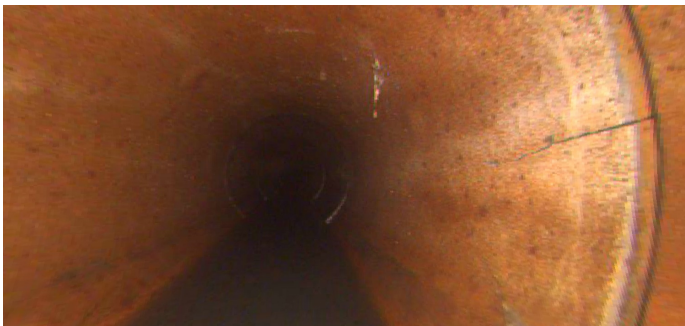
Code: **FL**  
Description: **Fracture Longitudinal**

Distance (ft): **118.4**  
Structural Grade: **3**  
O&M Grade: **0**  
Clock Start/From: **3**  
Clock To:  
1st Value:  
2nd Value:  
Value Percent:  
Continuous Index:  
Within 8" of Joint: **YES**  
Remarks:

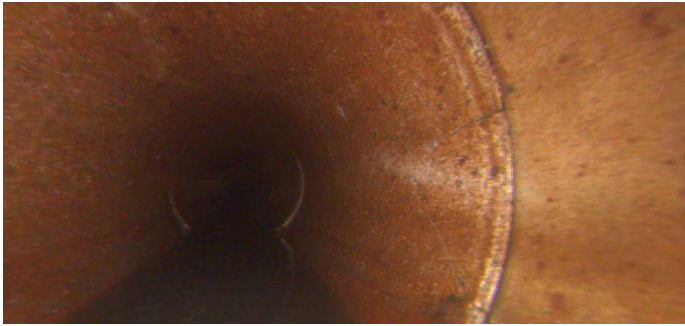
Code: **FS**  
Description: **Fracture Spiral**

Distance (ft): **120.6**  
Structural Grade: **3**  
O&M Grade: **0**  
Clock Start/From: **2**  
Clock To: **4**  
1st Value:  
2nd Value:  
Value Percent:  
Continuous Index:  
Within 8" of Joint: **YES**  
Remarks:

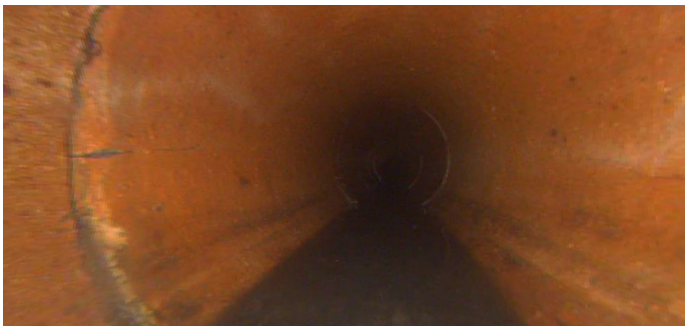
Code: **FL**  
Description: **Fracture Longitudinal**

Distance (ft): **122.6**  
Structural Grade: **3**  
O&M Grade: **0**  
Clock Start/From: **9**  
Clock To:  
1st Value:  
2nd Value:  
Value Percent:  
Continuous Index:  
Within 8" of Joint: **YES**  
Remarks:

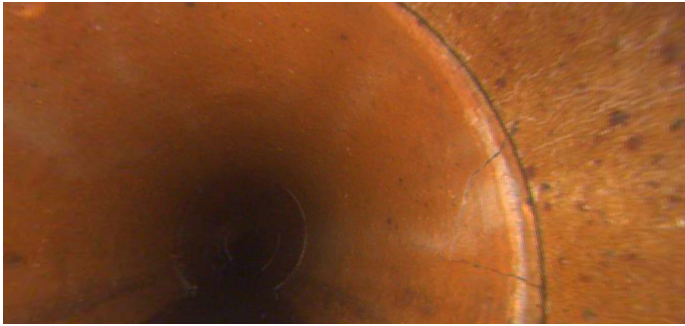
Code: **FS**  
Description: **Fracture Spiral**

Distance (ft): **122.6**  
Structural Grade: **3**  
O&M Grade: **0**  
Clock Start/From: **2**  
Clock To: **3**  
1st Value:  
2nd Value:  
Value Percent:  
Continuous Index:  
Within 8" of Joint: **YES**  
Remarks:

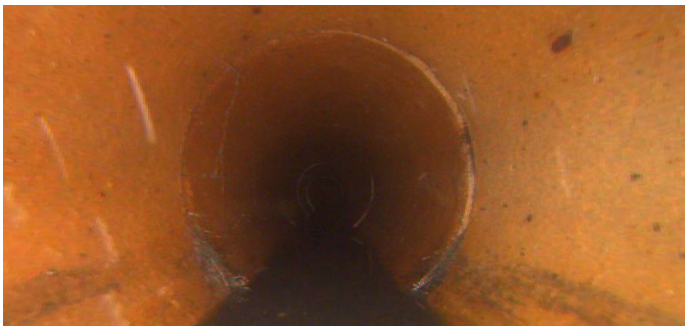
Code: **RFJ**  
Description: **Roots Fine Joint**

Distance (ft): **124.1**  
Structural Grade: **0**  
O&M Grade: **1**  
Clock Start/From: **7**  
Clock To: **5**  
1st Value:  
2nd Value:  
Value Percent:  
Continuous Index:  
Within 8" of Joint: **YES**  
Remarks:

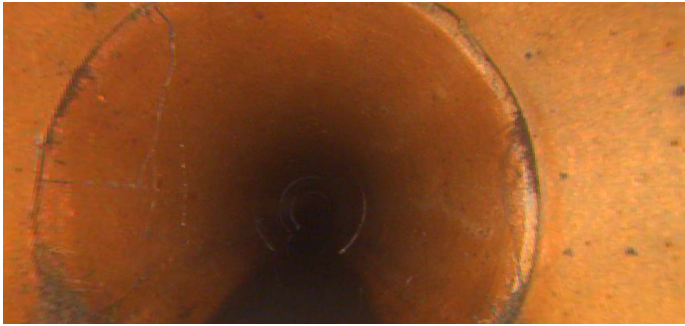
Code: **FS**  
Description: **Fracture Spiral**

Distance (ft): **124.3**  
Structural Grade: **3**  
O&M Grade: **0**  
Clock Start/From: **9**  
Clock To: **4**  
1st Value:  
2nd Value:  
Value Percent:  
Continuous Index:  
Within 8" of Joint: **YES**  
Remarks:

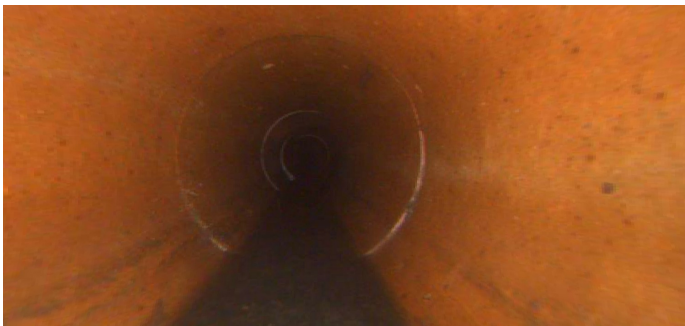
Code: **RFJ**  
Description: **Roots Fine Joint**

Distance (ft): **125.8**  
Structural Grade: **0**  
O&M Grade: **1**  
Clock Start/From: **7**  
Clock To: **5**  
1st Value:  
2nd Value:  
Value Percent:  
Continuous Index:  
Within 8" of Joint: **YES**  
Remarks:

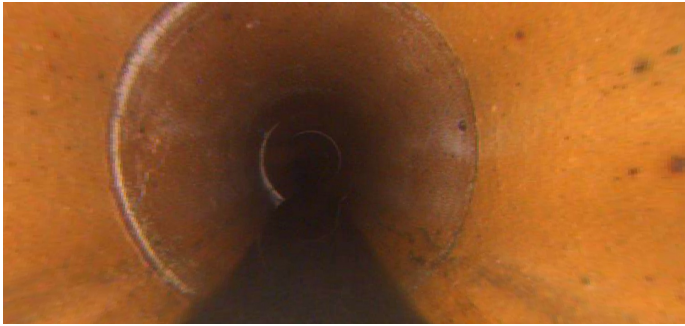
Code: **RFJ**  
Description: **Roots Fine Joint**

Distance (ft): **128.1**  
Structural Grade: **0**  
O&M Grade: **1**  
Clock Start/From: **4**  
Clock To:  
1st Value:  
2nd Value:  
Value Percent:  
Continuous Index:  
Within 8" of Joint: **YES**  
Remarks:

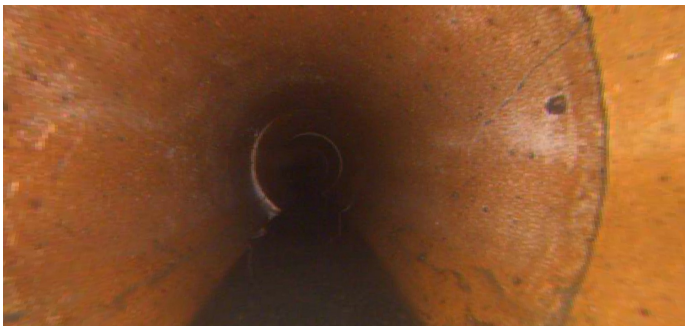
Code: **FL**  
Description: **Fracture Longitudinal**

Distance (ft): **128.5**  
Structural Grade: **3**  
O&M Grade: **0**  
Clock Start/From: **2**  
Clock To:  
1st Value:  
2nd Value:  
Value Percent:  
Continuous Index:  
Within 8" of Joint: **YES**  
Remarks:

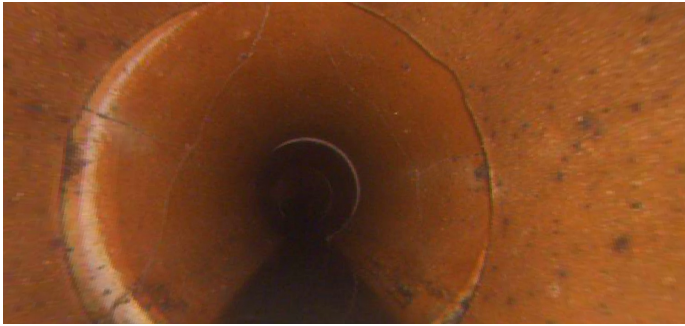
Code: **FM**  
Description: **Fracture Multiple**

Distance (ft): **130.2**  
Structural Grade: **4**  
O&M Grade: **0**  
Clock Start/From: **7**  
Clock To: **5**  
1st Value:  
2nd Value:  
Value Percent:  
Continuous Index:  
Within 8" of Joint: **YES**  
Remarks:

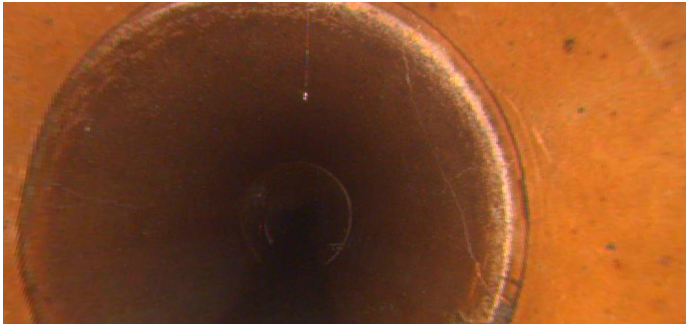
Code: **FL**  
Description: **Fracture Longitudinal**

Distance (ft): **132.4**  
Structural Grade: **3**  
O&M Grade: **0**  
Clock Start/From: **9**  
Clock To:  
1st Value:  
2nd Value:  
Value Percent:  
Continuous Index:  
Within 8" of Joint: **YES**  
Remarks:

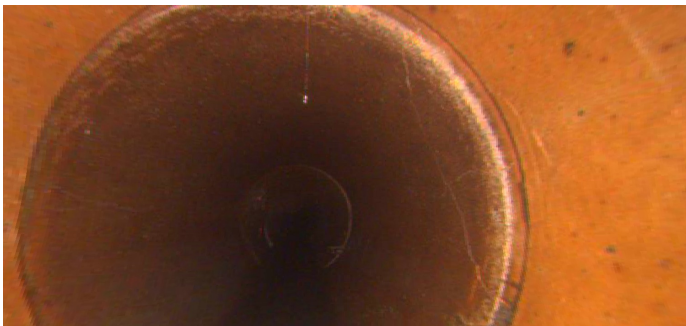
Code: **FS**  
Description: **Fracture Spiral**

Distance (ft): **132.4**  
Structural Grade: **3**  
O&M Grade: **0**  
Clock Start/From: **1**  
Clock To: **4**  
1st Value:  
2nd Value:  
Value Percent:  
Continuous Index:  
Within 8" of Joint: **YES**  
Remarks:

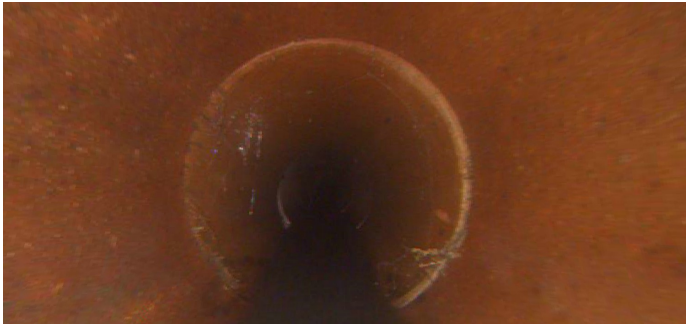
Code: **FM**  
Description: **Fracture Multiple**

Distance (ft): **134.0**  
Structural Grade: **4**  
O&M Grade: **0**  
Clock Start/From: **7**  
Clock To: **5**  
1st Value:  
2nd Value:  
Value Percent:  
Continuous Index:  
Within 8" of Joint: **YES**  
Remarks:

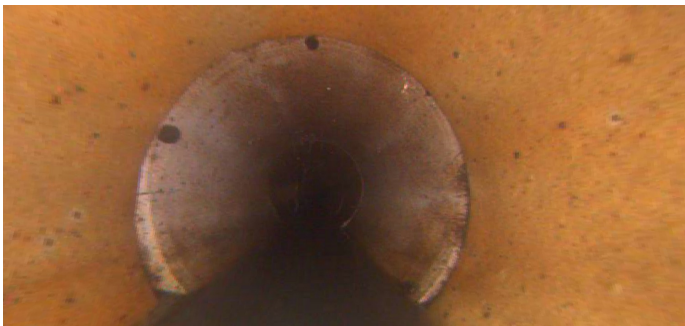
Code: **FL**  
Description: **Fracture Longitudinal**

Distance (ft): **136.1**  
Structural Grade: **3**  
O&M Grade: **0**  
Clock Start/From: **9**  
Clock To:  
1st Value:  
2nd Value:  
Value Percent:  
Continuous Index:  
Within 8" of Joint: **YES**  
Remarks:

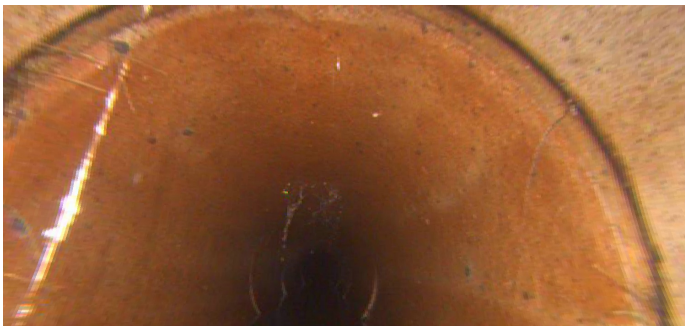
Code: **FS**  
Description: **Fracture Spiral**

Distance (ft): **138.6**  
Structural Grade: **3**  
O&M Grade: **0**  
Clock Start/From: **2**  
Clock To: **3**  
1st Value:  
2nd Value:  
Value Percent:  
Continuous Index:  
Within 8" of Joint: **YES**  
Remarks:

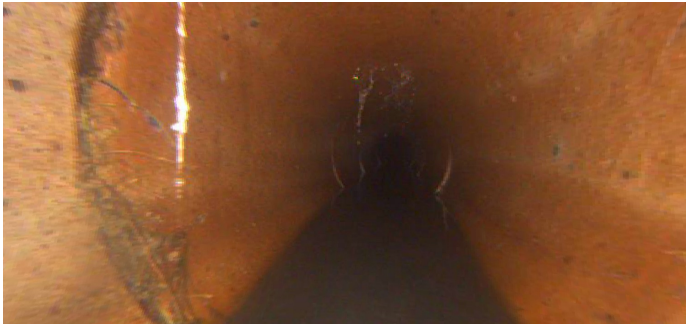
Code: **FL**  
Description: **Fracture Longitudinal**

Distance (ft): **138.6**  
Structural Grade: **3**  
O&M Grade: **0**  
Clock Start/From: **9**  
Clock To:  
1st Value:  
2nd Value:  
Value Percent:  
Continuous Index:  
Within 8" of Joint: **YES**  
Remarks:

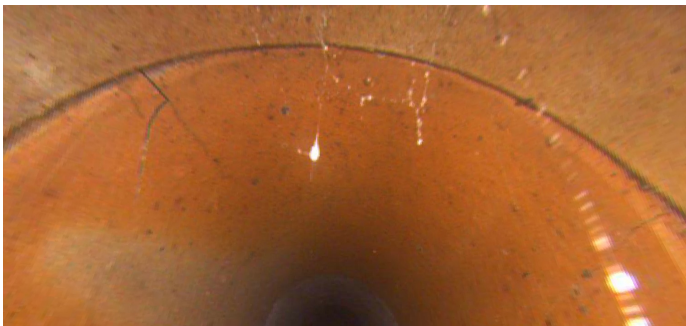
Code: **FL**  
Description: **Fracture Longitudinal**

Distance (ft): **140.6**  
Structural Grade: **3**  
O&M Grade: **0**  
Clock Start/From: **11**  
Clock To:  
1st Value:  
2nd Value:  
Value Percent:  
Continuous Index:  
Within 8" of Joint: **YES**  
Remarks:

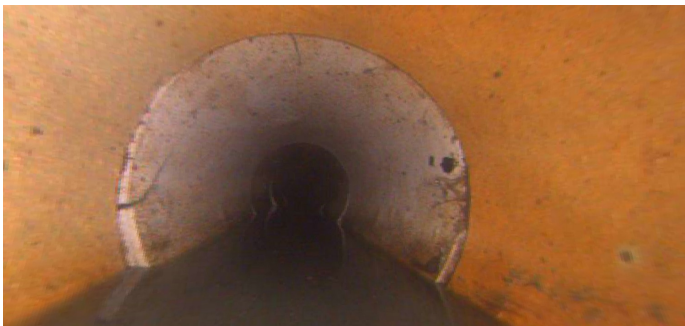
Code: **FL**  
Description: **Fracture Longitudinal**

Distance (ft): **142.1**  
Structural Grade: **3**  
O&M Grade: **0**  
Clock Start/From: **12**  
Clock To:  
1st Value:  
2nd Value:  
Value Percent:  
Continuous Index:  
Within 8" of Joint: **YES**  
Remarks:

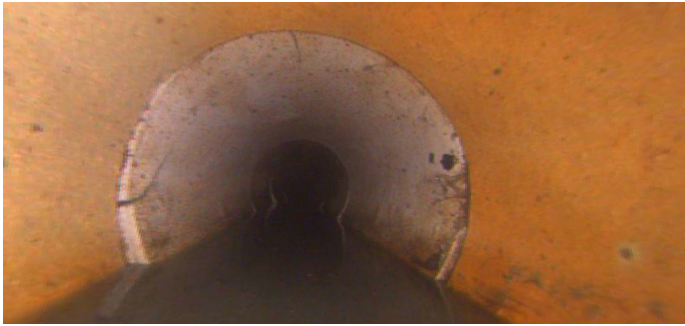
Code: **FL**  
Description: **Fracture Longitudinal**

Distance (ft): **142.1**  
Structural Grade: **3**  
O&M Grade: **0**  
Clock Start/From: **9**  
Clock To:  
1st Value:  
2nd Value:  
Value Percent:  
Continuous Index:  
Within 8" of Joint: **YES**  
Remarks:

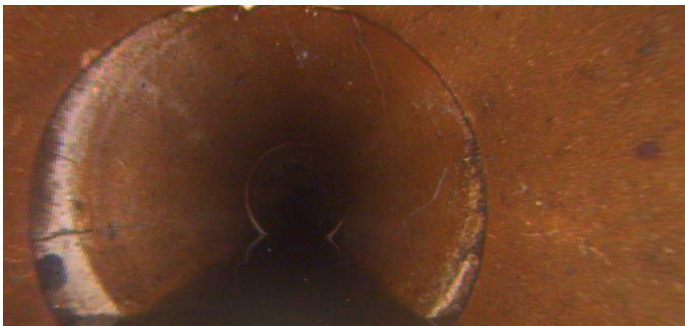
Code: **FM**  
Description: **Fracture Multiple**

Distance (ft): **146.3**  
Structural Grade: **4**  
O&M Grade: **0**  
Clock Start/From: **9**  
Clock To: **4**  
1st Value:  
2nd Value:  
Value Percent:  
Continuous Index:  
Within 8" of Joint: **YES**  
Remarks:

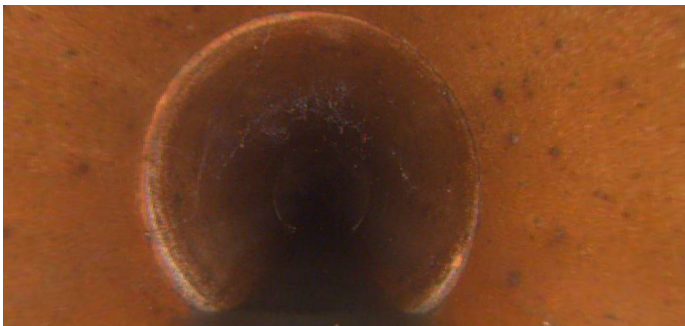
Code: **FM**  
Description: **Fracture Multiple**

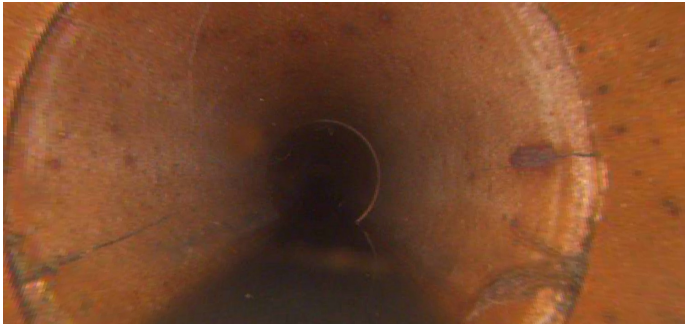
Code: **FL**  
Description: **Fracture Longitudinal**

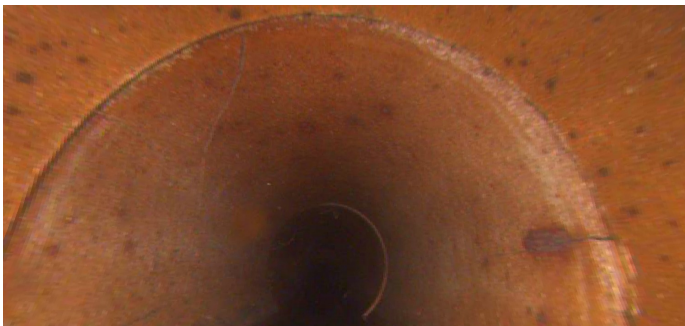
Code: **FL**  
Description: **Fracture Longitudinal**

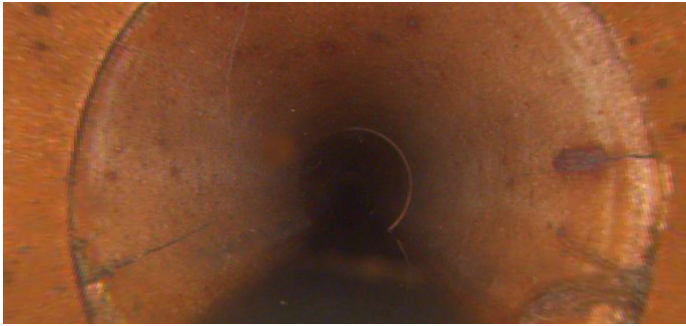
Code: **FL**  
Description: **Fracture Longitudinal**

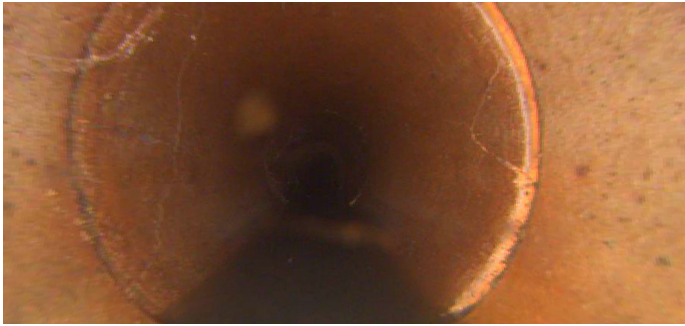
Code: **FM**  
Description: **Fracture Multiple**

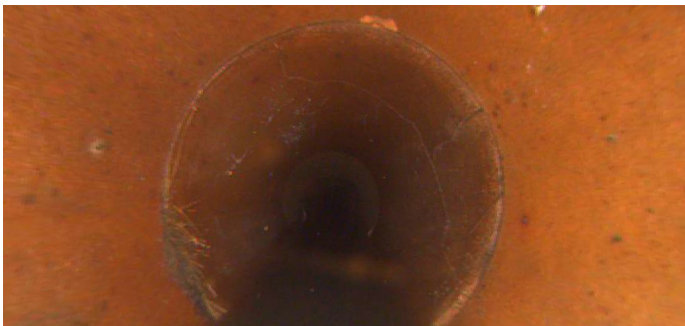
Code: **RFJ**  
Description: **Roots Fine Joint**

Distance (ft): **158.2**  
Structural Grade: **0**  
O&M Grade: **1**  
Clock Start/From: **7**  
Clock To: **5**  
1st Value:  
2nd Value:  
Value Percent:  
Continuous Index:  
Within 8" of Joint: **YES**  
Remarks:

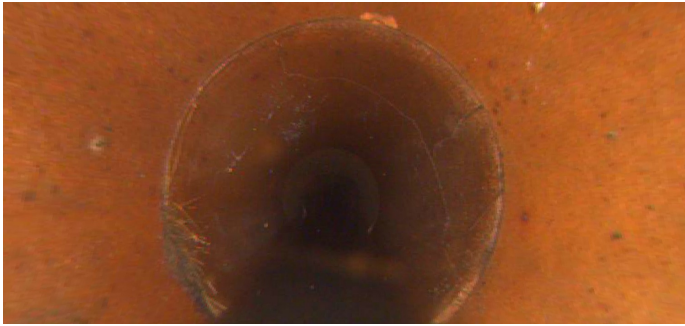
Code: **FM**  
Description: **Fracture Multiple**

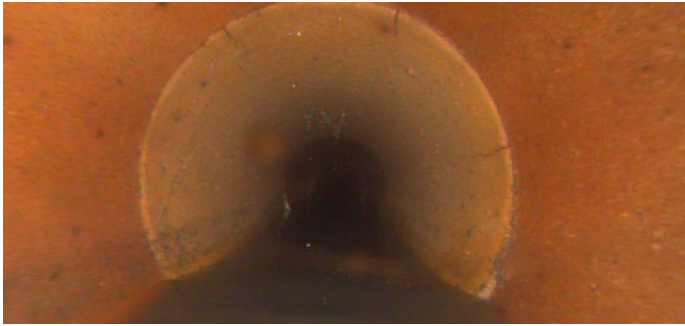
Code: **FL**  
Description: **Fracture Longitudinal**

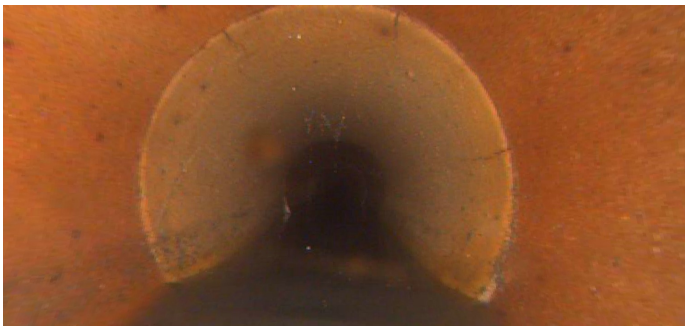
Code: **FL**  
Description: **Fracture Longitudinal**

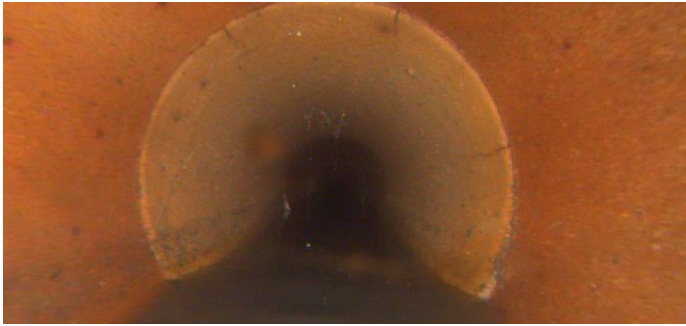
Code: **FL**  
Description: **Fracture Longitudinal**

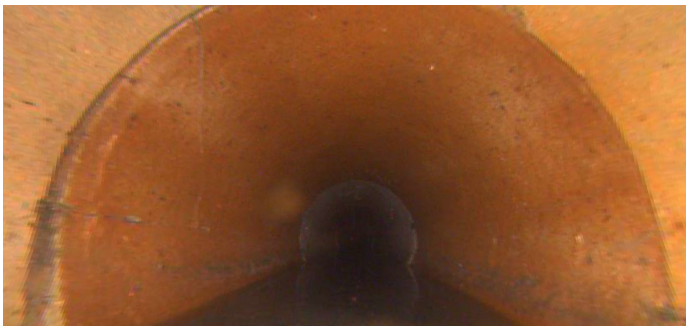
Code: **FS**  
Description: **Fracture Spiral**
