# Profile/Photo Observation Report

Street:	<b>HIGH ST &amp; N KELLY ST</b>	Flow Control:	<b>Not Controlled</b>
City:	<b>Hobart, IN</b>	Year Renewed:	
Location:	<b>Light Highway</b>	Tape/Media #:	
Purpose:	<b>Routine Assessment</b>	Dia/Height:	<b>12"</b>
Use:	<b>Sanitary</b>	Material:	<b>VCP</b>
Drain Area:	<b>NA</b>	Lining:	
Category:	<b>NA</b>		
Comment:			
Location Details:		Direction of Survey:	<b>Downstream</b>
US MH:	<b>M-803-046</b>	DS MH:	<b>M-804-056</b>
		Total Length Surveyed (ft):	<b>225.6</b>

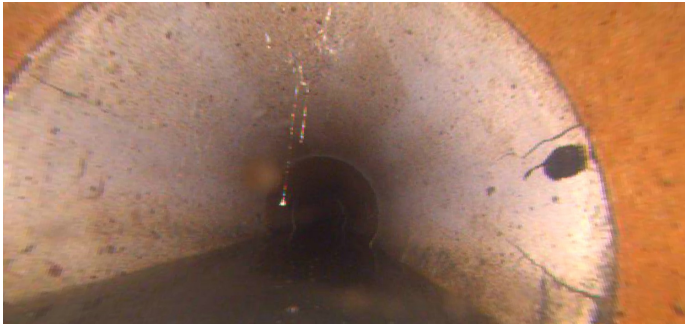
Code: **FL**  
Description: **Fracture Longitudinal**

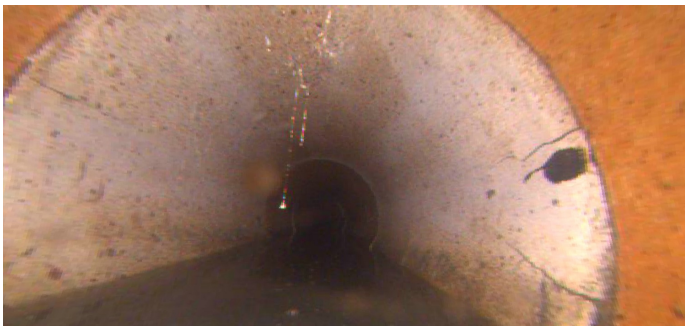
Code: **FL**  
Description: **Fracture Longitudinal**

Distance (ft): **164.6**  
Structural Grade: **3**  
O&M Grade: **0**  
Clock Start/From: **4**  
Clock To:  
1st Value:  
2nd Value:  
Value Percent:  
Continuous Index:  
Within 8" of Joint: **YES**  
Remarks:

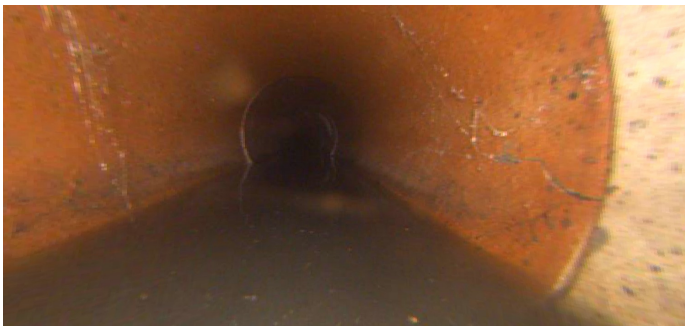
Code: **FL**  
Description: **Fracture Longitudinal**

Distance (ft): **166.7**  
Structural Grade: **3**  
O&M Grade: **0**  
Clock Start/From: **4**  
Clock To:  
1st Value:  
2nd Value:  
Value Percent:  
Continuous Index:  
Within 8" of Joint: **YES**  
Remarks:

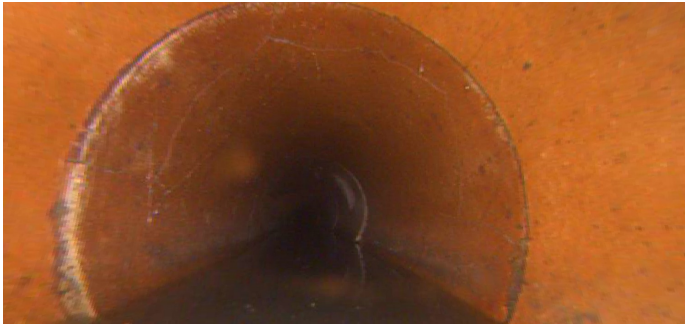
Code: **RFJ**  
Description: **Roots Fine Joint**

Distance (ft): **168.4**  
Structural Grade: **0**  
O&M Grade: **1**  
Clock Start/From: **4**  
Clock To:  
1st Value:  
2nd Value:  
Value Percent:  
Continuous Index:  
Within 8" of Joint: **YES**  
Remarks:

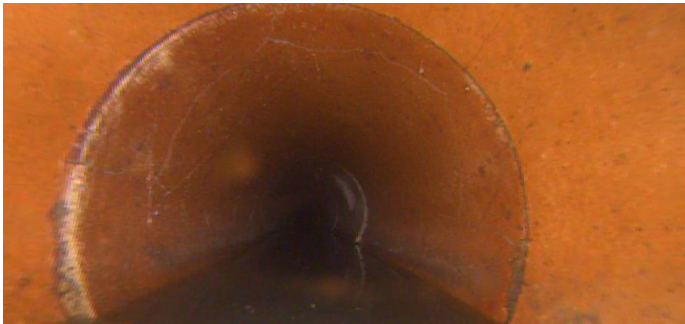
Code: **FM**  
Description: **Fracture Multiple**

Distance (ft): **168.4**  
Structural Grade: **4**  
O&M Grade: **0**  
Clock Start/From: **9**  
Clock To: **4**  
1st Value:  
2nd Value:  
Value Percent:  
Continuous Index:  
Within 8" of Joint: **YES**  
Remarks:

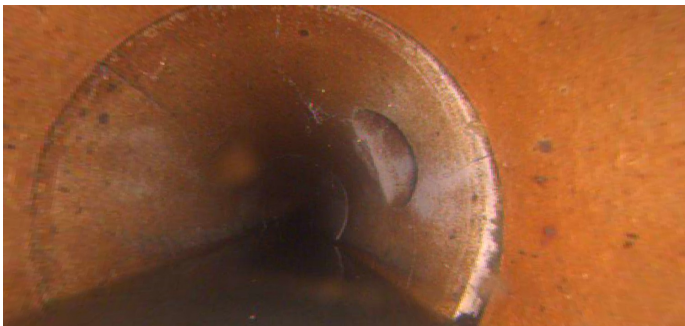
Code: **FL**  
Description: **Fracture Longitudinal**

Distance (ft): **170.4**  
Structural Grade: **3**  
O&M Grade: **0**  
Clock Start/From: **3**  
Clock To:  
1st Value:  
2nd Value:  
Value Percent:  
Continuous Index:  
Within 8" of Joint: **YES**  
Remarks:

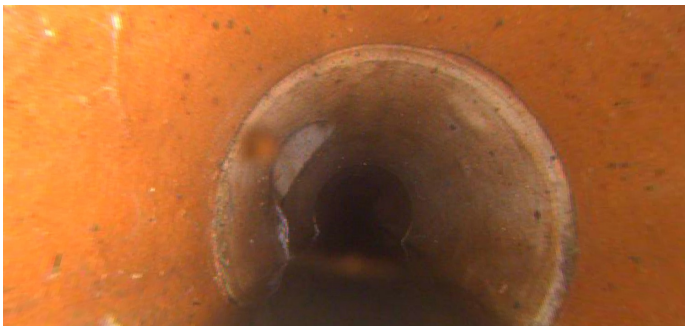
Code: **TF**  
Description: **Tap Factory**

Distance (ft): **178.3**  
Structural Grade: **0**  
O&M Grade: **0**  
Clock Start/From: **10**  
Clock To:  
1st Value: **4.000**  
2nd Value:  
Value Percent:  
Continuous Index:  
Within 8" of Joint:  
Remarks:

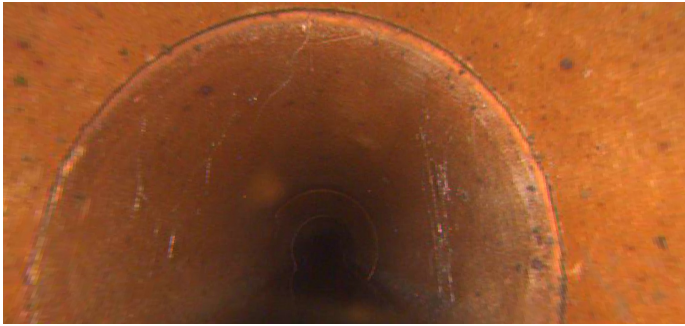
Code: **FS**  
Description: **Fracture Spiral**

Distance (ft): **182.6**  
Structural Grade: **3**  
O&M Grade: **0**  
Clock Start/From: **9**  
Clock To: **12**  
1st Value:  
2nd Value:  
Value Percent:  
Continuous Index:  
Within 8" of Joint: **YES**  
Remarks:

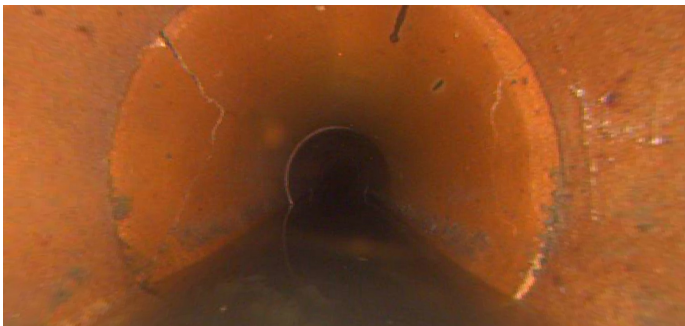
Code: **FS**  
Description: **Fracture Spiral**

Distance (ft): **184.5**  
Structural Grade: **3**  
O&M Grade: **0**  
Clock Start/From: **7**  
Clock To: **10**  
1st Value:  
2nd Value:  
Value Percent:  
Continuous Index:  
Within 8" of Joint: **YES**  
Remarks:

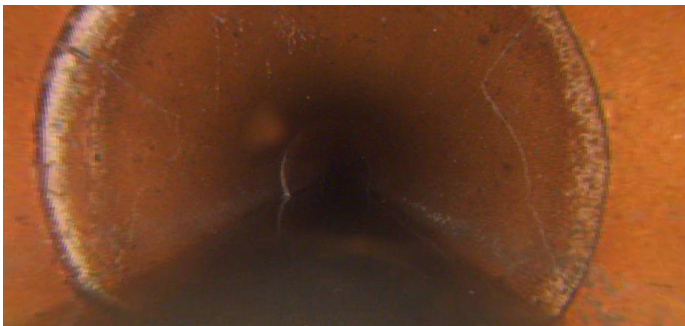
Code: **FS**  
Description: **Fracture Spiral**

Distance (ft): **192.6**  
Structural Grade: **3**  
O&M Grade: **0**  
Clock Start/From: **7**  
Clock To: **10**  
1st Value:  
2nd Value:  
Value Percent:  
Continuous Index:  
Within 8" of Joint: **YES**  
Remarks:

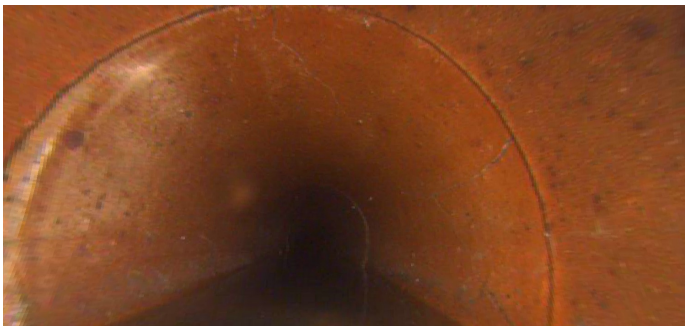
Code: **FM**  
Description: **Fracture Multiple**

Distance (ft): **194.7**  
Structural Grade: **4**  
O&M Grade: **0**  
Clock Start/From: **12**  
Clock To: **4**  
1st Value:  
2nd Value:  
Value Percent:  
Continuous Index:  
Within 8" of Joint: **YES**  
Remarks:

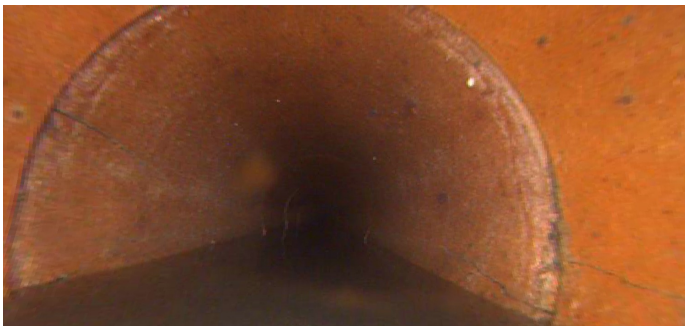
Code: **FL**  
Description: **Fracture Longitudinal**

Distance (ft): **196.7**  
Structural Grade: **3**  
O&M Grade: **0**  
Clock Start/From: **8**  
Clock To:  
1st Value:  
2nd Value:  
Value Percent:  
Continuous Index:  
Within 8" of Joint: **YES**  
Remarks:

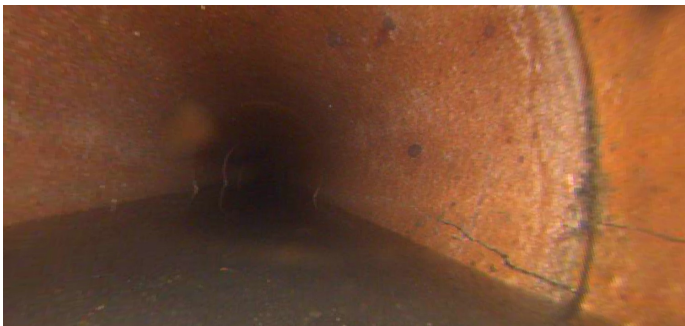
Code: **RFJ**  
Description: **Roots Fine Joint**

Distance (ft): **196.9**  
Structural Grade: **0**  
O&M Grade: **1**  
Clock Start/From: **3**  
Clock To:  
1st Value:  
2nd Value:  
Value Percent:  
Continuous Index:  
Within 8" of Joint: **YES**  
Remarks:

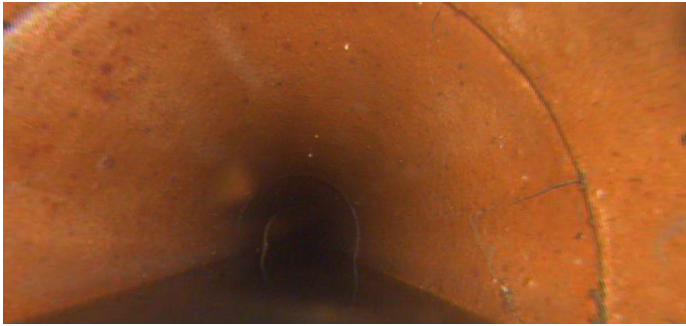
Code: **FC**  
Description: **Fracture Circumferential**

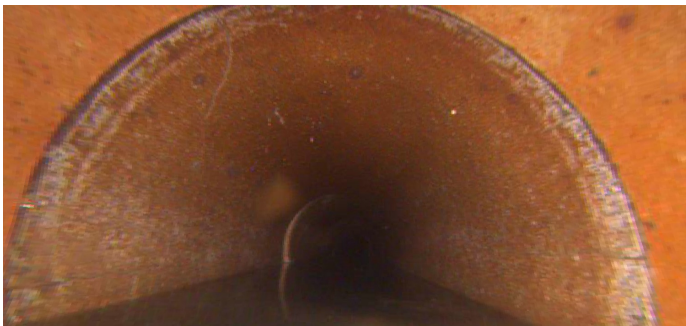
Code: **FL**  
Description: **Fracture Longitudinal**

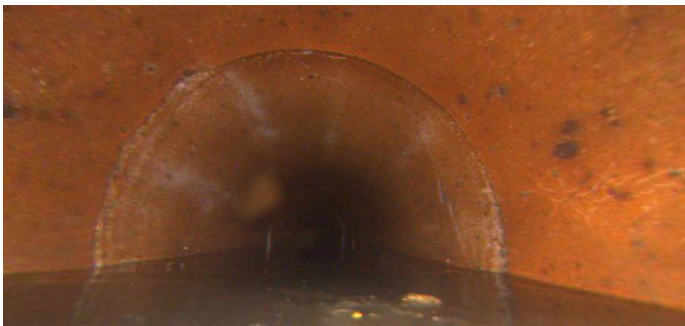
Code: **FC**  
Description: **Fracture Circumferential**

Distance (ft): **206.4**  
Structural Grade: **2**  
O&M Grade: **0**  
Clock Start/From: **12**  
Clock To: **4**  
1st Value:  
2nd Value:  
Value Percent:  
Continuous Index:  
Within 8" of Joint: **YES**  
Remarks:

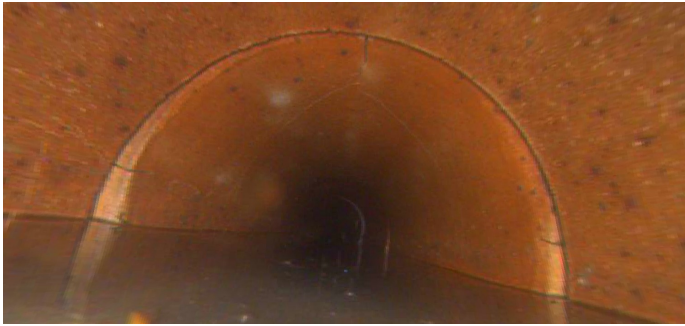
Code: **FM**  
Description: **Fracture Multiple**

Distance (ft): **208.6**  
Structural Grade: **4**  
O&M Grade: **0**  
Clock Start/From: **8**  
Clock To: **4**  
1st Value:  
2nd Value:  
Value Percent:  
Continuous Index:  
Within 8" of Joint: **YES**  
Remarks:

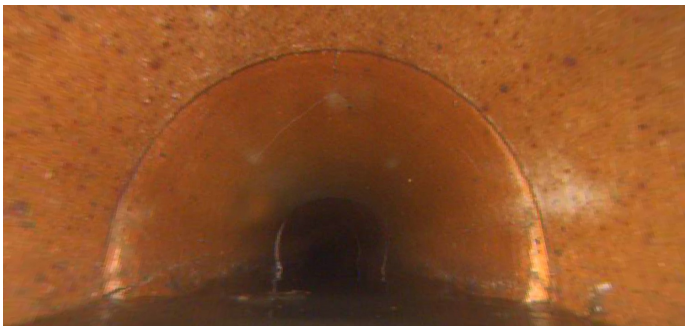
Code: **FM**  
Description: **Fracture Multiple**

Distance (ft): **216.7**  
Structural Grade: **4**  
O&M Grade: **0**  
Clock Start/From: **8**  
Clock To: **4**  
1st Value:  
2nd Value:  
Value Percent:  
Continuous Index:  
Within 8" of Joint: **YES**  
Remarks:

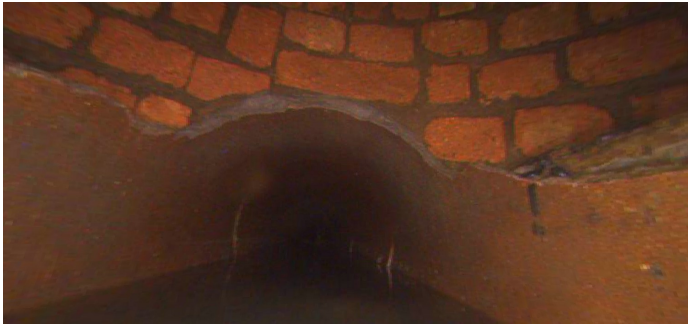
Code:	<b>AMH</b>
Description:	<b>Manhole</b>
Distance (ft):	<b>225.6</b>
Structural Grade:	<b>0</b>
O&M Grade:	<b>0</b>
Clock Start/From:	
Clock To:	
1st Value:	
2nd Value:	
Value Percent:	
Continuous Index:	
Within 8" of Joint:	<b>NO</b>
Remarks:	<b>M-804-056</b>
