## Profile/Photo Observation Report

Date:	<b>04/04/2018</b>	Weather:		Coding:	<b>PACP 6.0</b>
Pipe Length (ft):	<b>208.2</b>	Owner:	<b>NA</b>	Pre Clean:	<b>Not Known</b>
P.O.#:		Surveyor:	<b>Jen Costello</b>	PSR:	<b>P-803-048-046</b>
Customer:		Clean Date:	<b>01/01/1900</b>	Shape:	<b>C</b>

Street:	<b>N KELLY ST</b>	Flow Control:	<b>Not Controlled</b>
City:	<b>Hobart, IN</b>	Year Renewed:	
Location:	<b>Other</b>	Tape/Media #:	
Purpose:	<b>Not Known</b>	Dia/Height:	<b>12"</b>
Use:	<b>Sanitary</b>	Material:	<b>VCP</b>
Drain Area:	<b>NA</b>	Lining:	
Category:	<b>NA</b>		
Comment:

Location Details:		Direction of Survey:	<b>Upstream</b>
US MH:	<b>M-803-048</b>	DS MH:	<b>M-803-046</b>
		Total Length Surveyed (ft):	<b>193.7</b>

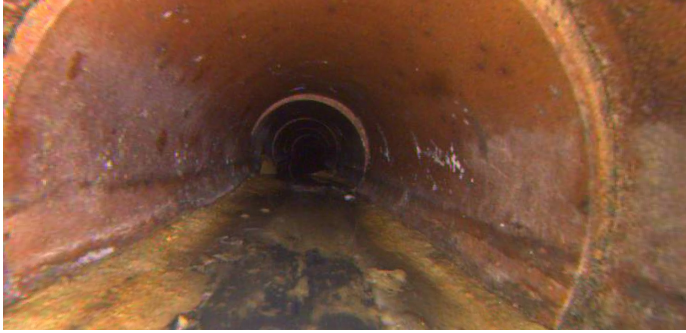
Code: **AMH**  
Description: **Manhole**

Distance (ft): **.0**  
Structural Grade: **0**  
O&M Grade: **0**  
Clock Start/From:  
Clock To:  
1st Value:  
2nd Value:  
Value Percent:  
Continuous Index:  
Within 8" of Joint: **NO**  
Remarks: **M-803-046**

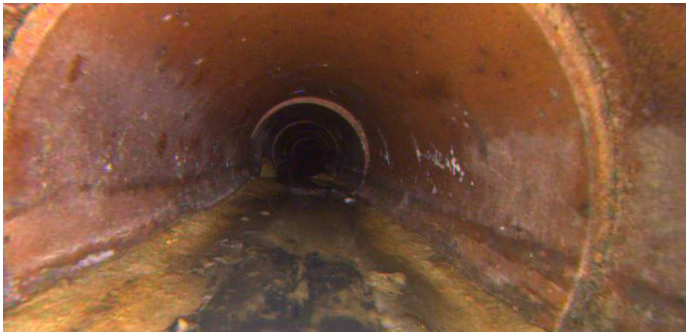
Code: **MWL**  
Description: **Water Level**

Distance (ft): **.0**  
Structural Grade: **0**  
O&M Grade: **0**  
Clock Start/From:  
Clock To:  
1st Value:  
2nd Value:  
Value Percent: **10.000**  
Continuous Index:  
Within 8" of Joint: **NO**  
Remarks:

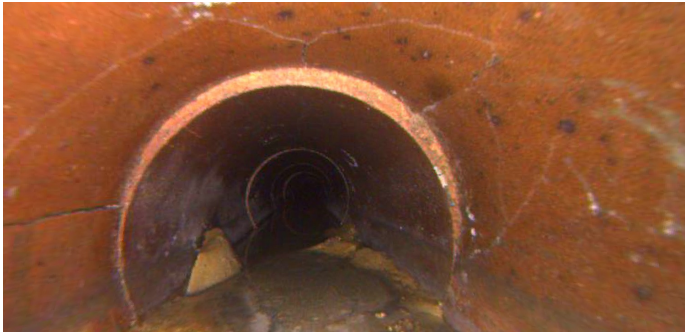
Code: **FM**  
Description: **Fracture Multiple**

Distance (ft): **2.4**  
Structural Grade: **4**  
O&M Grade: **0**  
Clock Start/From: **8**  
Clock To: **4**  
1st Value:  
2nd Value:  
Value Percent:  
Continuous Index: **S01**  
Within 8" of Joint: **YES**  
Remarks:

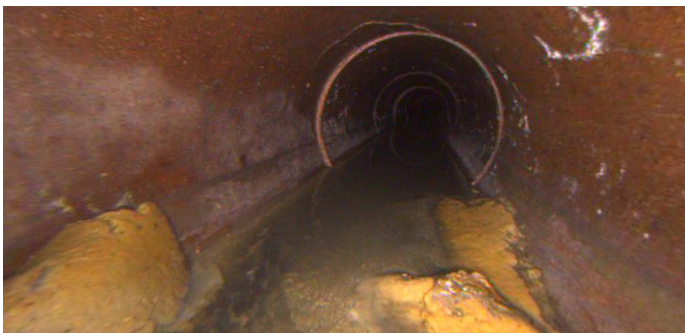
Code: **OBR**  
Description: **Obstacle Rocks**

Distance (ft): **3.4**  
Structural Grade: **0**  
O&M Grade: **2**  
Clock Start/From: **4**  
Clock To: **8**  
1st Value:  
2nd Value:  
Value Percent: **10.000**  
Continuous Index:  
Within 8" of Joint: **NO**  
Remarks:

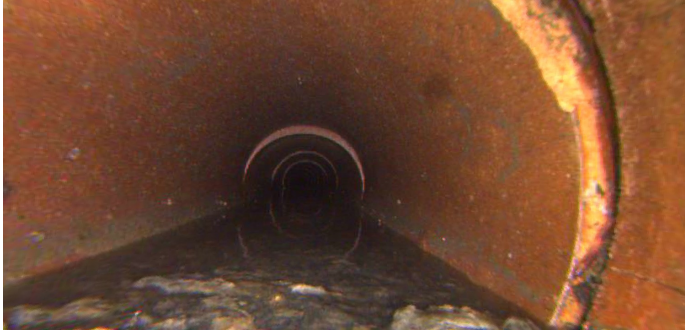
Code: **MWL**  
Description: **Water Level**

Distance (ft): **20.8**  
Structural Grade: **0**  
O&M Grade: **0**  
Clock Start/From:  
Clock To:  
1st Value:  
2nd Value:  
Value Percent: **20.000**  
Continuous Index:  
Within 8" of Joint: **NO**  
Remarks:

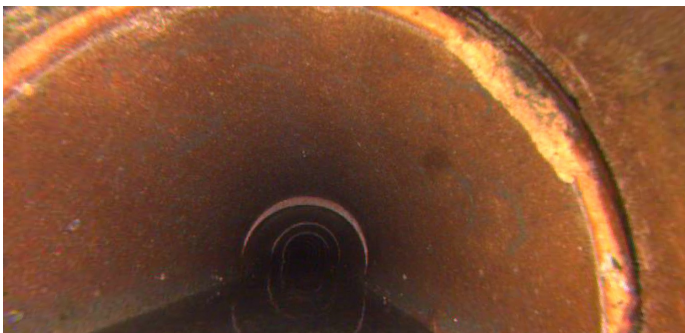
Code: **SSS**  
Description: **Surface Spalling**

Distance (ft): **20.8**  
Structural Grade: **2**  
O&M Grade: **0**  
Clock Start/From: **2**  
Clock To: **3**  
1st Value:  
2nd Value:  
Value Percent:  
Continuous Index:  
Within 8" of Joint: **YES**  
Remarks:

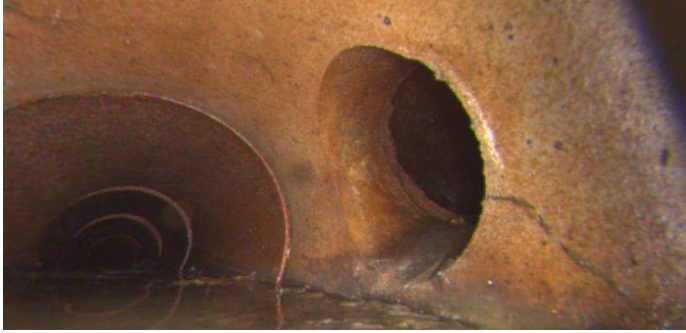
Code: **TF**  
Description: **Tap Factory**

Distance (ft): **28.2**  
Structural Grade: **0**  
O&M Grade: **0**  
Clock Start/From: **3**  
Clock To:  
1st Value: **4.000**  
2nd Value:  
Value Percent:  
Continuous Index:  
Within 8" of Joint:  
Remarks:

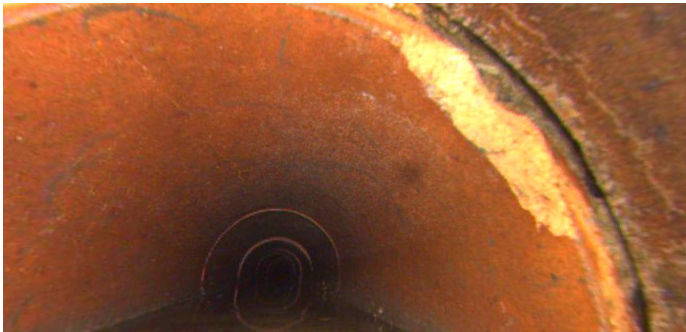
Code: **SSS**  
Description: **Surface Spalling**

Distance (ft): **33.1**  
Structural Grade: **2**  
O&M Grade: **0**  
Clock Start/From: **1**  
Clock To: **3**  
1st Value:  
2nd Value:  
Value Percent:  
Continuous Index:  
Within 8" of Joint: **YES**  
Remarks:

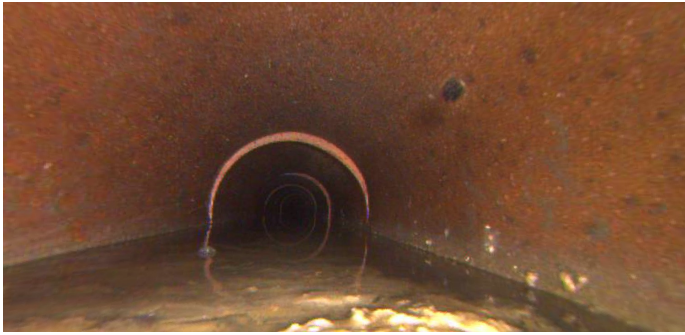
Code: **MWL**  
Description: **Water Level**

Distance (ft): **35.6**  
Structural Grade: **0**  
O&M Grade: **0**  
Clock Start/From:  
Clock To:  
1st Value:  
2nd Value:  
Value Percent: **30.000**  
Continuous Index:  
Within 8" of Joint: **NO**  
Remarks:

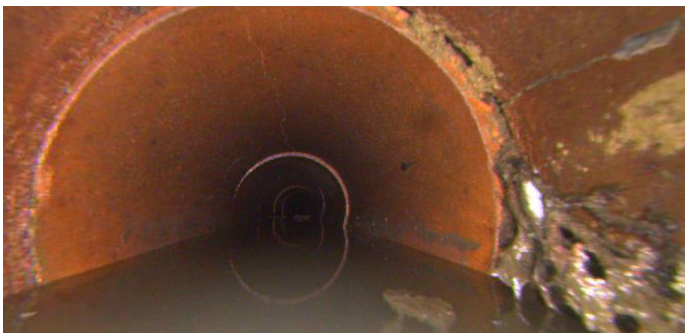
Code: **RMJ**  
Description: **Roots Medium Joint**

Distance (ft): **57.3**  
Structural Grade: **0**  
O&M Grade: **3**  
Clock Start/From: **3**  
Clock To:  
1st Value:  
2nd Value:  
Value Percent: **5.000**  
Continuous Index:  
Within 8" of Joint: **YES**  
Remarks:

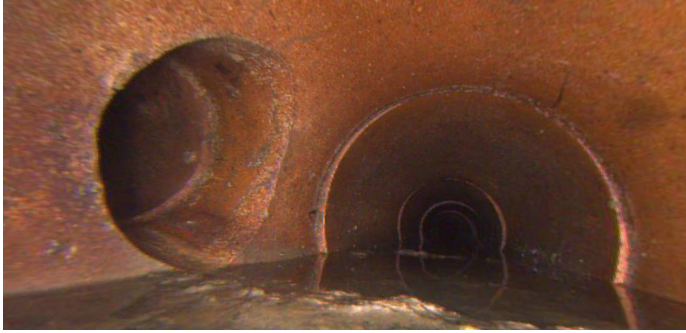
Code: **TF**  
Description: **Tap Factory**

Distance (ft): **67.2**  
Structural Grade: **0**  
O&M Grade: **0**  
Clock Start/From: **9**  
Clock To:  
1st Value: **4.000**  
2nd Value:  
Value Percent:  
Continuous Index:  
Within 8" of Joint:  
Remarks:

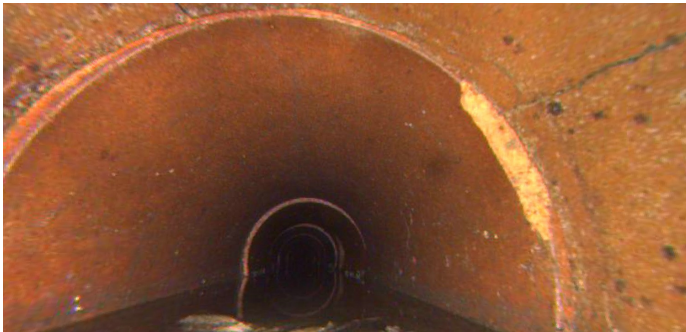
Code: **SSS**  
Description: **Surface Spalling**

Distance (ft): **69.8**  
Structural Grade: **2**  
O&M Grade: **0**  
Clock Start/From: **1**  
Clock To: **3**  
1st Value:  
2nd Value:  
Value Percent:  
Continuous Index:  
Within 8" of Joint: **YES**  
Remarks:

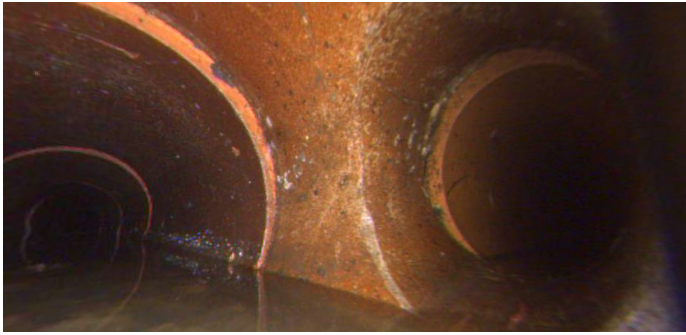
Code: **TF**  
Description: **Tap Factory**

Distance (ft): **73.4**  
Structural Grade: **0**  
O&M Grade: **0**  
Clock Start/From: **3**  
Clock To:  
1st Value: **4.000**  
2nd Value:  
Value Percent:  
Continuous Index:  
Within 8" of Joint:  
Remarks:

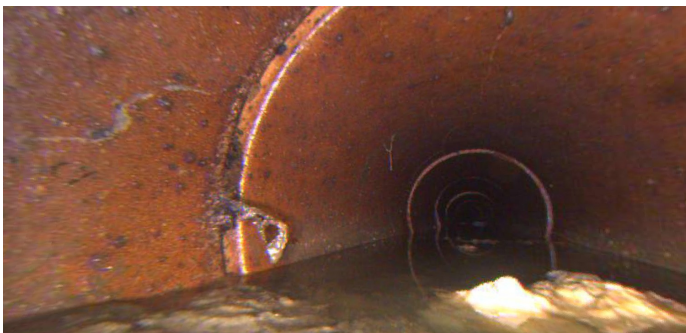
Code: **RFJ**  
Description: **Roots Fine Joint**

Distance (ft): **108.5**  
Structural Grade: **0**  
O&M Grade: **1**  
Clock Start/From: **9**  
Clock To:  
1st Value:  
2nd Value:  
Value Percent:  
Continuous Index:  
Within 8" of Joint: **YES**  
Remarks:

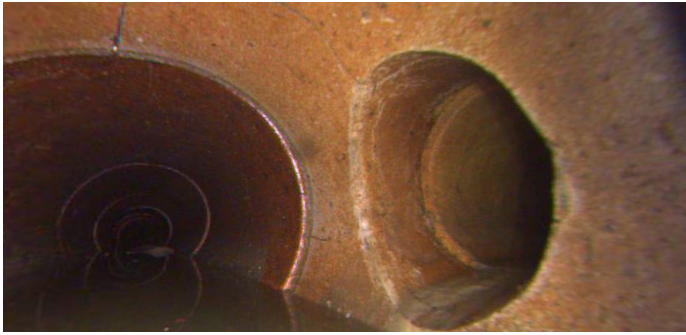
Code: **TF**  
Description: **Tap Factory**

Distance (ft): **124.3**  
Structural Grade: **0**  
O&M Grade: **0**  
Clock Start/From: **3**  
Clock To:  
1st Value: **4.000**  
2nd Value:  
Value Percent:  
Continuous Index:  
Within 8" of Joint:  
Remarks:

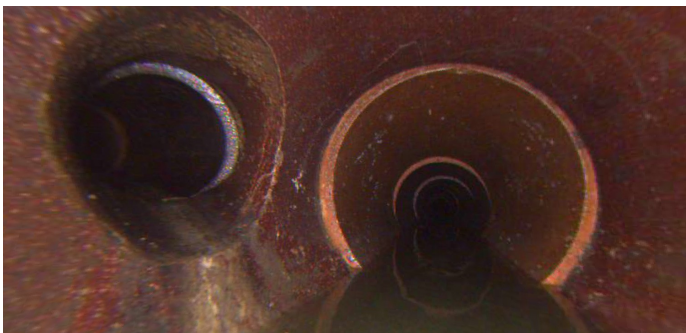
Code: **TF**  
Description: **Tap Factory**

Distance (ft): **144.4**  
Structural Grade: **0**  
O&M Grade: **0**  
Clock Start/From: **9**  
Clock To:  
1st Value: **4.000**  
2nd Value:  
Value Percent:  
Continuous Index:  
Within 8" of Joint:  
Remarks:

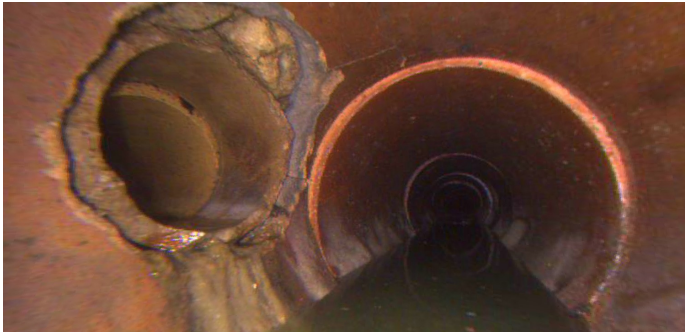
Code: **TBA**  
Description: **Tap Break-in Active**

Distance (ft): **183.5**  
Structural Grade: **0**  
O&M Grade: **0**  
Clock Start/From: **9**  
Clock To:  
1st Value: **4.000**  
2nd Value:  
Value Percent:  
Continuous Index:  
Within 8" of Joint:  
Remarks:

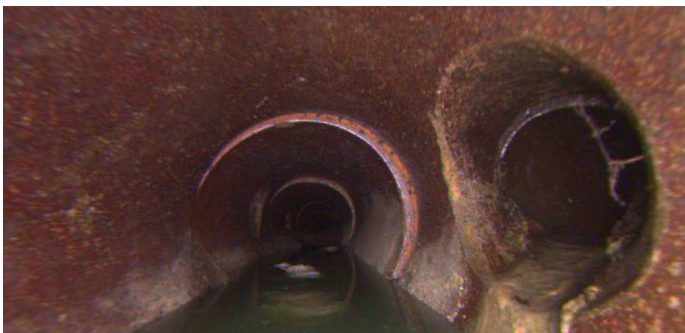
Code: **TFD**  
Description: **Tap Factory Defective**

Distance (ft): **187.3**  
Structural Grade: **0**  
O&M Grade: **2**  
Clock Start/From: **3**  
Clock To:  
1st Value: **4.000**  
2nd Value:  
Value Percent:  
Continuous Index:  
Within 8" of Joint:  
Remarks: **roots**

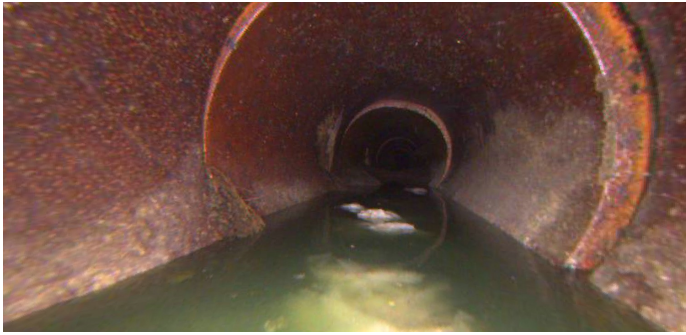
Code: **RFJ**  
Description: **Roots Fine Joint**

Distance (ft): **187.9**  
Structural Grade: **0**  
O&M Grade: **1**  
Clock Start/From: **9**  
Clock To:  
1st Value:  
2nd Value:  
Value Percent:  
Continuous Index:  
Within 8" of Joint: **YES**  
Remarks:

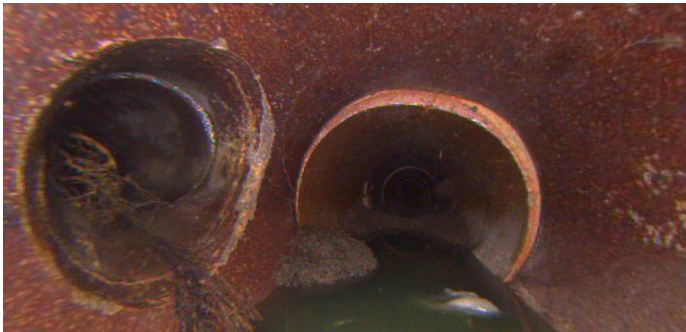
Code: **TFD**  
Description: **Tap Factory Defective**

Distance (ft): **189.5**  
Structural Grade: **0**  
O&M Grade: **2**  
Clock Start/From: **9**  
Clock To:  
1st Value: **4.000**  
2nd Value:  
Value Percent:  
Continuous Index:  
Within 8" of Joint:  
Remarks: **roots**

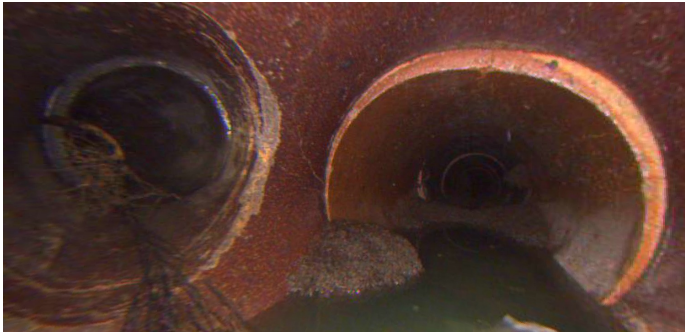
Code: **RFL**  
Description: **Roots Fine Lateral**

Distance (ft): **189.7**  
Structural Grade: **0**  
O&M Grade: **1**  
Clock Start/From: **9**  
Clock To:  
1st Value:  
2nd Value:  
Value Percent:  
Continuous Index:  
Within 8" of Joint: **NO**  
Remarks:

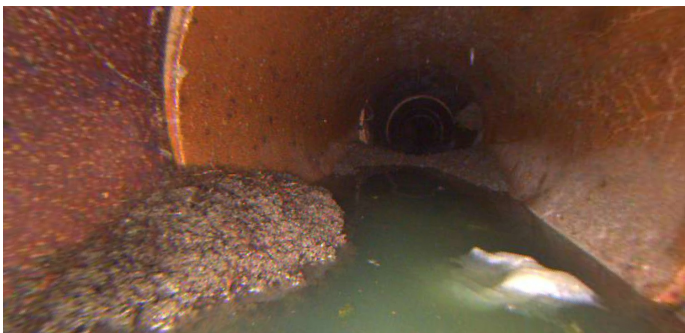
Code: **RMJ**  
Description: **Roots Medium Joint**

Distance (ft): **190.3**  
Structural Grade: **0**  
O&M Grade: **3**  
Clock Start/From: **7**  
Clock To: **9**  
1st Value:  
2nd Value:  
Value Percent: **10.000**  
Continuous Index:  
Within 8" of Joint: **YES**  
Remarks:

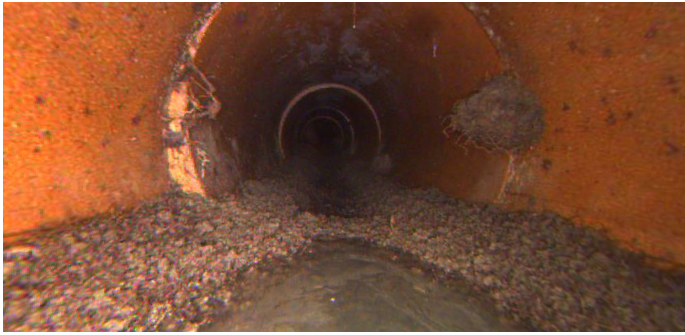
Code: **DSF**  
Description: **Deposits Settled Fine**

Distance (ft): **192.3**  
Structural Grade: **0**  
O&M Grade: **3**  
Clock Start/From: **4**  
Clock To: **8**  
1st Value:  
2nd Value:  
Value Percent: **20.000**  
Continuous Index:  
Within 8" of Joint: **NO**  
Remarks:

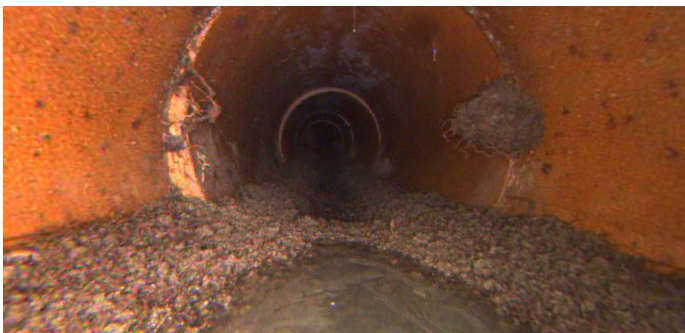
Code: **RMJ**  
Description: **Roots Medium Joint**

Distance (ft): **192.3**  
Structural Grade: **0**  
O&M Grade: **3**  
Clock Start/From: **8**  
Clock To: **4**  
1st Value:  
2nd Value:  
Value Percent: **5.000**  
Continuous Index:  
Within 8" of Joint: **YES**  
Remarks:

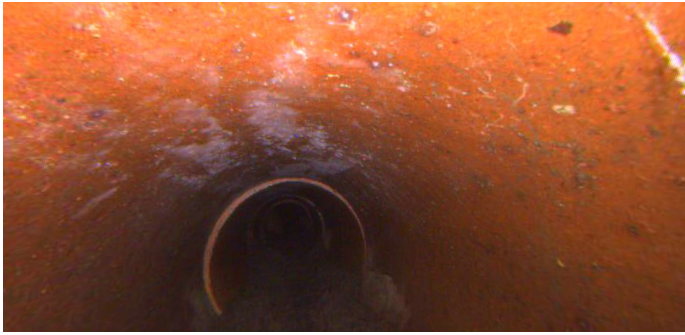
Code: **FM**  
Description: **Fracture Multiple**

Distance (ft): **193.7**  
Structural Grade: **4**  
O&M Grade: **0**  
Clock Start/From: **8**  
Clock To: **4**  
1st Value:  
2nd Value:  
Value Percent:  
Continuous Index: **F01**  
Within 8" of Joint: **YES**  
Remarks:

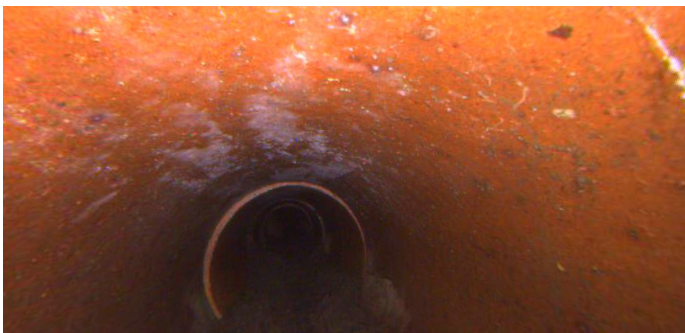
Code: **MSA**  
Description: **Abandoned Survey**

Distance (ft): **193.7**  
Structural Grade: **0**  
O&M Grade: **0**  
Clock Start/From:  
Clock To:  
1st Value:  
2nd Value:  
Value Percent:  
Continuous Index:  
Within 8" of Joint: **NO**  
Remarks: **dsf**
