Profile/Photo Observation Report

Date:	04/04/2018	Weather:		Coding:	PACP 6.0
Pipe Length (ft):	208.2	Owner:	NA	Pre Clean:	Not Known
P.O.#:		Surveyor:	Jen Costello	PSR:	P-803-048-046
Customer:		Clean Date:	01/01/1900	Shape:	C

Street:	N Kelly Ave.	Flow Control:	Not Controlled
City:	Hobart, IN	Year Renewed:	
Location:	Other	Tape/Media #:	
Purpose:	Not Known	Dia/Height:	12"
Use:	Sanitary	Material:	VCP
Drain Area:	NA	Lining:	
Category:	NA		
Comment:

Location Details:		Direction of Survey:	Upstream
US MH:	M-803-048	DS MH:	M-803-046
		Total Length Surveyed (ft):	193.7

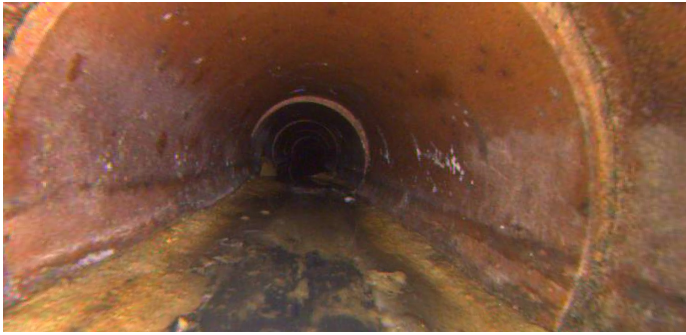
Code: **AMH**
Description: **Manhole**

Distance (ft): **.0**
Structural Grade: **0**
O&M Grade: **0**
Clock Start/From:
Clock To:
1st Value:
2nd Value:
Value Percent:
Continuous Index:
Within 8" of Joint: **NO**
Remarks: **M-803-046**

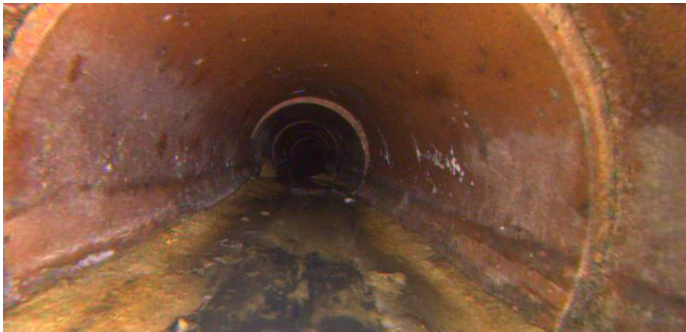
Code: **MWL**
Description: **Water Level**

Distance (ft): **.0**
Structural Grade: **0**
O&M Grade: **0**
Clock Start/From:
Clock To:
1st Value:
2nd Value:
Value Percent: **10.000**
Continuous Index:
Within 8" of Joint: **NO**
Remarks:

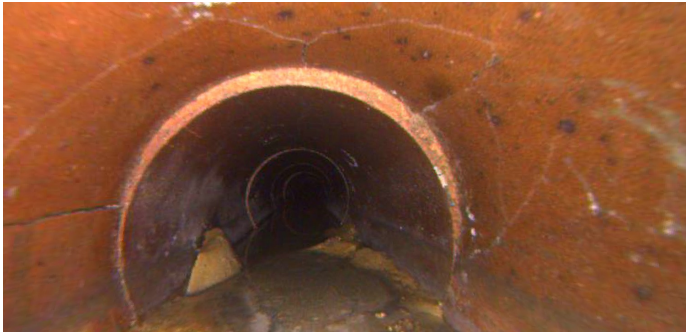
Code: **FM**
Description: **Fracture Multiple**

Distance (ft): **2.4**
Structural Grade: **4**
O&M Grade: **0**
Clock Start/From: **8**
Clock To: **4**
1st Value:
2nd Value:
Value Percent:
Continuous Index: **S01**
Within 8" of Joint: **YES**
Remarks:

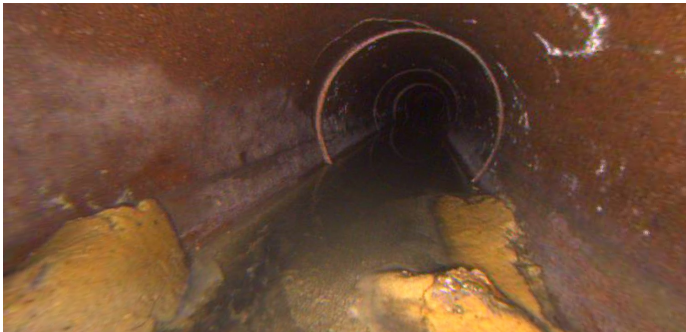
Code: **OBR**
Description: **Obstacle Rocks**

Distance (ft): **3.4**
Structural Grade: **0**
O&M Grade: **2**
Clock Start/From: **4**
Clock To: **8**
1st Value:
2nd Value:
Value Percent: **10.000**
Continuous Index:
Within 8" of Joint: **NO**
Remarks:

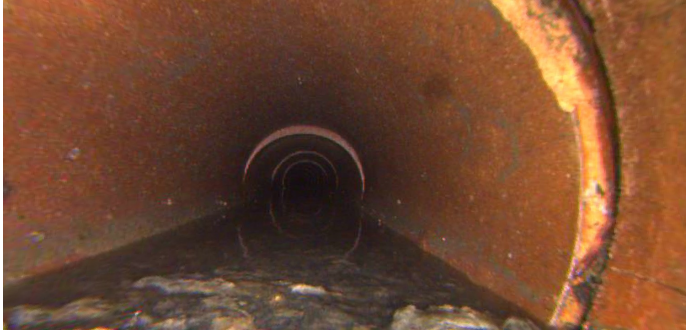
Code: **MWL**
Description: **Water Level**

Distance (ft): **20.8**
Structural Grade: **0**
O&M Grade: **0**
Clock Start/From:
Clock To:
1st Value:
2nd Value:
Value Percent: **20.000**
Continuous Index:
Within 8" of Joint: **NO**
Remarks:

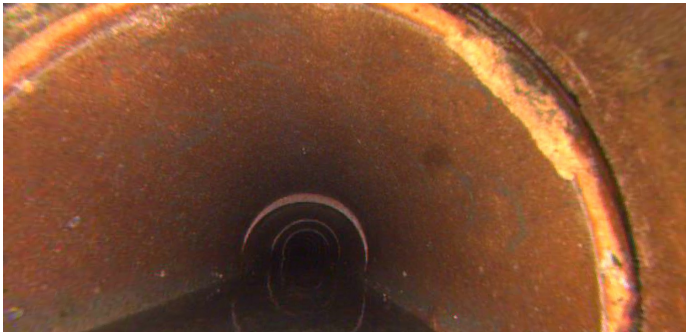
Code: **SSS**
Description: **Surface Spalling**

Distance (ft): **20.8**
Structural Grade: **2**
O&M Grade: **0**
Clock Start/From: **2**
Clock To: **3**
1st Value:
2nd Value:
Value Percent:
Continuous Index:
Within 8" of Joint: **YES**
Remarks:

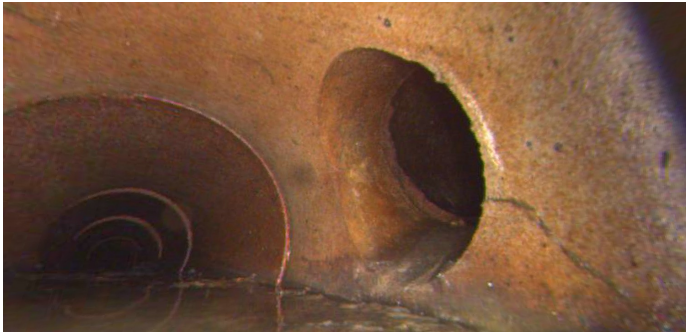
Code: **TF**
Description: **Tap Factory**

Distance (ft): **28.2**
Structural Grade: **0**
O&M Grade: **0**
Clock Start/From: **3**
Clock To:
1st Value: **4.000**
2nd Value:
Value Percent:
Continuous Index:
Within 8" of Joint:
Remarks:

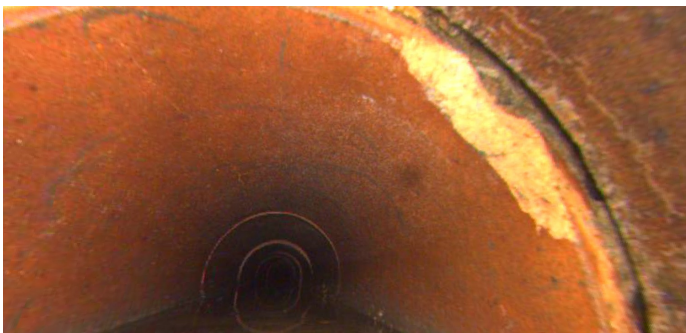
Code: **SSS**
Description: **Surface Spalling**

Distance (ft): **33.1**
Structural Grade: **2**
O&M Grade: **0**
Clock Start/From: **1**
Clock To: **3**
1st Value:
2nd Value:
Value Percent:
Continuous Index:
Within 8" of Joint: **YES**
Remarks:

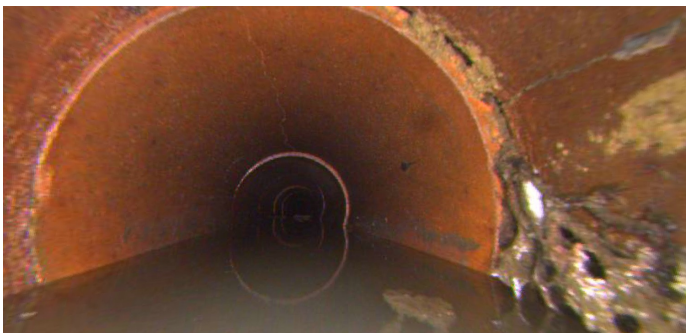
Code: **RMJ**
Description: **Roots Medium Joint**

Distance (ft): **57.3**
Structural Grade: **0**
O&M Grade: **3**
Clock Start/From: **3**
Clock To:
1st Value:
2nd Value:
Value Percent: **5.000**
Continuous Index:
Within 8" of Joint: **YES**
Remarks:

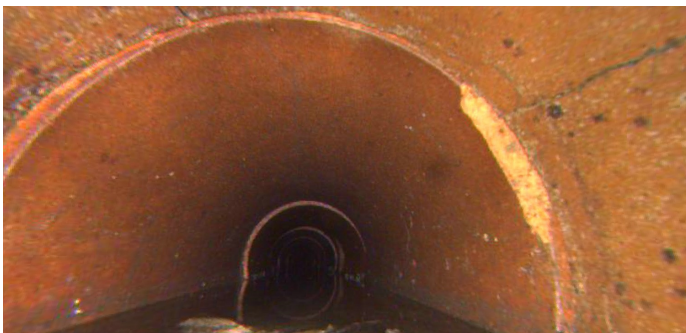
Code: **SSS**
Description: **Surface Spalling**

Distance (ft): **69.8**
Structural Grade: **2**
O&M Grade: **0**
Clock Start/From: **1**
Clock To: **3**
1st Value:
2nd Value:
Value Percent:
Continuous Index:
Within 8" of Joint: **YES**
Remarks:

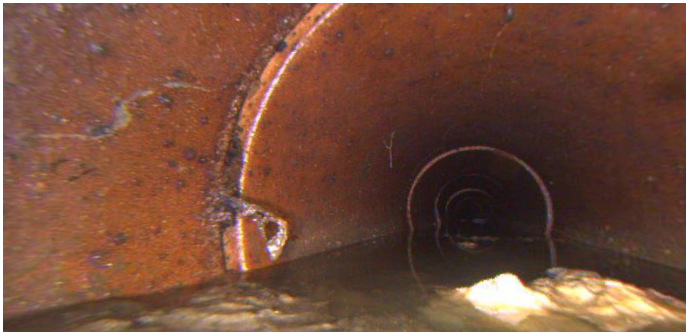
Code: **RFJ**
Description: **Roots Fine Joint**

Distance (ft): **108.5**
Structural Grade: **0**
O&M Grade: **1**
Clock Start/From: **9**
Clock To:
1st Value:
2nd Value:
Value Percent:
Continuous Index:
Within 8" of Joint: **YES**
Remarks:

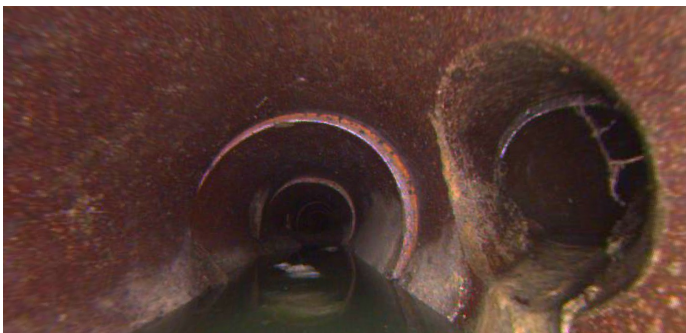
Code: **TFD**
Description: **Tap Factory Defective**

Distance (ft): **187.3**
Structural Grade: **0**
O&M Grade: **2**
Clock Start/From: **3**
Clock To:
1st Value: **4.000**
2nd Value:
Value Percent:
Continuous Index:
Within 8" of Joint:
Remarks: **roots**

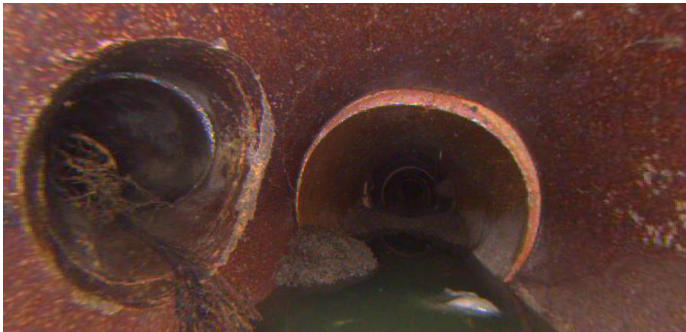
Code: **TFD**
Description: **Tap Factory Defective**

Distance (ft): **189.5**
Structural Grade: **0**
O&M Grade: **2**
Clock Start/From: **9**
Clock To:
1st Value: **4.000**
2nd Value:
Value Percent:
Continuous Index:
Within 8" of Joint:
Remarks: **roots**

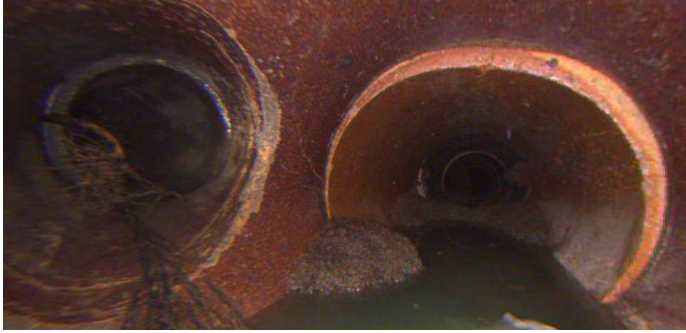
Code: **RFL**
Description: **Roots Fine Lateral**

Distance (ft): **189.7**
Structural Grade: **0**
O&M Grade: **1**
Clock Start/From: **9**
Clock To:
1st Value:
2nd Value:
Value Percent:
Continuous Index:
Within 8" of Joint: **NO**
Remarks:

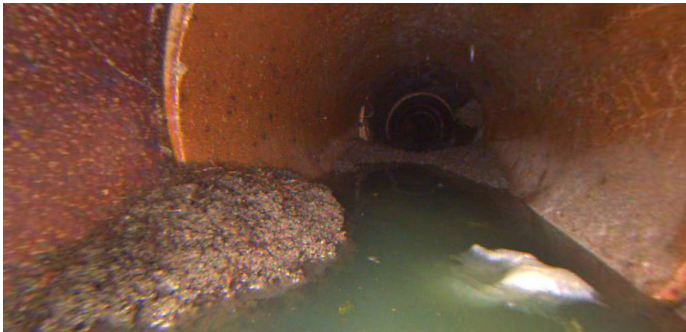
Code: **RMJ**
Description: **Roots Medium Joint**

Distance (ft): **190.3**
Structural Grade: **0**
O&M Grade: **3**
Clock Start/From: **7**
Clock To: **9**
1st Value:
2nd Value:
Value Percent: **10.000**
Continuous Index:
Within 8" of Joint: **YES**
Remarks:

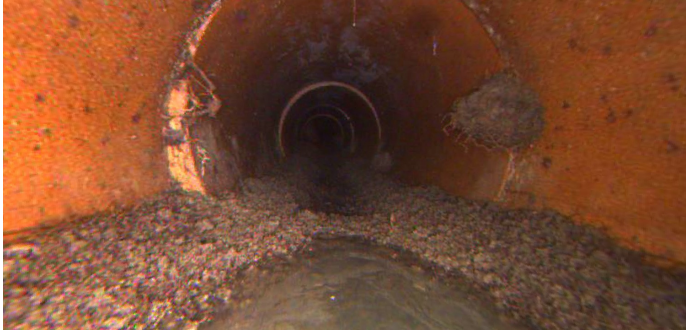
Code: **DSF**
Description: **Deposits Settled Fine**

Distance (ft): **192.3**
Structural Grade: **0**
O&M Grade: **3**
Clock Start/From: **4**
Clock To: **8**
1st Value:
2nd Value:
Value Percent: **20.000**
Continuous Index:
Within 8" of Joint: **NO**
Remarks:

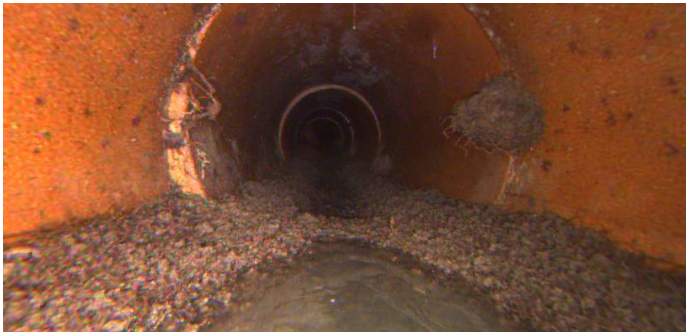
Code: **RMJ**
Description: **Roots Medium Joint**

Distance (ft): **192.3**
Structural Grade: **0**
O&M Grade: **3**
Clock Start/From: **8**
Clock To: **4**
1st Value:
2nd Value:
Value Percent: **5.000**
Continuous Index:
Within 8" of Joint: **YES**
Remarks:
