Profile/Photo Observation Report

Street:	N Kelly Ave.	Flow Control:	Not Controlled
City:	Hobart, IN	Year Renewed:	
Location:	Other	Tape/Media #:	
Purpose:	Not Known	Dia/Height:	10"
Use:	Sanitary	Material:	VCP
Drain Area:	NA	Lining:	
Category:	NA		
Comment:

Location Details:		Direction of Survey:	Downstream
US MH:	M-803-051	DS MH:	M-803-050
		Total Length Surveyed (ft):	7.8

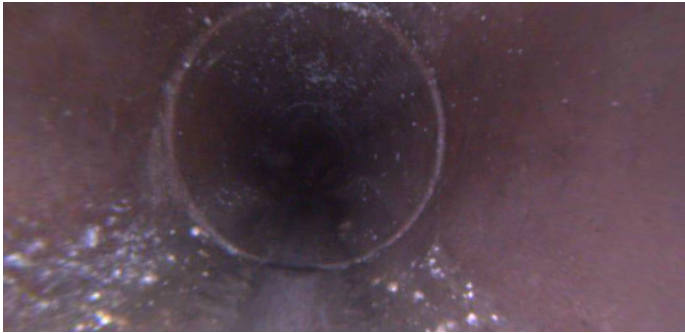
Code:	MWL
Description:	Water Level

Distance (ft):	.0
Structural Grade:	0
O&M Grade:	0
Clock Start/From:	
Clock To:	
1st Value:	
2nd Value:	
Value Percent:	5.000
Continuous Index:	
Within 8" of Joint:	NO
Remarks:

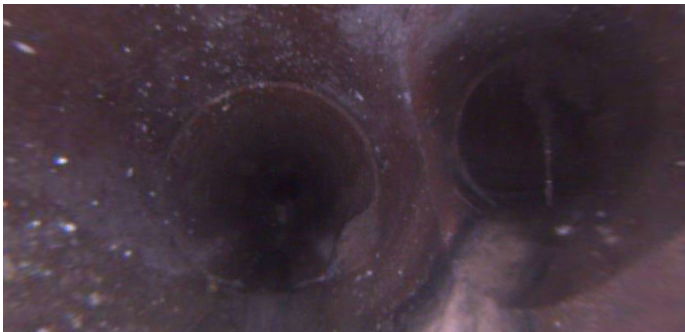
Code:	TFA
Description:	Tap Factory Active

Distance (ft):	3.8
Structural Grade:	0
O&M Grade:	0
Clock Start/From:	3
Clock To:	
1st Value:	4.000
2nd Value:	
Value Percent:	
Continuous Index:	
Within 8" of Joint:	
Remarks:

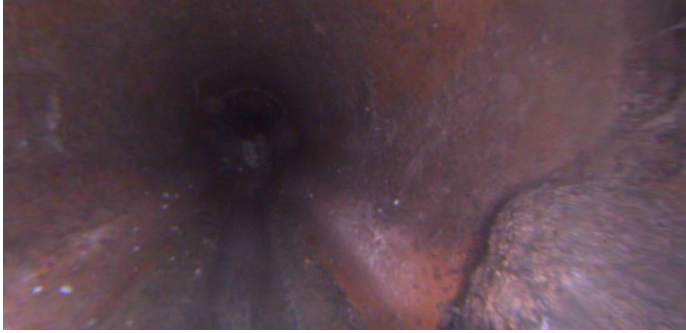
Code: **DAZ**
Description: **Deposits Attached Other**

Distance (ft): **4.8**
Structural Grade: **0**
O&M Grade: **2**
Clock Start/From: **3**
Clock To: **4**
1st Value:
2nd Value:
Value Percent: **10.000**
Continuous Index:
Within 8" of Joint: **YES**
Remarks:

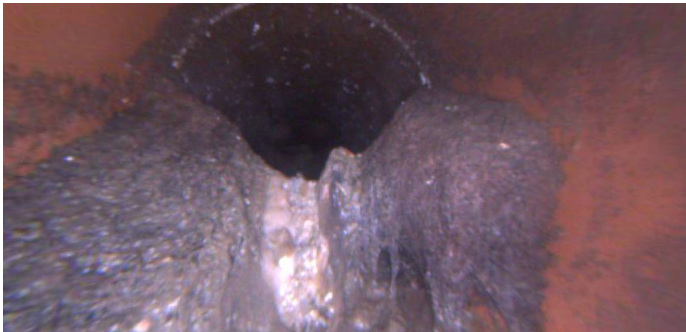
Code: **RMJ**
Description: **Roots Medium Joint**

Distance (ft): **7.1**
Structural Grade: **0**
O&M Grade: **3**
Clock Start/From: **3**
Clock To: **9**
1st Value:
2nd Value:
Value Percent: **45.000**
Continuous Index:
Within 8" of Joint: **YES**
Remarks:

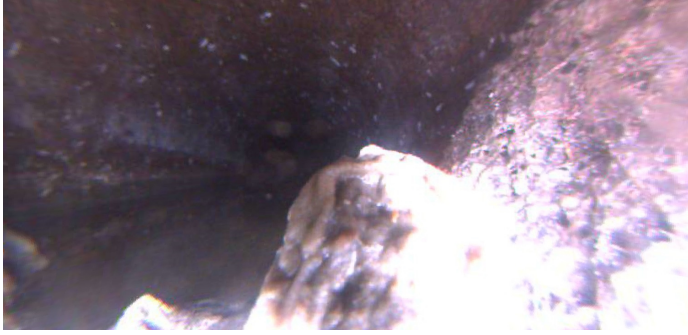
Code:	MSA
Description:	Abandoned Survey
Distance (ft):	7.8
Structural Grade:	0
O&M Grade:	0
Clock Start/From:	
Clock To:	
1st Value:	
2nd Value:	
Value Percent:	
Continuous Index:	
Within 8" of Joint:	NO
Remarks:	roots
