Profile/Photo Observation Report

Street:	N KELLY ST	Flow Control:	Not Controlled
City:	Hobart, IN	Year Renewed:	
Location:	Light Highway	Tape/Media #:	
Purpose:	Routine Assessment	Dia/Height:	10"
Use:	Sanitary	Material:	VCP
Drain Area:	NA	Lining:	
Category:	NA		
Comment:

Location Details:		Direction of Survey:	Downstream
US MH:	M-803-051	DS MH:	M-803-050
		Total Length Surveyed (ft):	195.4

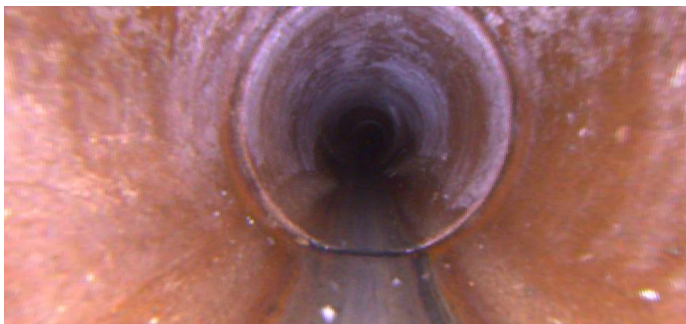
Code: **AMH**
Description: **Manhole**

Distance (ft): **.0**
Structural Grade: **0**
O&M Grade: **0**
Clock Start/From:
Clock To:
1st Value:
2nd Value:
Value Percent:
Continuous Index:
Within 8" of Joint: **NO**
Remarks: **M-803-051**

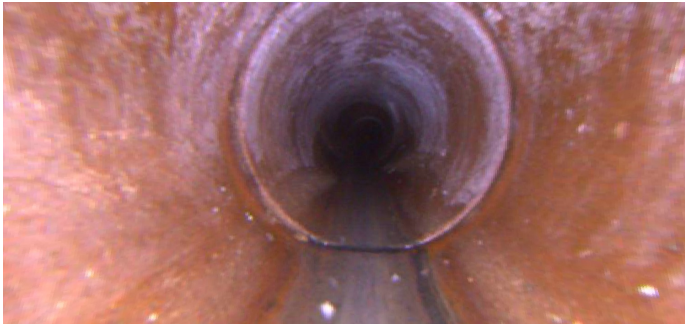
Code:	MWL
Description:	Water Level

Distance (ft):	.0
Structural Grade:	0
O&M Grade:	0
Clock Start/From:	
Clock To:	
1st Value:	
2nd Value:	
Value Percent:	5.000
Continuous Index:	
Within 8" of Joint:	NO
Remarks:

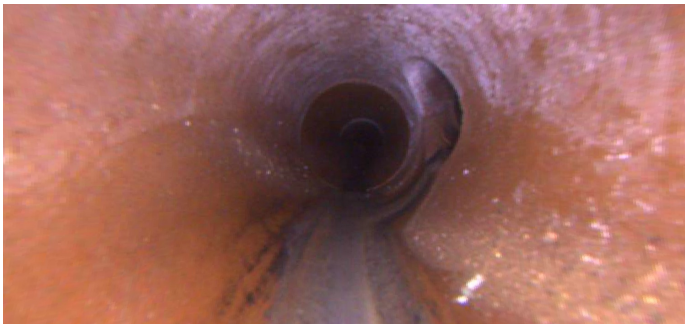
Code:	TF
Description:	Tap Factory

Distance (ft):	3.0
Structural Grade:	0
O&M Grade:	0
Clock Start/From:	3
Clock To:	
1st Value:	4.000
2nd Value:	
Value Percent:	
Continuous Index:	
Within 8" of Joint:	
Remarks:

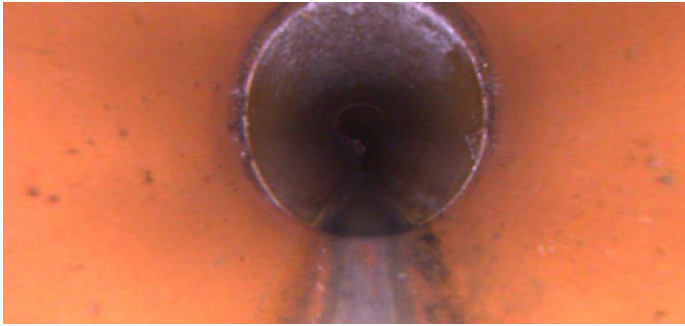
Code: **RFJ**
Description: **Roots Fine Joint**

Distance (ft): **7.1**
Structural Grade: **0**
O&M Grade: **1**
Clock Start/From: **7**
Clock To: **5**
1st Value:
2nd Value:
Value Percent:
Continuous Index:
Within 8" of Joint: **YES**
Remarks:

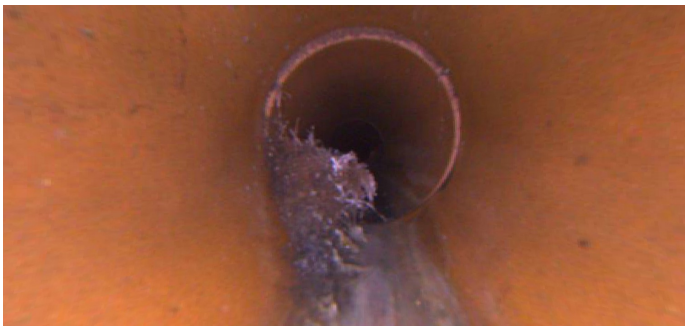
Code: **RMJ**
Description: **Roots Medium Joint**

Distance (ft): **9.7**
Structural Grade: **0**
O&M Grade: **3**
Clock Start/From: **7**
Clock To: **5**
1st Value:
2nd Value:
Value Percent: **15.000**
Continuous Index:
Within 8" of Joint: **YES**
Remarks:

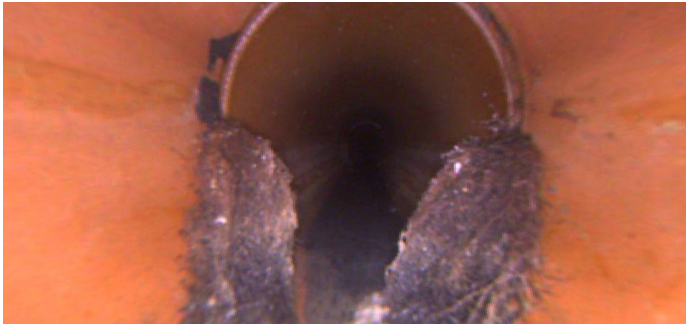
Code: **RMJ**
Description: **Roots Medium Joint**

Distance (ft): **13.1**
Structural Grade: **0**
O&M Grade: **3**
Clock Start/From: **7**
Clock To: **6**
1st Value:
2nd Value:
Value Percent: **20.000**
Continuous Index:
Within 8" of Joint: **YES**
Remarks:

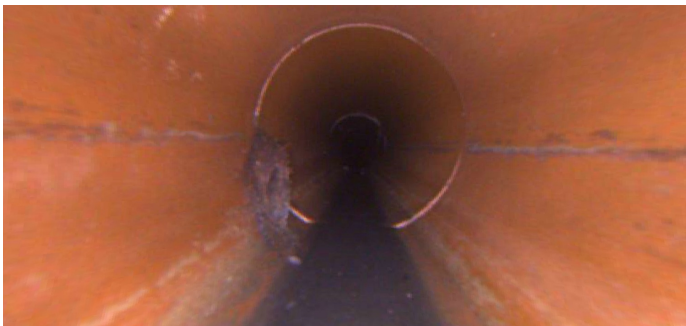
Code: **RFJ**
Description: **Roots Fine Joint**

Distance (ft): **15.8**
Structural Grade: **0**
O&M Grade: **1**
Clock Start/From: **7**
Clock To: **9**
1st Value:
2nd Value:
Value Percent:
Continuous Index:
Within 8" of Joint: **YES**
Remarks:

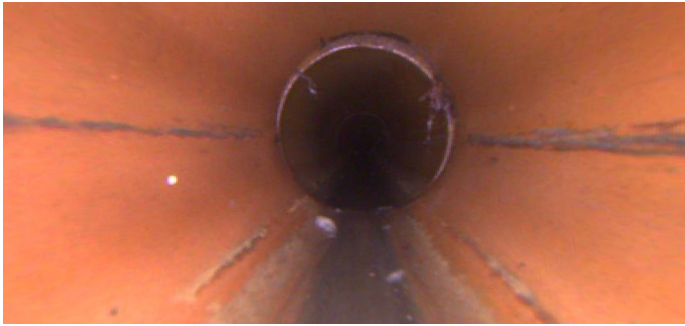
Code: **RFJ**
Description: **Roots Fine Joint**

Distance (ft): **18.6**
Structural Grade: **0**
O&M Grade: **1**
Clock Start/From: **7**
Clock To: **5**
1st Value:
2nd Value:
Value Percent:
Continuous Index:
Within 8" of Joint: **YES**
Remarks:

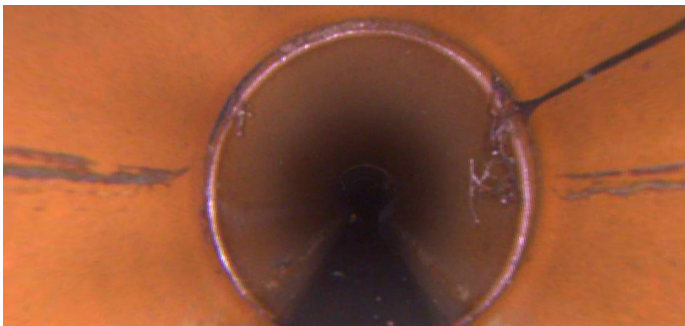
Code: **RFJ**
Description: **Roots Fine Joint**

Distance (ft): **22.3**
Structural Grade: **0**
O&M Grade: **1**
Clock Start/From: **10**
Clock To: **2**
1st Value:
2nd Value:
Value Percent:
Continuous Index:
Within 8" of Joint: **YES**
Remarks:

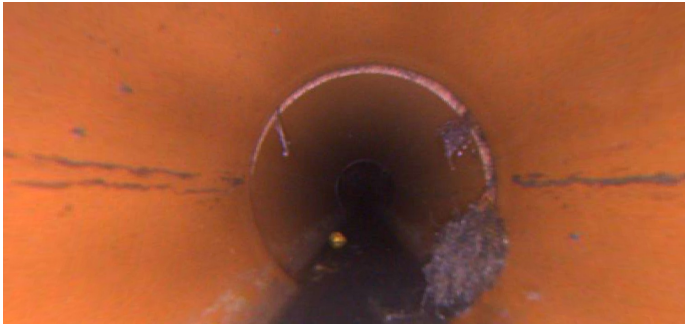
Code: **RFJ**
Description: **Roots Fine Joint**

Distance (ft): **25.0**
Structural Grade: **0**
O&M Grade: **1**
Clock Start/From: **7**
Clock To: **5**
1st Value:
2nd Value:
Value Percent:
Continuous Index: **S01**
Within 8" of Joint: **YES**
Remarks:

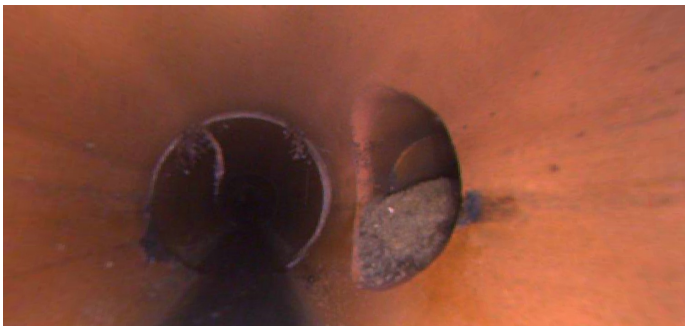
Code: **RFJ**
Description: **Roots Fine Joint**

Distance (ft): **33.6**
Structural Grade: **0**
O&M Grade: **1**
Clock Start/From: **7**
Clock To: **5**
1st Value:
2nd Value:
Value Percent:
Continuous Index: **F01**
Within 8" of Joint: **YES**
Remarks:

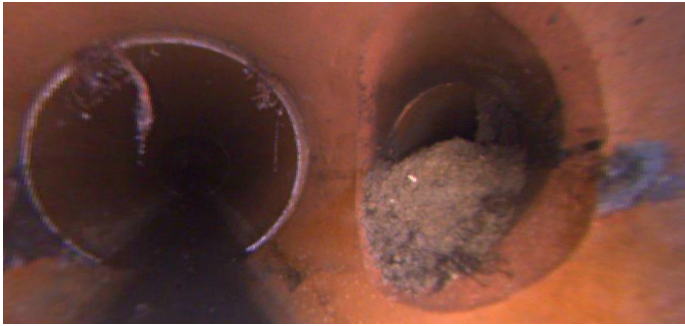
Code: **TFD**
Description: **Tap Factory Defective**

Distance (ft): **34.0**
Structural Grade: **0**
O&M Grade: **2**
Clock Start/From: **3**
Clock To:
1st Value: **4.000**
2nd Value:
Value Percent:
Continuous Index:
Within 8" of Joint:
Remarks: **root infiltration**

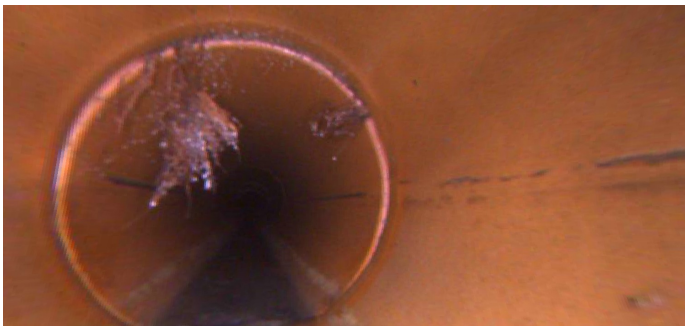
Code: **RFJ**
Description: **Roots Fine Joint**

Distance (ft): **40.4**
Structural Grade: **0**
O&M Grade: **1**
Clock Start/From: **9**
Clock To: **2**
1st Value:
2nd Value:
Value Percent:
Continuous Index:
Within 8" of Joint: **YES**
Remarks:

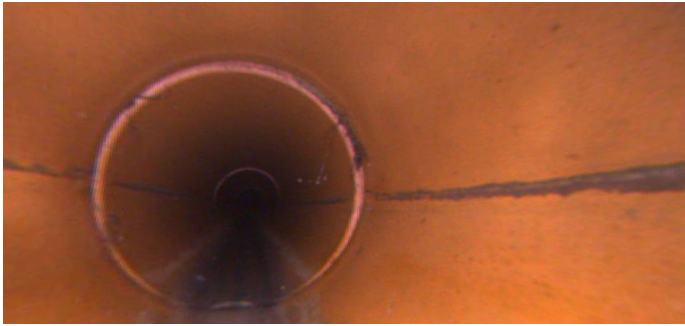
Code: **RFJ**
Description: **Roots Fine Joint**

Distance (ft): **46.2**
Structural Grade: **0**
O&M Grade: **1**
Clock Start/From: **7**
Clock To: **5**
1st Value:
2nd Value:
Value Percent:
Continuous Index:
Within 8" of Joint: **YES**
Remarks:

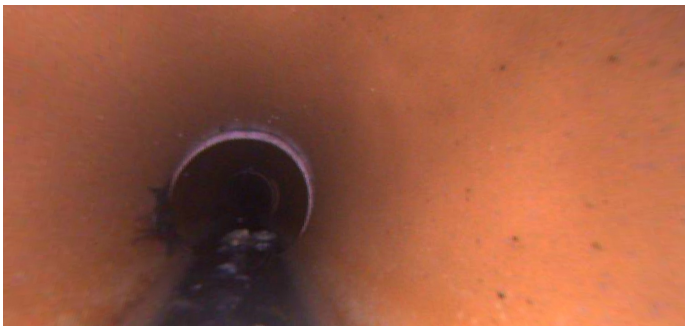
Code: **RFJ**
Description: **Roots Fine Joint**

Distance (ft): **138.9**
Structural Grade: **0**
O&M Grade: **1**
Clock Start/From: **7**
Clock To: **12**
1st Value:
2nd Value:
Value Percent:
Continuous Index:
Within 8" of Joint: **YES**
Remarks:

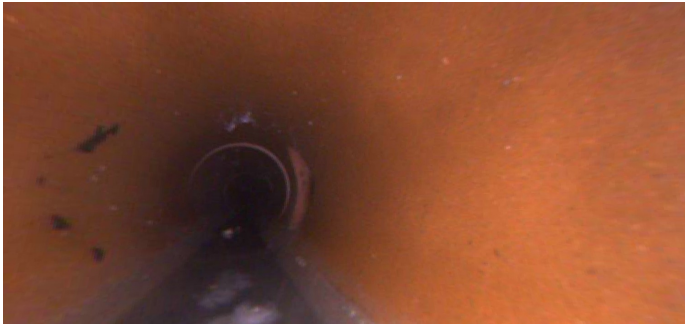
Code: **TF**
Description: **Tap Factory**

Distance (ft): **141.1**
Structural Grade: **0**
O&M Grade: **0**
Clock Start/From: **3**
Clock To:
1st Value: **4.000**
2nd Value:
Value Percent:
Continuous Index:
Within 8" of Joint:
Remarks:

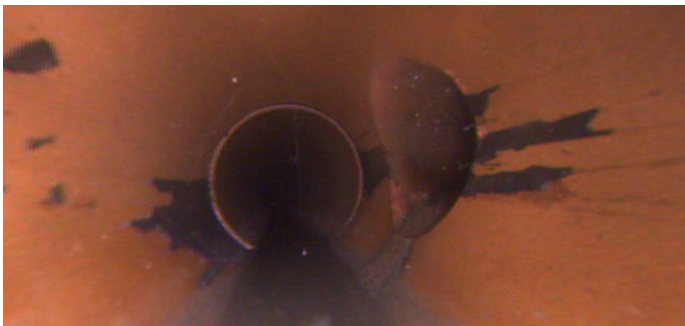
Code: **TF**
Description: **Tap Factory**

Distance (ft): **145.2**
Structural Grade: **0**
O&M Grade: **0**
Clock Start/From: **3**
Clock To:
1st Value: **4.000**
2nd Value:
Value Percent:
Continuous Index:
Within 8" of Joint:
Remarks:

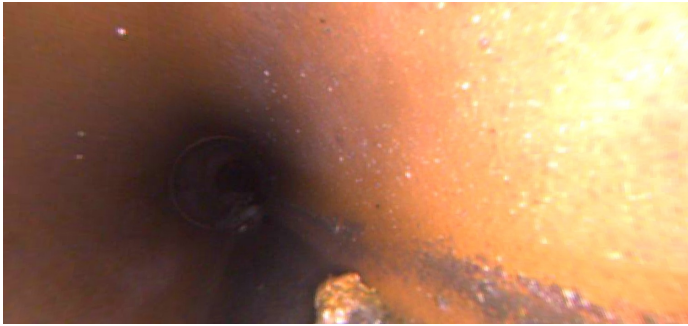
Code:	AMH
Description:	Manhole
Distance (ft):	195.4
Structural Grade:	0
O&M Grade:	0
Clock Start/From:	
Clock To:	
1st Value:	
2nd Value:	
Value Percent:	
Continuous Index:	
Within 8" of Joint:	NO
Remarks:	M-803-050
