## Profile/Photo Observation Report

| Street: | <b>Kelly St.</b> | Flow Control: | <b>Not Controlled</b> |
| City: | <b>Hobart, IN</b> | Year Renewed: | |

| US MH: | <b>M-803-051</b> | DS MH: | <b>M-803-050</b> |

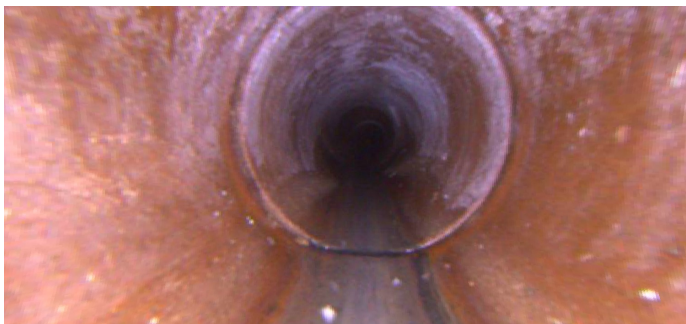
Code: **AMH**  
Description: **Manhole**

Distance (ft): **.0**  
Structural Grade: **0**  
O&M Grade: **0**  
Clock Start/From:  
Clock To:  
1st Value:  
2nd Value:  
Value Percent:  
Continuous Index:  
Within 8" of Joint: **NO**  
Remarks: **M-803-051**

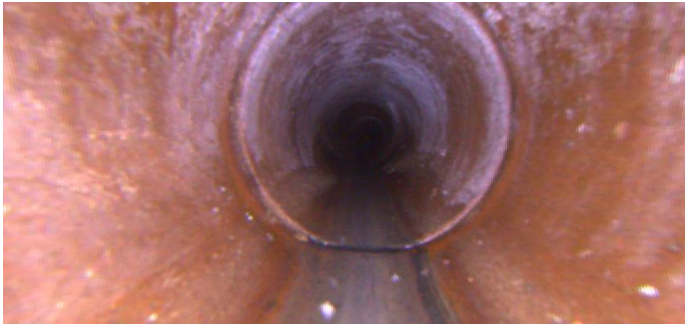
| Code: | <b>MWL</b> |
| Description: | <b>Water Level</b> |

| Value Percent: | <b>5.000</b> |

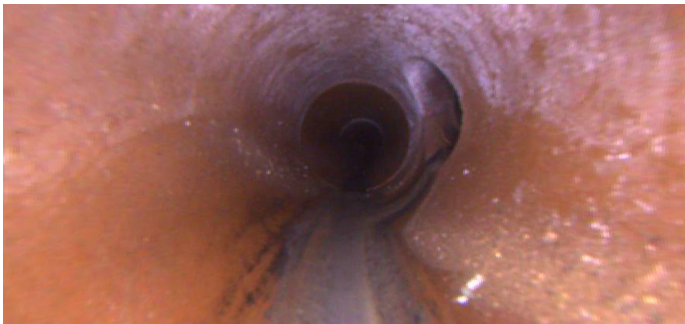
| Code: | <b>TF</b> |
| Description: | <b>Tap Factory</b> |

| Distance (ft): | <b>3.0</b> |
| Clock Start/From: | <b>3</b> |

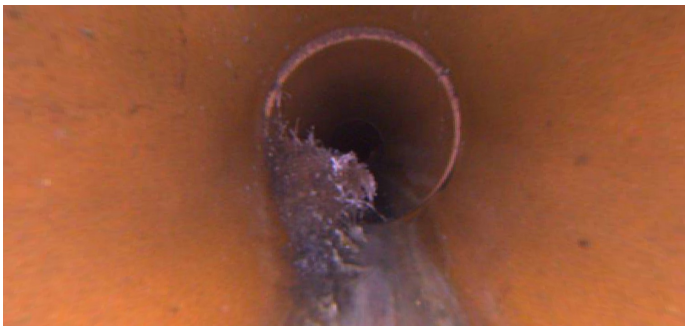
Code: **RMJ**  
Description: **Roots Medium Joint**

Distance (ft): **9.7**  
Structural Grade: **0**  
O&M Grade: **3**  
Clock Start/From: **7**  
Clock To: **5**  
1st Value:  
2nd Value:  
Value Percent: **15.000**  
Continuous Index:  
Within 8" of Joint: **YES**  
Remarks:

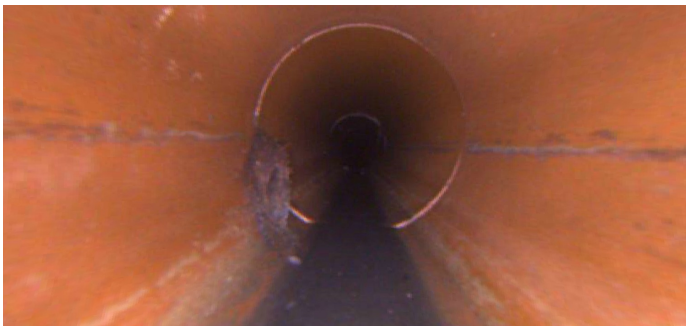
Code: **RFJ**  
Description: **Roots Fine Joint**

Distance (ft): **15.8**  
Structural Grade: **0**  
O&M Grade: **1**  
Clock Start/From: **7**  
Clock To: **9**  
1st Value:  
2nd Value:  
Value Percent:  
Continuous Index:  
Within 8" of Joint: **YES**  
Remarks:

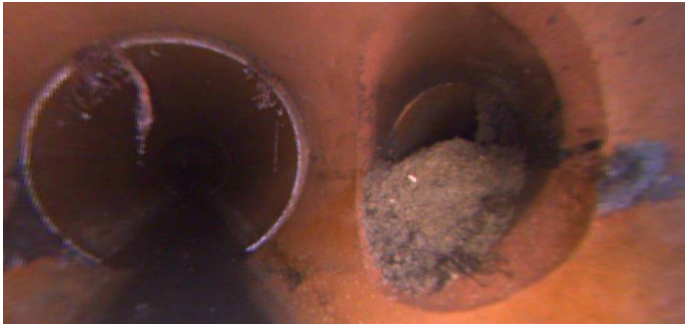
Code: **TFD**  
Description: **Tap Factory Defective**

Distance (ft): **34.0**  
Structural Grade: **0**  
O&M Grade: **2**  
Clock Start/From: **3**  
Clock To:  
1st Value: **4.000**  
2nd Value:  
Value Percent:  
Continuous Index:  
Within 8" of Joint:  
Remarks: **root infiltration**

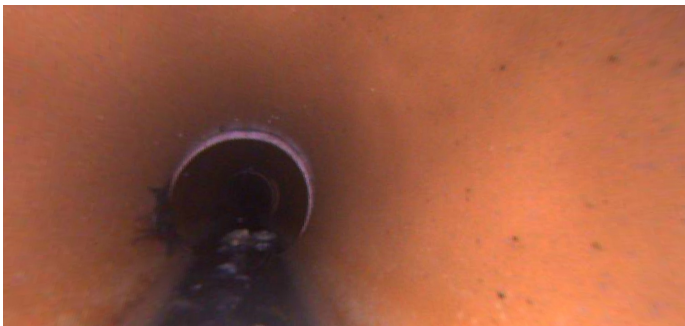
Code: **RFJ**  
Description: **Roots Fine Joint**

Distance (ft): **138.9**  
Structural Grade: **0**  
O&M Grade: **1**  
Clock Start/From: **7**  
Clock To: **12**  
1st Value:  
2nd Value:  
Value Percent:  
Continuous Index:  
Within 8" of Joint: **YES**  
Remarks:

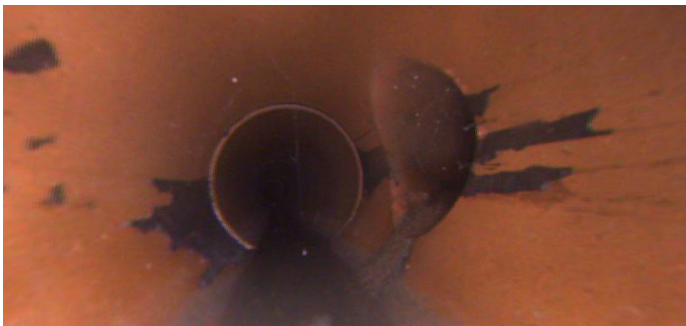
Code: **TF**  
Description: **Tap Factory**

Distance (ft): **145.2**  
Structural Grade: **0**  
O&M Grade: **0**  
Clock Start/From: **3**  
Clock To:  
1st Value: **4.000**  
2nd Value:  
Value Percent:  
Continuous Index:  
Within 8" of Joint:  
Remarks:
