Profile/Photo Observation Report

Date:	04/13/2018	Weather:		Coding:	PACP 4.2
Pipe Length (ft):	241.5	Owner:	City of Hobart	Pre Clean:	No Pre-Cleaning
P.O.#:	2004	Surveyor:	SAN	PSR:	P-803-053-054
Customer:	Red Zone	Clean Date:		Shape:	C

Street:	910 High St	Flow Control:	Not Controlled
City:	Hobart In	Year Renewed:	
Location:	Light Highway	Tape/Media #:	Deliverable 1
Purpose:	Routine Assessment	Dia/Height:	15"
Use:	Sanitary	Material:	VCP
Drain Area:	Northeast	Lining:	
Category:	NA		
Comment:	409-2/Unable to open MH 054.		
Location Details:	Edge of street	Direction of Survey:	Downstream
US MH:	M-803-053	DS MH:	M-803-054
		Total Length Surveyed (ft):	241.5

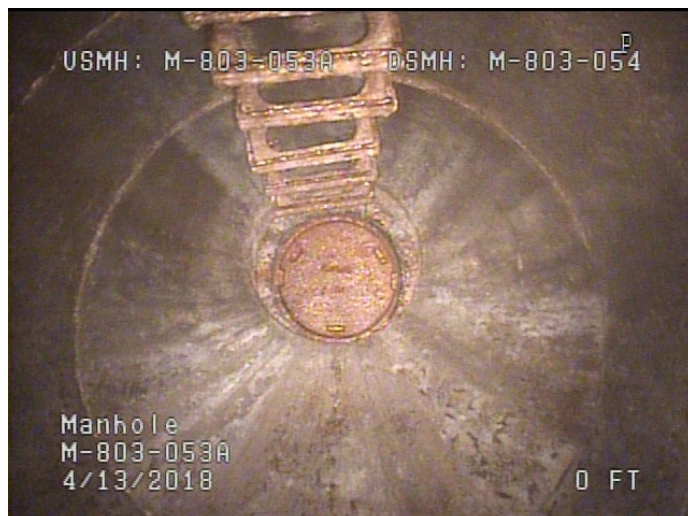
Code: **AMH**
 Description: **Manhole**

Distance (ft): **.0**
 Structural Grade: **0**
 O&M Grade: **0**
 Clock Start/From:
 Clock To:
 1st Value:
 2nd Value:
 Value Percent:
 Continuous Index:
 Within 8" of Joint: **NO**
 Remarks: **M-803-053A**

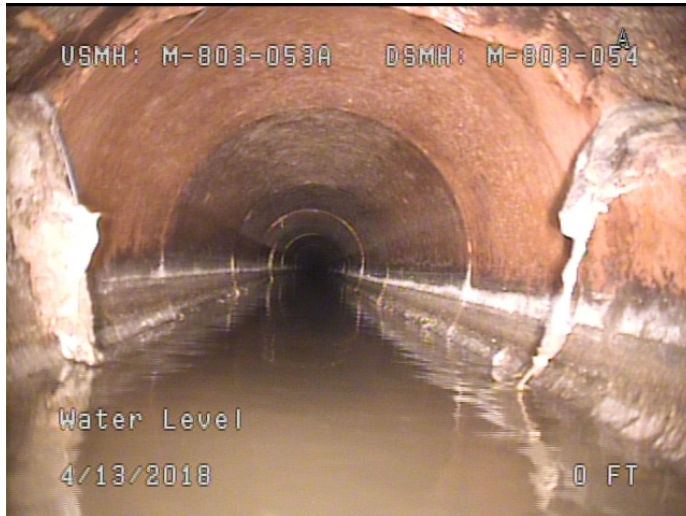
Code: **MWL**
 Description: **Water Level**

Distance (ft): **.0**
 Structural Grade: **0**
 O&M Grade: **0**
 Clock Start/From:
 Clock To:
 1st Value:
 2nd Value:
 Value Percent: **15.000**
 Continuous Index:
 Within 8" of Joint: **NO**
 Remarks:

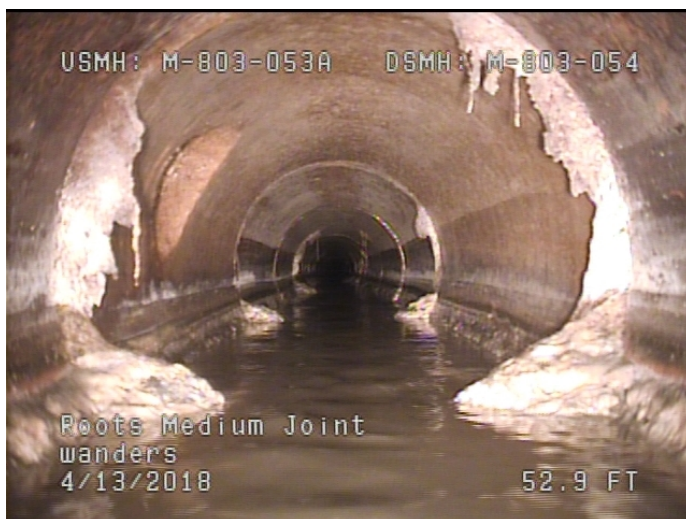
Code: **RMJ**
 Description: **Roots Medium Joint**

Distance (ft): **52.9**
 Structural Grade: **0**
 O&M Grade: **3**
 Clock Start/From: **1**
 Clock To: **10**
 1st Value:
 2nd Value:
 Value Percent: **15.000**
 Continuous Index: **S01**
 Within 8" of Joint: **YES**
 Remarks: **wanders**

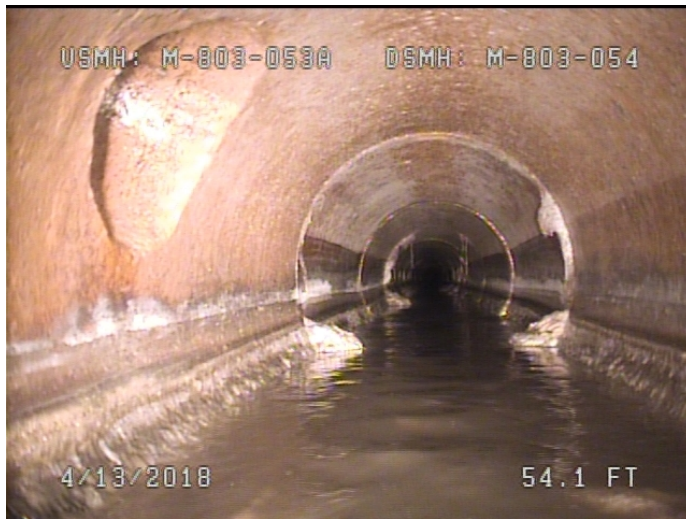
Code: **TFC**
 Description: **Tap Factory Capped**

Distance (ft): **54.1**
 Structural Grade: **0**
 O&M Grade: **0**
 Clock Start/From: **10**
 Clock To:
 1st Value: **6.000**
 2nd Value:
 Value Percent:
 Continuous Index:
 Within 8" of Joint: **NO**
 Remarks:

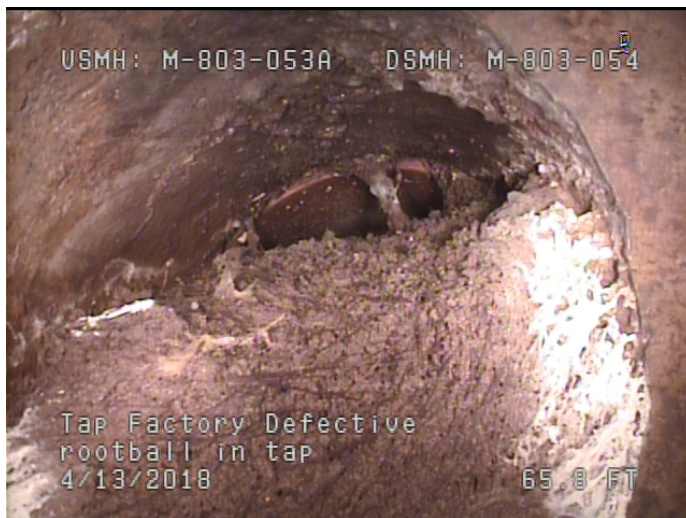
Code: **TFD**
 Description: **Tap Factory Defective**

Distance (ft): **65.8**
 Structural Grade: **0**
 O&M Grade: **2**
 Clock Start/From: **2**
 Clock To:
 1st Value: **6.000**
 2nd Value:
 Value Percent:
 Continuous Index:
 Within 8" of Joint: **NO**
 Remarks: **rootball in tap**

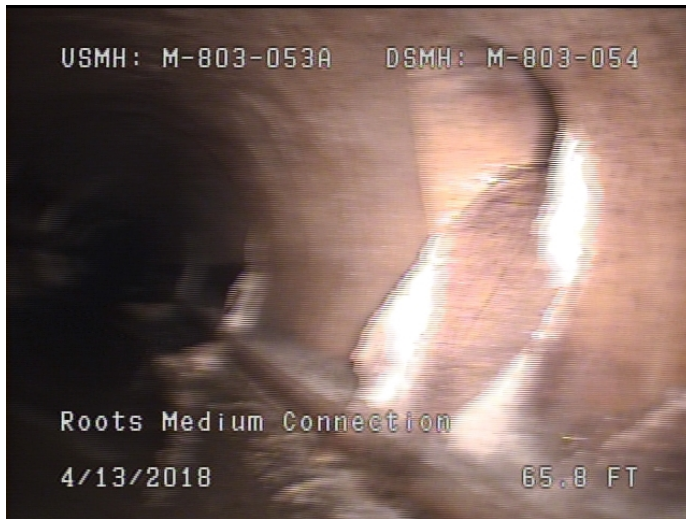
Code:	RMC
Description:	Roots Medium Connection
Distance (ft):	65.8
Structural Grade:	0
O&M Grade:	3
Clock Start/From:	2
Clock To:	4
1st Value:	
2nd Value:	
Value Percent:	10.000
Continuous Index:	
Within 8" of Joint:	NO
Remarks:

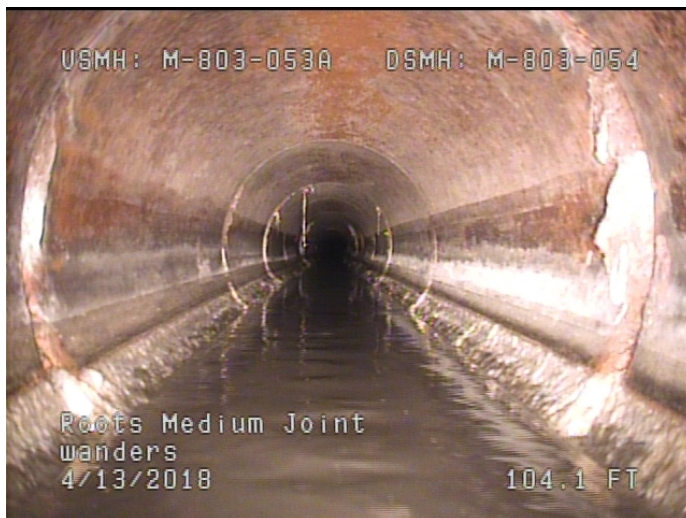
Code:	RMJ
Description:	Roots Medium Joint
Distance (ft):	104.1
Structural Grade:	0
O&M Grade:	3
Clock Start/From:	1
Clock To:	10
1st Value:	
2nd Value:	
Value Percent:	15.000
Continuous Index:	F01
Within 8" of Joint:	YES
Remarks:	wanders

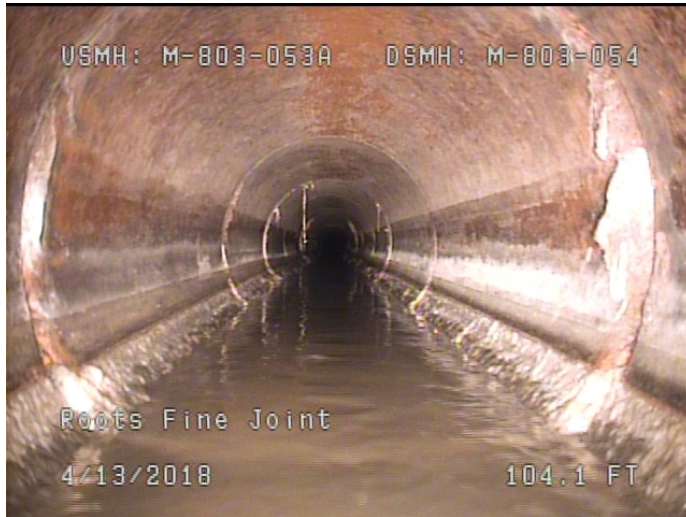
Code: **RFJ**
 Description: **Roots Fine Joint**

Distance (ft): **104.1**
 Structural Grade: **0**
 O&M Grade: **1**
 Clock Start/From: **7**
 Clock To: **5**
 1st Value:
 2nd Value:
 Value Percent:
 Continuous Index: **S02**
 Within 8" of Joint: **YES**
 Remarks:

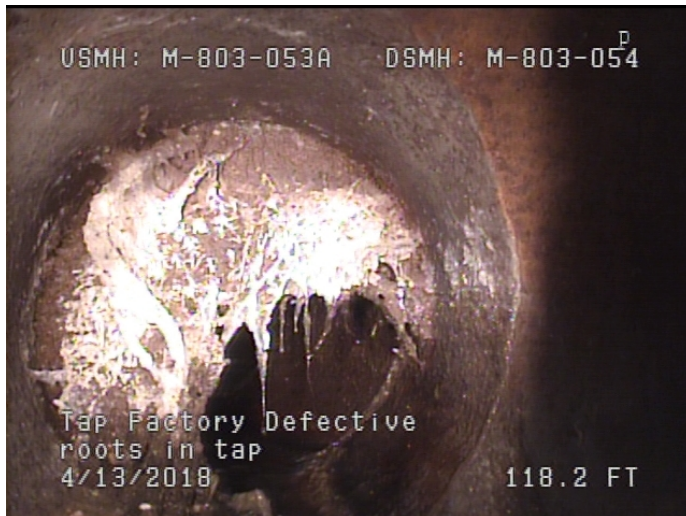
Code: **TFD**
 Description: **Tap Factory Defective**

Distance (ft): **118.2**
 Structural Grade: **0**
 O&M Grade: **2**
 Clock Start/From: **3**
 Clock To:
 1st Value: **6.000**
 2nd Value:
 Value Percent:
 Continuous Index:
 Within 8" of Joint: **NO**
 Remarks: **roots in tap**

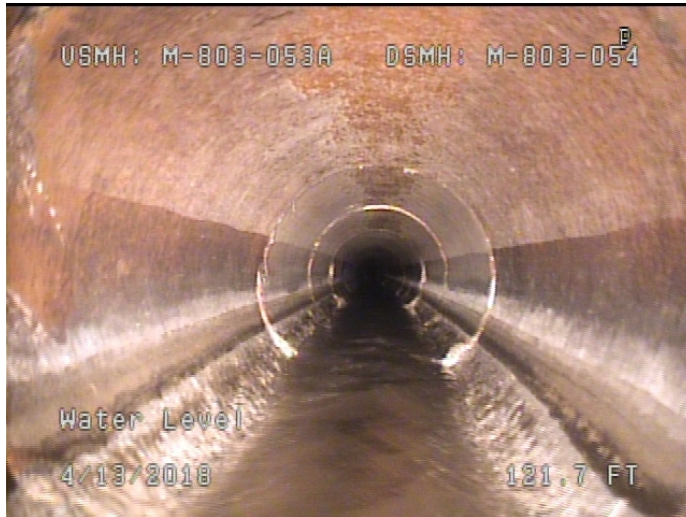
Code: **MWL**
 Description: **Water Level**

Distance (ft): **121.7**
 Structural Grade: **0**
 O&M Grade: **0**
 Clock Start/From:
 Clock To:
 1st Value:
 2nd Value:
 Value Percent: **5.000**
 Continuous Index:
 Within 8" of Joint: **NO**
 Remarks:

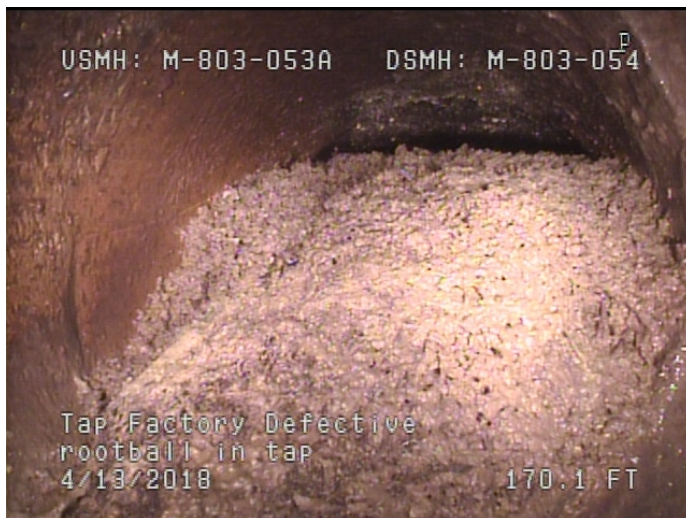
Code: **TFD**
 Description: **Tap Factory Defective**

Distance (ft): **170.1**
 Structural Grade: **0**
 O&M Grade: **2**
 Clock Start/From: **2**
 Clock To:
 1st Value: **6.000**
 2nd Value:
 Value Percent:
 Continuous Index:
 Within 8" of Joint: **NO**
 Remarks: **rootball in tap**

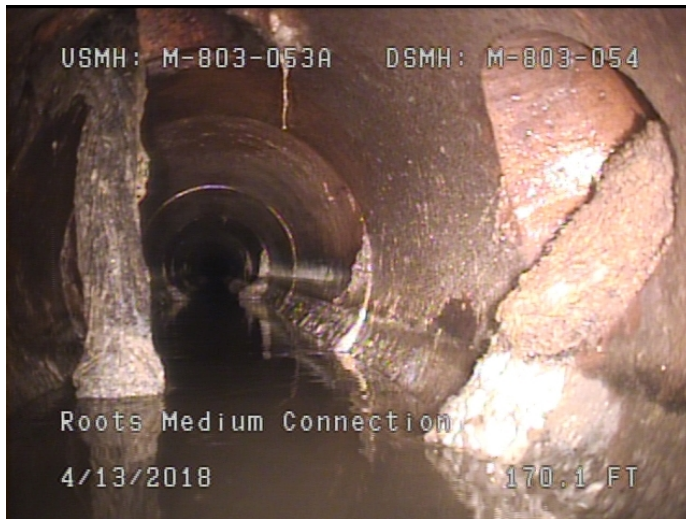
Code:	RMC
Description:	Roots Medium Connection
Distance (ft):	170.1
Structural Grade:	0
O&M Grade:	3
Clock Start/From:	3
Clock To:	5
1st Value:	
2nd Value:	
Value Percent:	15.000
Continuous Index:	
Within 8" of Joint:	NO
Remarks:

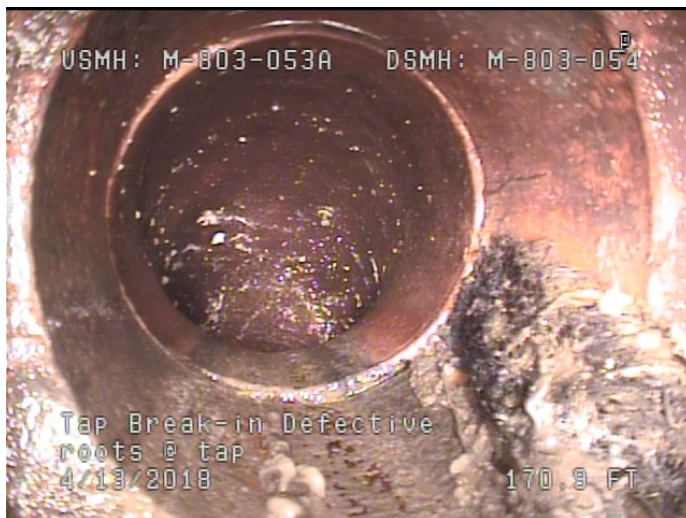
Code:	TBD
Description:	Tap Break-in Defective
Distance (ft):	170.9
Structural Grade:	0
O&M Grade:	3
Clock Start/From:	11
Clock To:	
1st Value:	6.000
2nd Value:	
Value Percent:	
Continuous Index:	
Within 8" of Joint:	NO
Remarks:	roots @ tap

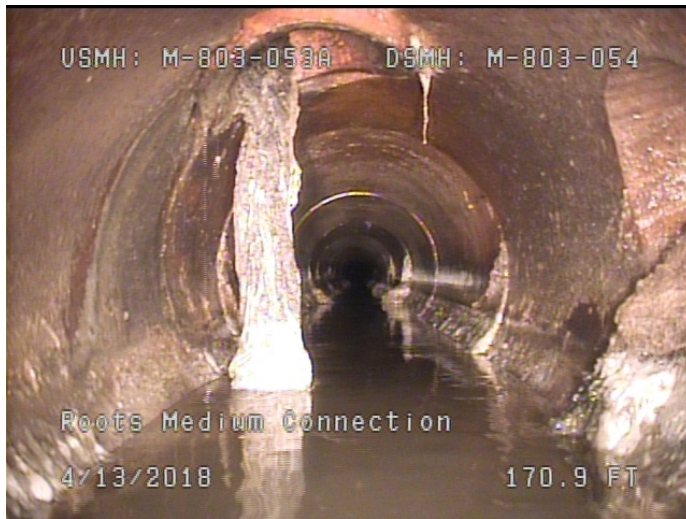
Code:	RMC
Description:	Roots Medium Connection
Distance (ft):	170.9
Structural Grade:	0
O&M Grade:	3
Clock Start/From:	7
Clock To:	11
1st Value:	
2nd Value:	
Value Percent:	15.000
Continuous Index:	
Within 8" of Joint:	NO
Remarks:

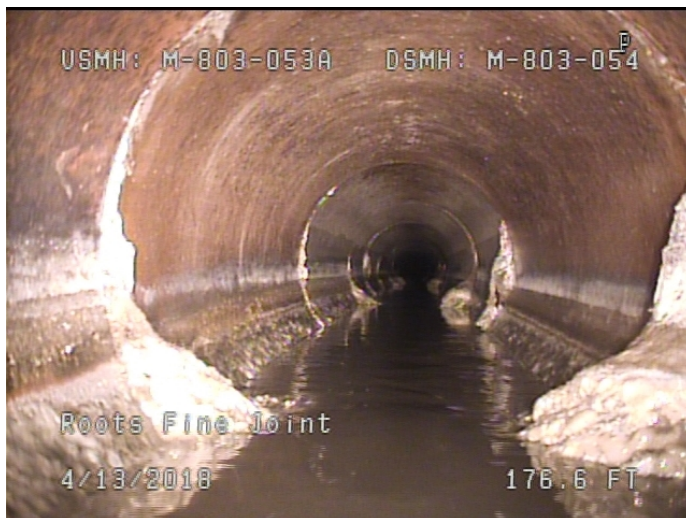
Code:	RFJ
Description:	Roots Fine Joint
Distance (ft):	176.6
Structural Grade:	0
O&M Grade:	1
Clock Start/From:	7
Clock To:	5
1st Value:	
2nd Value:	
Value Percent:	
Continuous Index:	F02
Within 8" of Joint:	YES
Remarks:

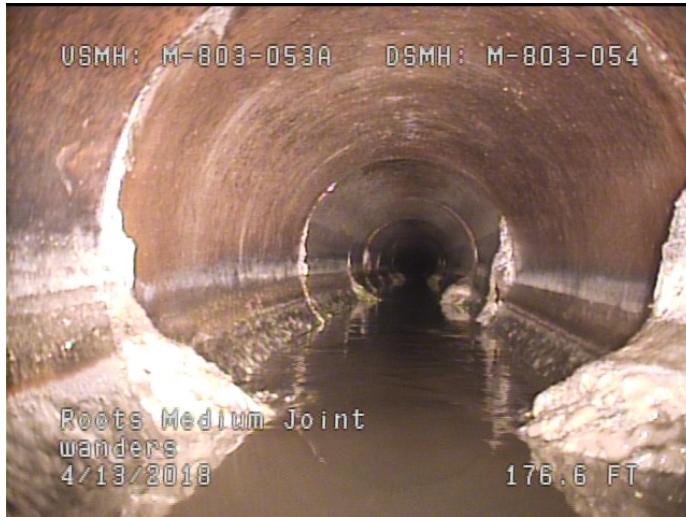
Code: **RMJ**
 Description: **Roots Medium Joint**

Distance (ft): **176.6**
 Structural Grade: **0**
 O&M Grade: **3**
 Clock Start/From: **3**
 Clock To: **9**
 1st Value:
 2nd Value:
 Value Percent: **15.000**
 Continuous Index: **S03**
 Within 8" of Joint: **YES**
 Remarks: **wanders**

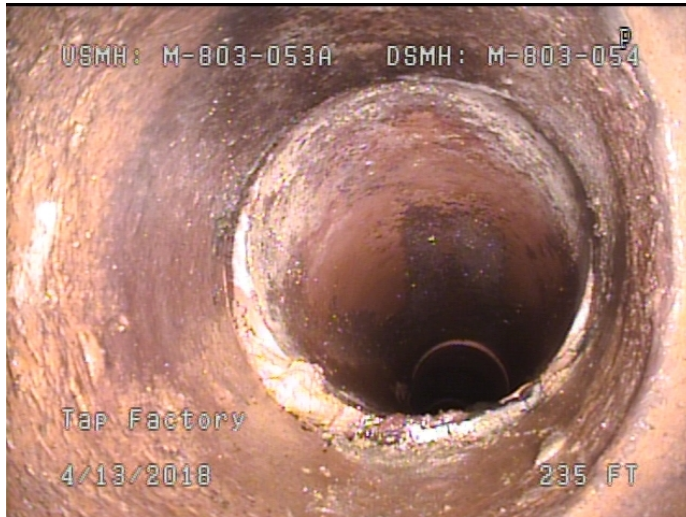
Code:	TF
Description:	Tap Factory
Distance (ft):	235.0
Structural Grade:	0
O&M Grade:	0
Clock Start/From:	2
Clock To:	
1st Value:	6.000
2nd Value:	
Value Percent:	
Continuous Index:	
Within 8" of Joint:	NO
Remarks:

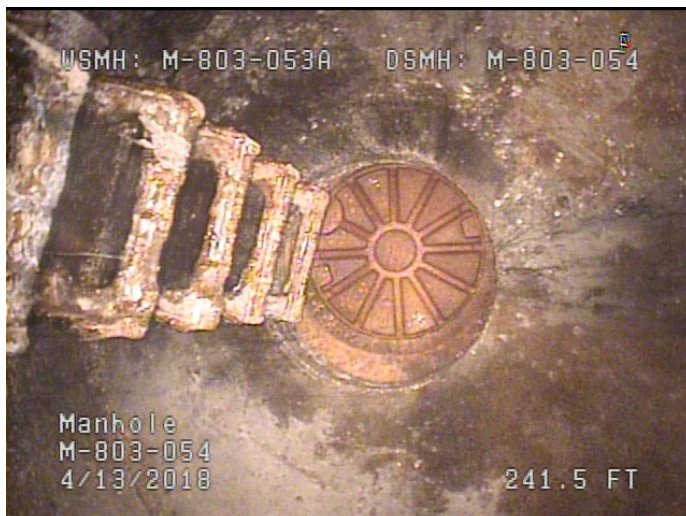
Code:	AMH
Description:	Manhole
Distance (ft):	241.5
Structural Grade:	0
O&M Grade:	0
Clock Start/From:	
Clock To:	
1st Value:	
2nd Value:	
Value Percent:	
Continuous Index:	
Within 8" of Joint:	NO
Remarks:	M-803-054
