Profile/Photo Observation Report

Street:	E RAND ST	Flow Control:	Not Controlled
City:	Hobart, IN	Year Renewed:	
Location:	Other	Tape/Media #:	
Purpose:	Not Known	Dia/Height:	10"
Use:	Sanitary	Material:	VCP
Drain Area:	NA	Lining:	
Category:	NA		
Comment:

Location Details:		Direction of Survey:	Downstream
US MH:	M-803-055	DS MH:	M-803-028
		Total Length Surveyed (ft):	122.4

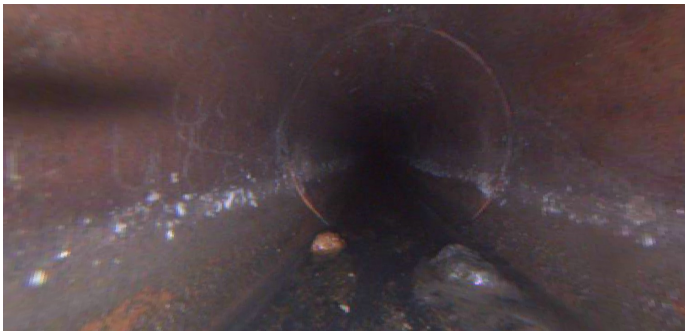
Code: **AMH**
Description: **Manhole**

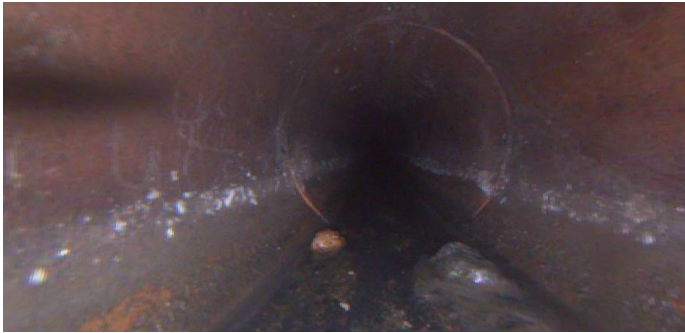
Code:	MWL
Description:	Water Level

Distance (ft):	.0
Structural Grade:	0
O&M Grade:	0
Clock Start/From:	
Clock To:	
1st Value:	
2nd Value:	
Value Percent:	5.000
Continuous Index:	
Within 8" of Joint:	NO
Remarks:

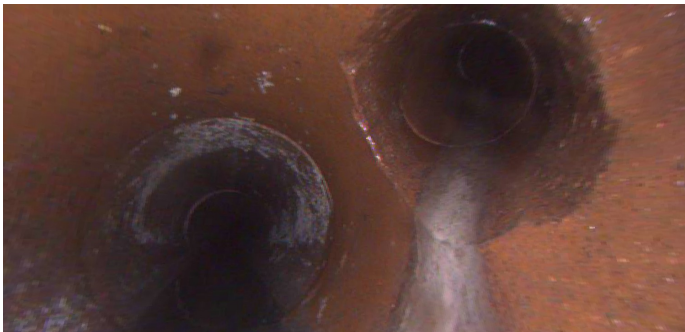
Code:	TF
Description:	Tap Factory

Distance (ft):	75.9
Structural Grade:	0
O&M Grade:	0
Clock Start/From:	2
Clock To:	
1st Value:	4.000
2nd Value:	
Value Percent:	
Continuous Index:	
Within 8" of Joint:	YES
Remarks:

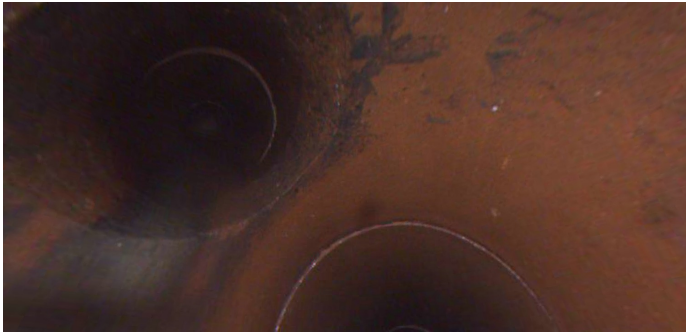
Code: **TF**
Description: **Tap Factory**

Distance (ft): **98.7**
Structural Grade: **0**
O&M Grade: **0**
Clock Start/From: **11**
Clock To:
1st Value: **4.000**
2nd Value:
Value Percent:
Continuous Index:
Within 8" of Joint:
Remarks:

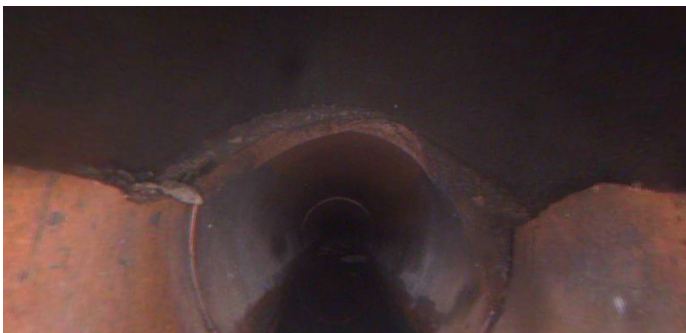
Code: **AMH**
Description: **Manhole**

Distance (ft): **122.4**
Structural Grade: **0**
O&M Grade: **0**
Clock Start/From:
Clock To:
1st Value:
2nd Value:
Value Percent:
Continuous Index:
Within 8" of Joint: **NO**
Remarks: **M-803-028**
