Profile/Photo Observation Report

Street:	N LIBERTY CT	Flow Control:	Not Controlled
City:	Hobart, IN	Year Renewed:	
Location:	Other	Tape/Media #:	
Purpose:	Not Known	Dia/Height:	10"
Use:	Sanitary	Material:	PVC
Drain Area:	NA	Lining:	
Category:	NA		
Comment:

Location Details:		Direction of Survey:	Upstream
US MH:	M-803-057	DS MH:	M-803-058
		Total Length Surveyed (ft):	146.9

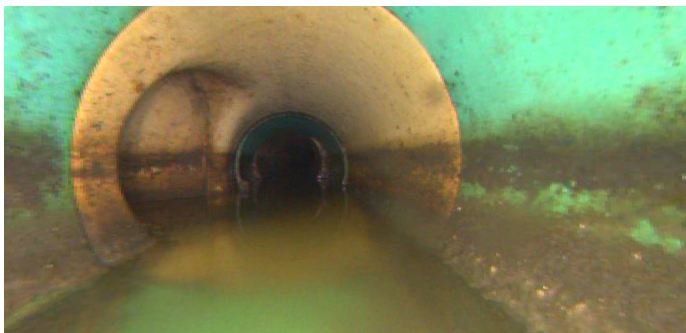
Code: **AMH**
Description: **Manhole**

Distance (ft): **.0**
Structural Grade: **0**
O&M Grade: **0**
Clock Start/From:
Clock To:
1st Value:
2nd Value:
Value Percent:
Continuous Index:
Within 8" of Joint: **NO**
Remarks: **M-803-058**

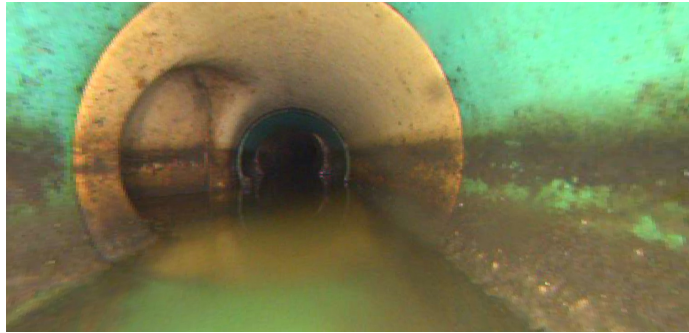
Code: **MWL**
Description: **Water Level**

Distance (ft): **.0**
Structural Grade: **0**
O&M Grade: **0**
Clock Start/From:
Clock To:
1st Value:
2nd Value:
Value Percent: **5.000**
Continuous Index:
Within 8" of Joint: **NO**
Remarks:

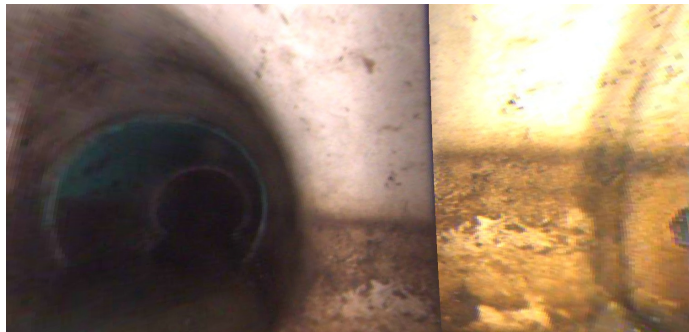
Code: **TF**
Description: **Tap Factory**

Distance (ft): **3.2**
Structural Grade: **0**
O&M Grade: **0**
Clock Start/From: **9**
Clock To:
1st Value: **6.000**
2nd Value:
Value Percent:
Continuous Index:
Within 8" of Joint: **YES**
Remarks:

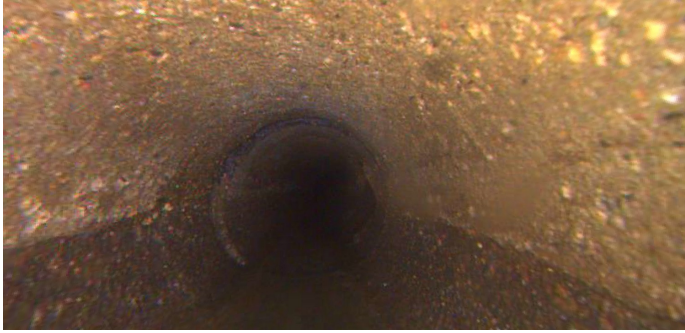
Code: **SAP**
Description: **Surface Aggregate Projecting**

Distance (ft): **4.4**
Structural Grade: **3**
O&M Grade: **0**
Clock Start/From: **8**
Clock To: **4**
1st Value:
2nd Value:
Value Percent:
Continuous Index: **S01**
Within 8" of Joint:
Remarks:

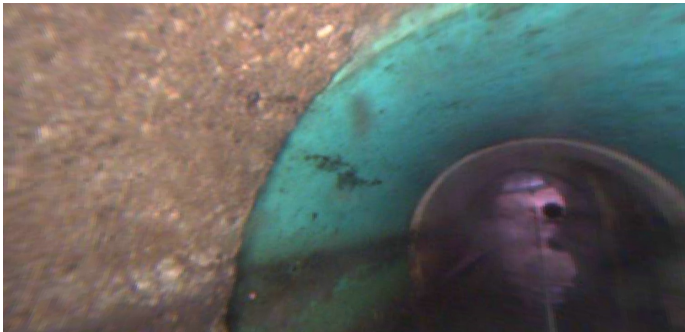
Code: **MMC**
Description: **Material Change**

Distance (ft): **4.4**
Structural Grade: **0**
O&M Grade: **0**
Clock Start/From:
Clock To:
1st Value:
2nd Value:
Value Percent:
Continuous Index:
Within 8" of Joint: **NO**
Remarks: **concrete**

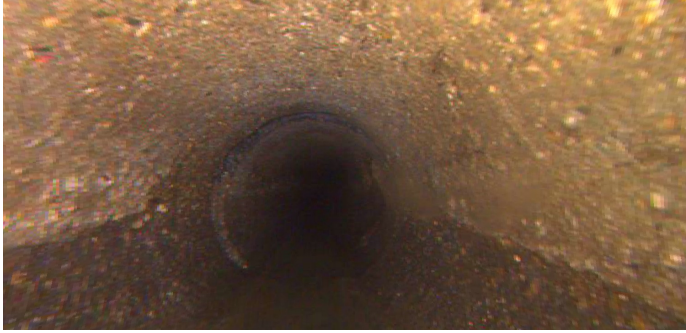
Code: **CM**
Description: **Crack Multiple**

Distance (ft): **4.4**
Structural Grade: **3**
O&M Grade: **0**
Clock Start/From: **9**
Clock To: **3**
1st Value:
2nd Value:
Value Percent:
Continuous Index:
Within 8" of Joint: **YES**
Remarks: **wandering**

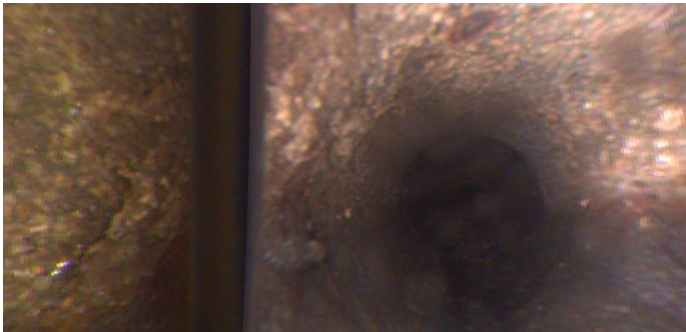
Code: **TF**
Description: **Tap Factory**

Distance (ft): **6.5**
Structural Grade: **0**
O&M Grade: **0**
Clock Start/From: **3**
Clock To:
1st Value: **4.000**
2nd Value:
Value Percent:
Continuous Index:
Within 8" of Joint:
Remarks:

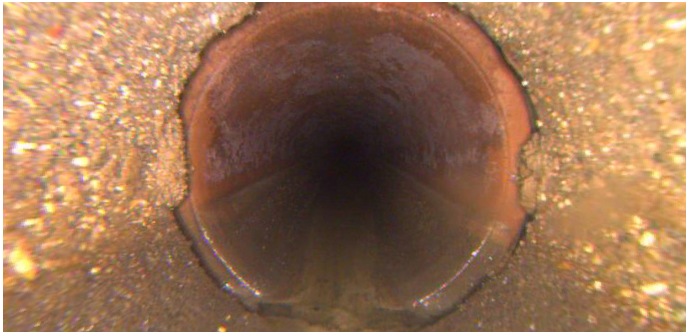
Code: **SAP**
Description: **Surface Aggregate Projecting**

Distance (ft): **16.8**
Structural Grade: **3**
O&M Grade: **0**
Clock Start/From: **8**
Clock To: **4**
1st Value:
2nd Value:
Value Percent:
Continuous Index: **F01**
Within 8" of Joint:
Remarks:

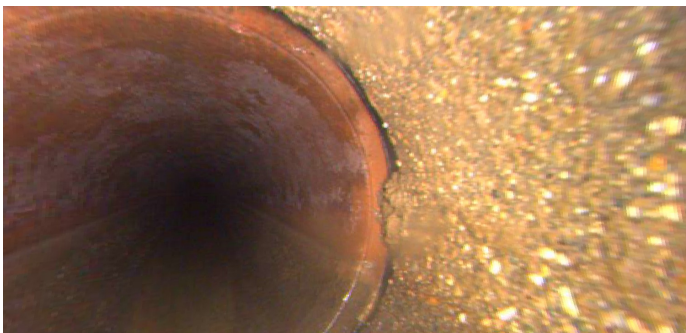
Code: **MMC**
Description: **Material Change**

Distance (ft): **16.8**
Structural Grade: **0**
O&M Grade: **0**
Clock Start/From:
Clock To:
1st Value:
2nd Value:
Value Percent:
Continuous Index:
Within 8" of Joint: **NO**
Remarks: **vcp**

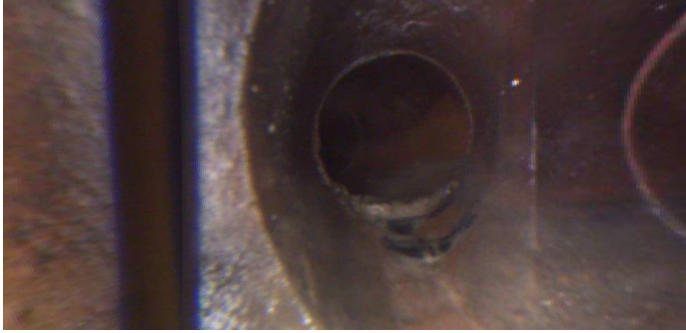
Code: **TF**
Description: **Tap Factory**

Distance (ft): **34.4**
Structural Grade: **0**
O&M Grade: **0**
Clock Start/From: **3**
Clock To:
1st Value: **4.000**
2nd Value:
Value Percent:
Continuous Index:
Within 8" of Joint: **YES**
Remarks:

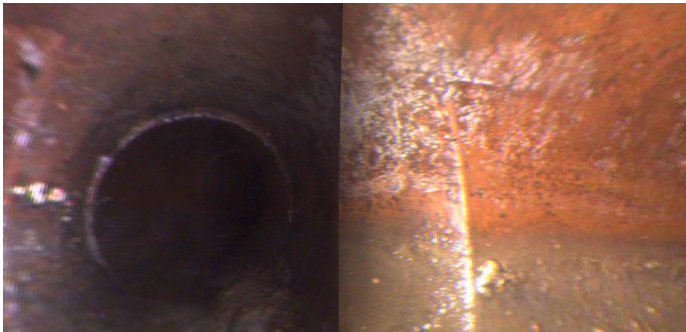
Code: **TF**
Description: **Tap Factory**

Distance (ft): **48.0**
Structural Grade: **0**
O&M Grade: **0**
Clock Start/From: **9**
Clock To:
1st Value: **4.000**
2nd Value:
Value Percent:
Continuous Index:
Within 8" of Joint: **YES**
Remarks:

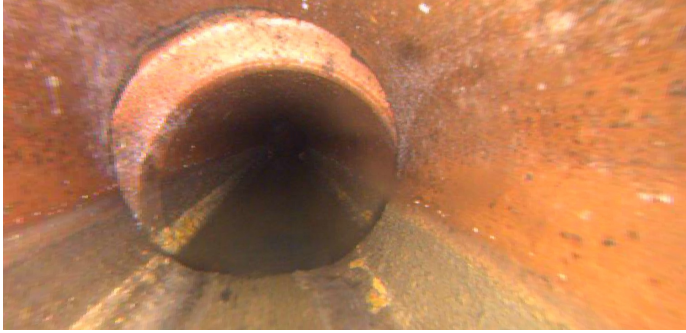
Code: **JOM**
Description: **Joint Offset Medium**

Distance (ft): **140.4**
Structural Grade: **1**
O&M Grade: **0**
Clock Start/From:
Clock To:
1st Value:
2nd Value:
Value Percent:
Continuous Index:
Within 8" of Joint: **NO**
Remarks:

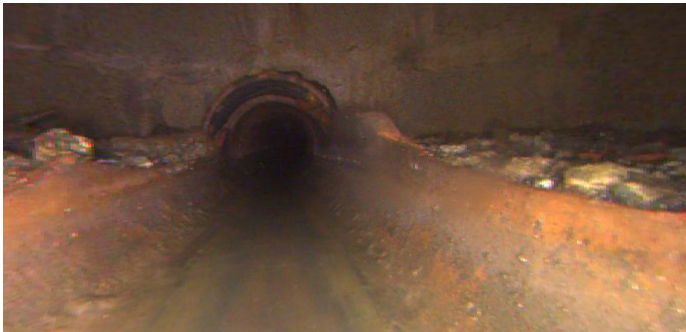
Code: **AMH**
Description: **Manhole**

Distance (ft): **146.9**
Structural Grade: **0**
O&M Grade: **0**
Clock Start/From:
Clock To:
1st Value:
2nd Value:
Value Percent:
Continuous Index:
Within 8" of Joint: **NO**
Remarks: **M-803-057**
