# Profile/Photo Observation Report

Date:	<b>03/26/2018</b>	Weather:		Coding:	<b>PACP 6.0</b>
Pipe Length (ft):	<b>152.3</b>	Owner:	<b>NA</b>	Pre Clean:	<b>Not Known</b>
P.O.#:		Surveyor:	<b>Byrd Fitzgerald</b>	PSR:	<b>P-803-058-057</b>
Customer:		Clean Date:	<b>01/01/1900</b>	Shape:	<b>C</b>

Street:	<b>N LIBERTY CT</b>	Flow Control:	<b>Not Controlled</b>
City:	<b>Hobart, IN</b>	Year Renewed:	
Location:	<b>Other</b>	Tape/Media #:	
Purpose:	<b>Not Known</b>	Dia/Height:	<b>10"</b>
Use:	<b>Sanitary</b>	Material:	<b>PVC</b>
Drain Area:	<b>NA</b>	Lining:	
Category:	<b>NA</b>		
Comment:			
Location Details:		Direction of Survey:	<b>Upstream</b>
US MH:	<b>M-803-057</b>	DS MH:	<b>M-803-058</b>
		Total Length Surveyed (ft):	<b>146.9</b>

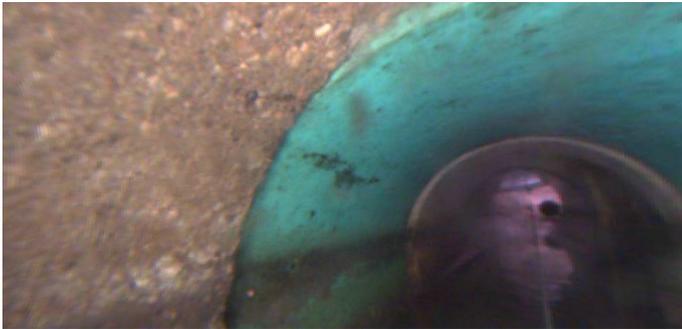
Code: **MMC**  
Description: **Material Change**

Distance (ft): **4.4**  
Structural Grade: **0**  
O&M Grade: **0**  
Clock Start/From:  
Clock To:  
1st Value:  
2nd Value:  
Value Percent:  
Continuous Index:  
Within 8" of Joint: **NO**  
Remarks: **concrete**

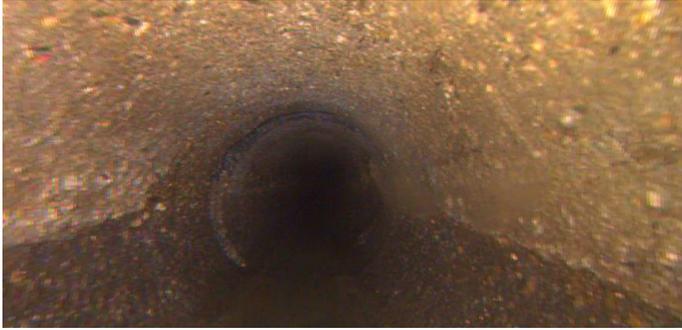
Code: **CM**  
Description: **Crack Multiple**

Distance (ft): **4.4**  
Structural Grade: **3**  
O&M Grade: **0**  
Clock Start/From: **9**  
Clock To: **3**  
1st Value:  
2nd Value:  
Value Percent:  
Continuous Index:  
Within 8" of Joint: **YES**  
Remarks: **wandering**

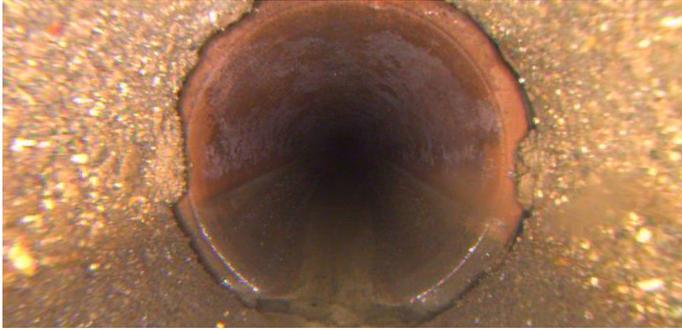
Code: **SAP**  
Description: **Surface Aggregate Projecting**

Distance (ft): **16.8**  
Structural Grade: **3**  
O&M Grade: **0**  
Clock Start/From: **8**  
Clock To: **4**  
1st Value:  
2nd Value:  
Value Percent:  
Continuous Index: **F01**  
Within 8" of Joint:  
Remarks:

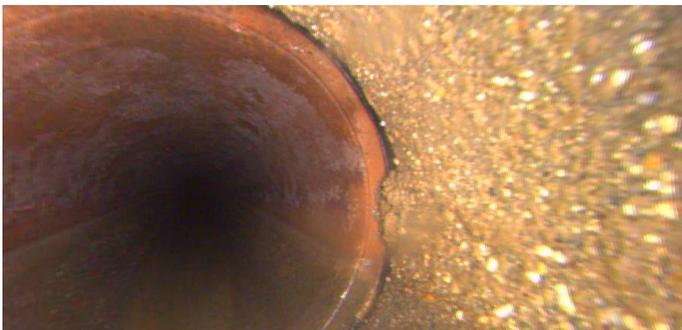
Code: **MMC**  
Description: **Material Change**

Distance (ft): **16.8**  
Structural Grade: **0**  
O&M Grade: **0**  
Clock Start/From:  
Clock To:  
1st Value:  
2nd Value:  
Value Percent:  
Continuous Index:  
Within 8" of Joint: **NO**  
Remarks: **vcp**

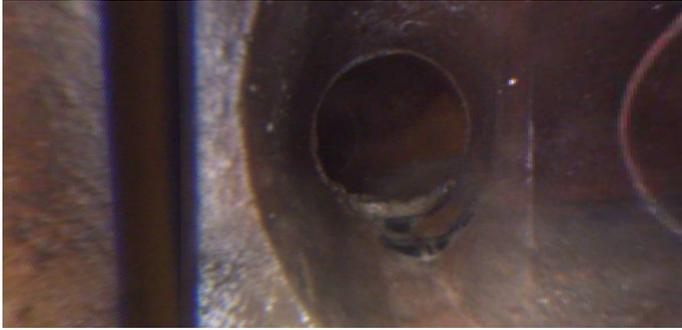
Code: **TF**  
Description: **Tap Factory**

Distance (ft): **34.4**  
Structural Grade: **0**  
O&M Grade: **0**  
Clock Start/From: **3**  
Clock To:  
1st Value: **4.000**  
2nd Value:  
Value Percent:  
Continuous Index:  
Within 8" of Joint: **YES**  
Remarks:

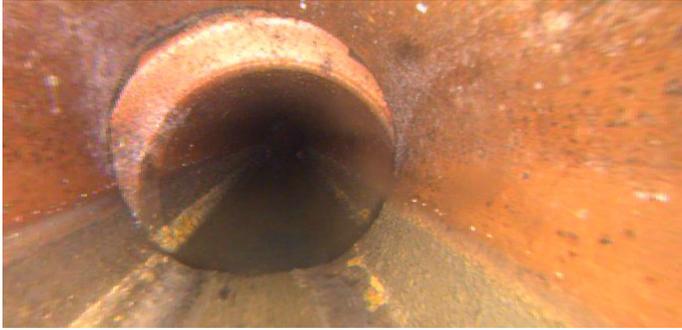
Code: **JOM**  
Description: **Joint Offset Medium**

Distance (ft): **140.4**  
Structural Grade: **1**  
O&M Grade: **0**  
Clock Start/From:  
Clock To:  
1st Value:  
2nd Value:  
Value Percent:  
Continuous Index:  
Within 8" of Joint: **NO**  
Remarks:

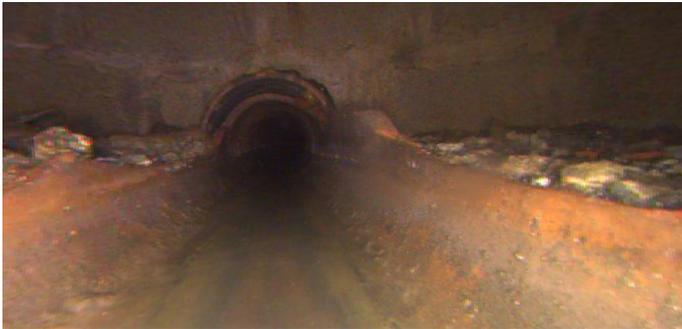
Code: **AMH**  
Description: **Manhole**

Distance (ft): **146.9**  
Structural Grade: **0**  
O&M Grade: **0**  
Clock Start/From:  
Clock To:  
1st Value:  
2nd Value:  
Value Percent:  
Continuous Index:  
Within 8" of Joint: **NO**  
Remarks: **M-803-057**
