Profile/Photo Observation Report

Date:	10/15/2021	Weather:		Coding:	PACP 6.0
Pipe Length (ft):		Owner:	Hobart, IN	Pre Clean:	Not Known
P.O.#:	814_1	Surveyor:	M. Pielacha	PSR:	P-803-062-063
Customer:	Hobart, IN	Clean Date:		Shape:	C

Street:	Off 37th Avenue	Flow Control:	
City:	Hobart, IN	Year Renewed:	
Location:	Sidewalk	Tape/Media #:	814
Purpose:	Routine Assessment	Dia/Height:	8"
Use:	Sanitary	Material:	PVC
Drain Area:		Lining:	
Category:	NA		
Comment:

Location Details:		Direction of Survey:	Upstream
US MH:	M-803-63	DS MH:	M-803-62
		Total Length Surveyed (ft):	142.3

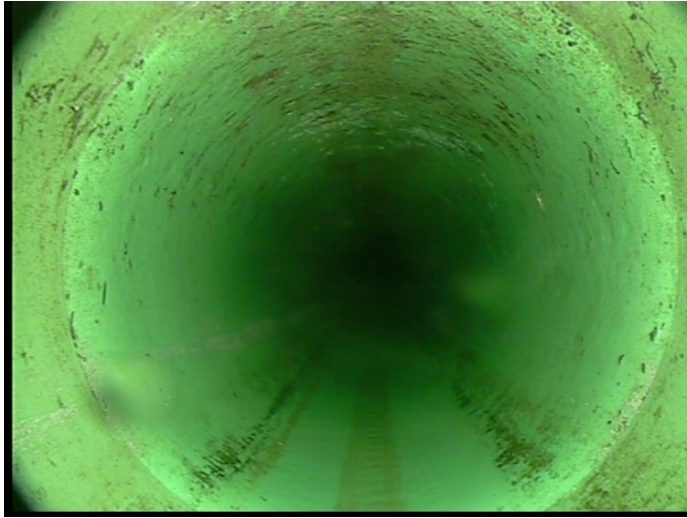
Code: **MWL**
Description: **Water Level**

Distance (ft): **.0**
Structural Grade: **0**
O&M Grade: **0**
Clock Start/From:
Clock To:
1st Value:
2nd Value:
Value Percent: **5.000**
Continuous Index:
Within 8" of Joint: **NO**
Remarks:

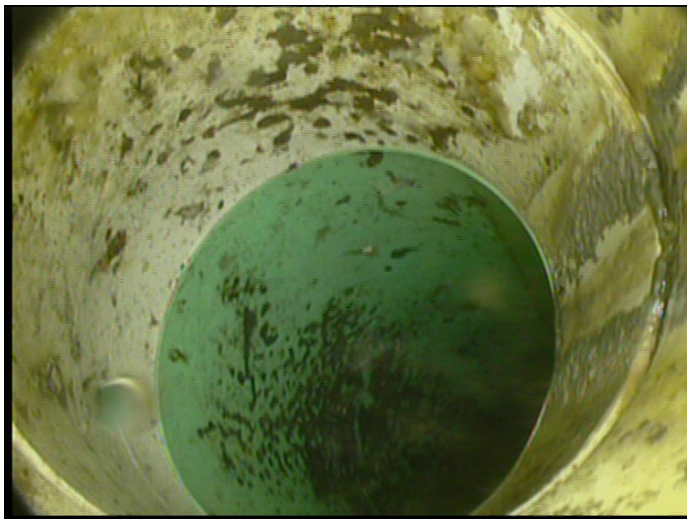
Code: **TF**
Description: **Tap Factory**

Distance (ft): **71.2**
Structural Grade: **0**
O&M Grade: **0**
Clock Start/From: **1**
Clock To:
1st Value: **4.000**
2nd Value:
Value Percent:
Continuous Index:
Within 8" of Joint: **NO**
Remarks:
