Profile/Photo Observation Report

Date:	03/26/2018	Weather:		Coding:	PACP 6.0
Pipe Length (ft):	14.3	Owner:	NA	Pre Clean:	Not Known
P.O.#:		Surveyor:	Byrd Fitzgerald	PSR:	P-803-063-LS023
Customer:		Clean Date:	01/01/1900	Shape:	C

Street:	OFF E 37TH AVE	Flow Control:	Not Controlled
City:	Hobart, IN	Year Renewed:	
Location:	Other	Tape/Media #:	
Purpose:	Not Known	Dia/Height:	10"
Use:	Sanitary	Material:	PVC
Drain Area:	NA	Lining:	
Category:	NA		
Comment:

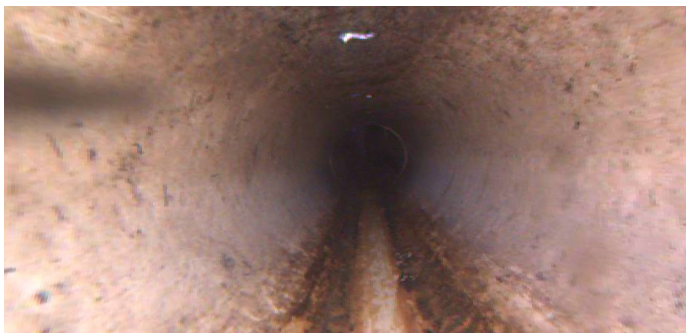
Code: **AMH**
Description: **Manhole**

Distance (ft): **.0**
Structural Grade: **0**
O&M Grade: **0**
Clock Start/From:
Clock To:
1st Value:
2nd Value:
Value Percent:
Continuous Index:
Within 8" of Joint: **NO**
Remarks: **M-803-063**

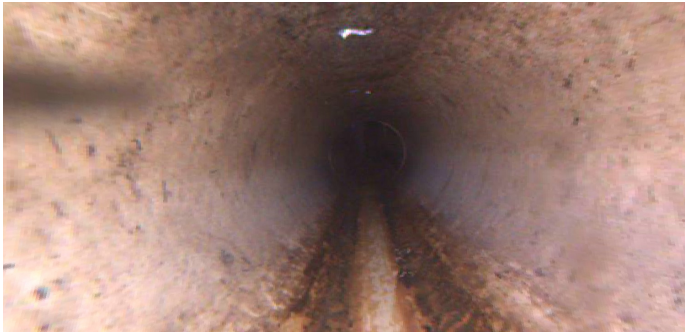
Code:	MWL
Description:	Water Level

Distance (ft):	.0
Structural Grade:	0
O&M Grade:	0
Clock Start/From:	
Clock To:	
1st Value:	
2nd Value:	
Value Percent:	5.000
Continuous Index:	
Within 8" of Joint:	NO
Remarks:
