Profile/Photo Observation Report

Date:	04/24/2018	Weather:		Coding:	PACP 4.2
Pipe Length (ft):	79.0	Owner:	City of Hobart	Pre Clean:	No Pre-Cleaning
P.O.#:	2004	Surveyor:	SAN	PSR:	P-803-064-LS024
Customer:	Red Zone	Clean Date:		Shape:	C

Street:	37th Ave	Flow Control:	Not Controlled
City:	Hobart In	Year Renewed:	
Location:	Parking Lot	Tape/Media #:	Deliverable 1
Purpose:	Routine Assessment	Dia/Height:	6"
Use:	Sanitary	Material:	PVC
Drain Area:	Northeast	Lining:	
Category:	NA		
Comment:	430-1. DSMH incorrect in video overlay.		
Location Details:	Quik Lube parking lot	Direction of Survey:	Downstream
US MH:	M-803-064	DS MH:	LS024
		Total Length Surveyed (ft):	79.0

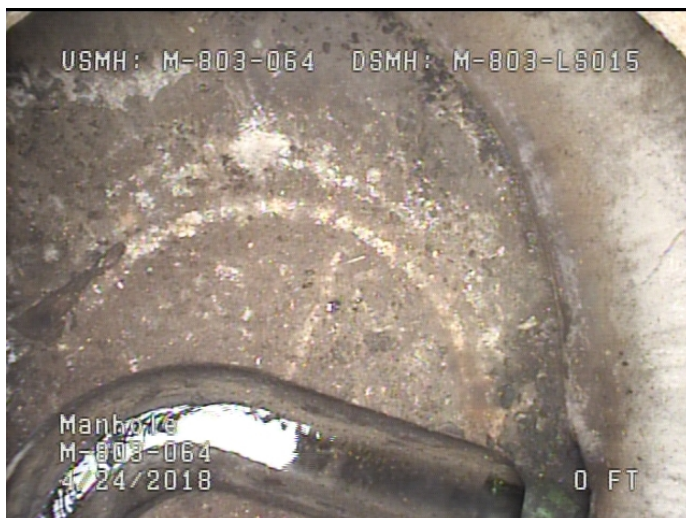
Code:	AMH
Description:	Manhole
Distance (ft):	.0
Structural Grade:	0
O&M Grade:	0
Clock Start/From:	
Clock To:	
1st Value:	
2nd Value:	
Value Percent:	
Continuous Index:	
Within 8" of Joint:	NO
Remarks:	M-803-064

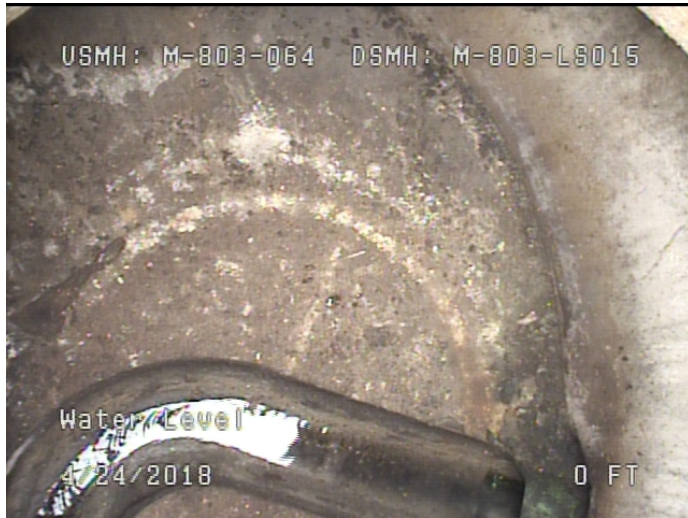
Code:	MWL
Description:	Water Level
Distance (ft):	.0
Structural Grade:	0
O&M Grade:	0
Clock Start/From:	
Clock To:	
1st Value:	
2nd Value:	
Value Percent:	5.000
Continuous Index:	
Within 8" of Joint:	NO
Remarks:

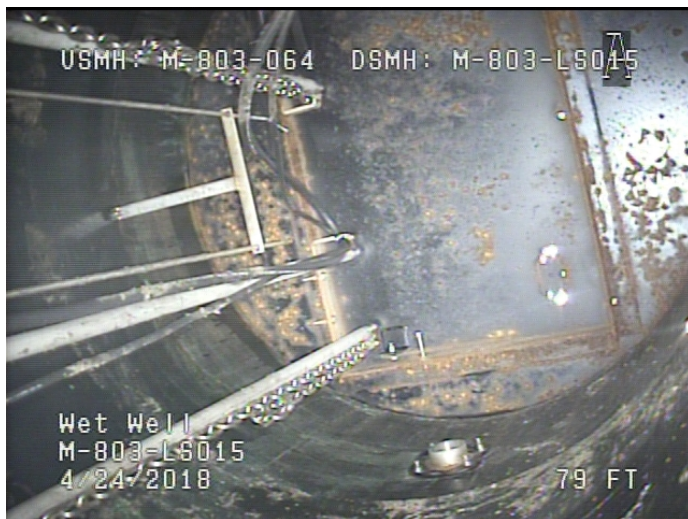
Code:	AWW
Description:	Wet Well
Distance (ft):	79.0
Structural Grade:	0
O&M Grade:	0
Clock Start/From:	
Clock To:	
1st Value:	
2nd Value:	
Value Percent:	
Continuous Index:	
Within 8" of Joint:	NO
Remarks:	M-803-LS015
