Profile/Photo Observation Report

Date:	03/22/2018	Weather:		Coding:	PACP 6.0
Pipe Length (ft):	58.7	Owner:	NA	Pre Clean:	Not Known
P.O.#:		Surveyor:	Selasie Honu	PSR:	P-803-065-050
Customer:		Clean Date:	01/01/1900	Shape:	C

Street:	N HOBART RD	Flow Control:	Not Controlled
City:	Hobart, IN	Year Renewed:	
Location:	Other	Tape/Media #:	
Purpose:	Not Known	Dia/Height:	10"
Use:	Sanitary	Material:	VCP
Drain Area:	NA	Lining:	
Category:	NA		
Comment:

Location Details:		Direction of Survey:	Upstream
US MH:	M-803-065	DS MH:	M-903-050
		Total Length Surveyed (ft):	53.5

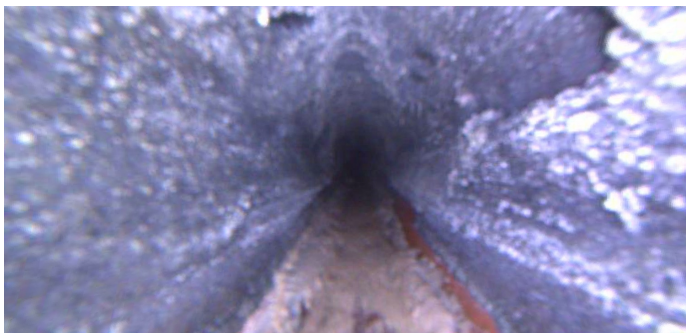
Code: **DAGS**
Description: **Deposits Attached Grease**

Distance (ft): **.0**
Structural Grade: **0**
O&M Grade: **2**
Clock Start/From: **7**
Clock To: **5**
1st Value:
2nd Value:
Value Percent: **10.000**
Continuous Index: **S01**
Within 8" of Joint: **NO**
Remarks:

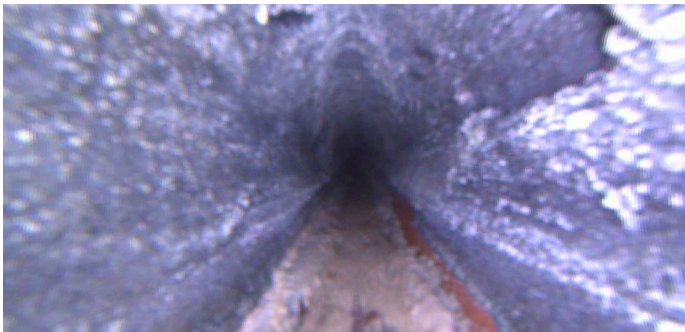
Code:	MWL
Description:	Water Level

Distance (ft):	.0
Structural Grade:	0
O&M Grade:	0
Clock Start/From:	
Clock To:	
1st Value:	
2nd Value:	
Value Percent:	5.000
Continuous Index:	
Within 8" of Joint:	NO
Remarks:

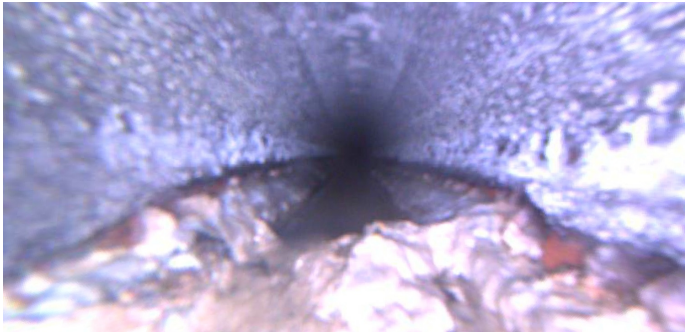
Code: **DSZ**
Description: **Deposits Settled Other**

Distance (ft): **15.1**
Structural Grade: **0**
O&M Grade: **3**
Clock Start/From: **4**
Clock To: **8**
1st Value:
2nd Value:
Value Percent: **20.000**
Continuous Index:
Within 8" of Joint: **NO**
Remarks: **MISC**

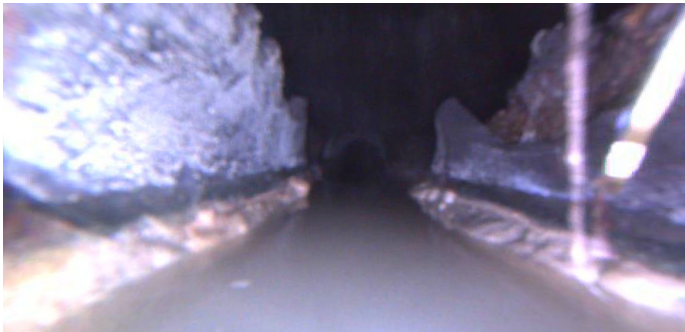
Code: **DAGS**
Description: **Deposits Attached Grease**

Distance (ft): **51.6**
Structural Grade: **0**
O&M Grade: **2**
Clock Start/From: **7**
Clock To: **5**
1st Value:
2nd Value:
Value Percent: **10.000**
Continuous Index: **F01**
Within 8" of Joint: **NO**
Remarks:

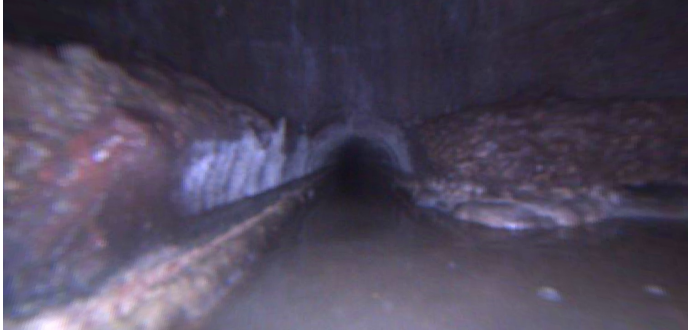
Code:	AMH
Description:	Manhole
Distance (ft):	53.5
Structural Grade:	0
O&M Grade:	0
Clock Start/From:	
Clock To:	
1st Value:	
2nd Value:	
Value Percent:	
Continuous Index:	
Within 8" of Joint:	NO
Remarks:	M-803-065
