Profile/Photo Observation Report

Date:	03/22/2018	Weather:		Coding:	PACP 6.0
Pipe Length (ft):	58.7	Owner:	NA	Pre Clean:	Not Known
P.O.#:		Surveyor:	Selasie Honu	PSR:	P-803-065-050
Customer:		Clean Date:	01/01/1900	Shape:	C

Location Details:		Direction of Survey:	Upstream
US MH:	M-803-065	DS MH:	M-903-050
		Total Length Surveyed (ft):	53.5

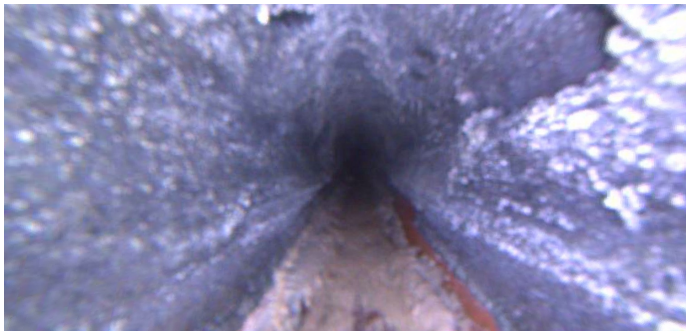
Code: **DAGS**
Description: **Deposits Attached Grease**

Distance (ft): **.0**
Structural Grade: **0**
O&M Grade: **2**
Clock Start/From: **7**
Clock To: **5**
1st Value:
2nd Value:
Value Percent: **10.000**
Continuous Index: **S01**
Within 8" of Joint: **NO**
Remarks:

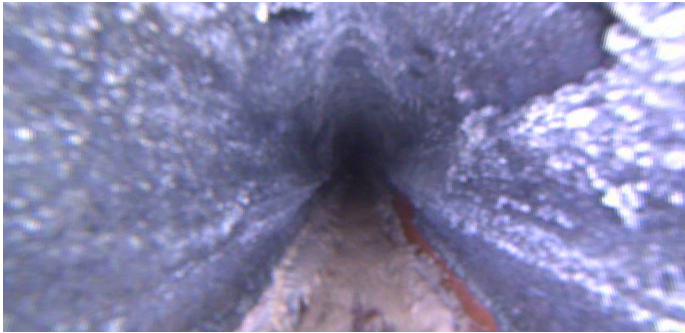
Code:	AMH
Description:	Manhole

Distance (ft):	.0
Structural Grade:	0
O&M Grade:	0
Clock Start/From:	
Clock To:	
1st Value:	
2nd Value:	
Value Percent:	
Continuous Index:	
Within 8" of Joint:	NO
Remarks:	M-903-050

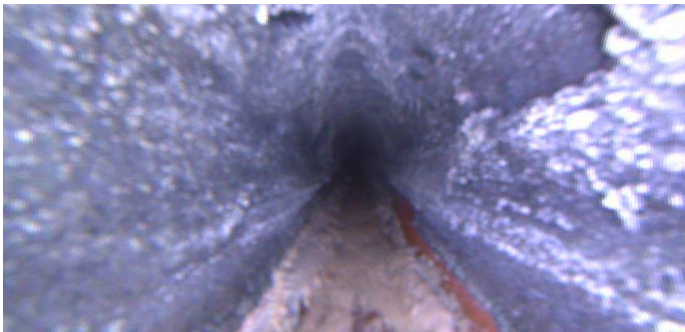
Code:	MWL
Description:	Water Level

Distance (ft):	.0
Structural Grade:	0
O&M Grade:	0
Clock Start/From:	
Clock To:	
1st Value:	
2nd Value:	
Value Percent:	5.000
Continuous Index:	
Within 8" of Joint:	NO
Remarks:

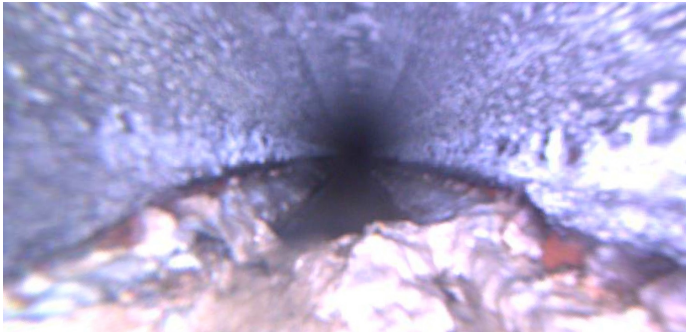
Code: **DSZ**
Description: **Deposits Settled Other**

Distance (ft): **15.1**
Structural Grade: **0**
O&M Grade: **3**
Clock Start/From: **4**
Clock To: **8**
1st Value:
2nd Value:
Value Percent: **20.000**
Continuous Index:
Within 8" of Joint: **NO**
Remarks: **MISC**

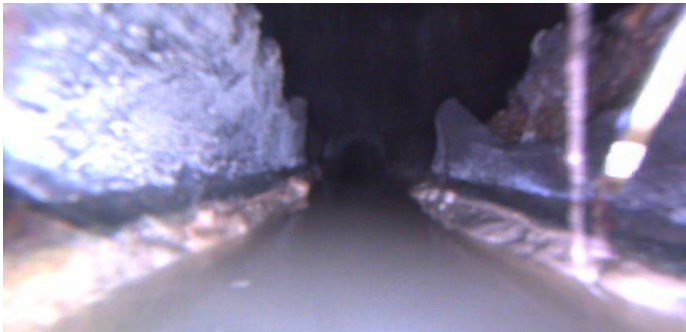
Code: **DAGS**
Description: **Deposits Attached Grease**

Distance (ft): **51.6**
Structural Grade: **0**
O&M Grade: **2**
Clock Start/From: **7**
Clock To: **5**
1st Value:
2nd Value:
Value Percent: **10.000**
Continuous Index: **F01**
Within 8" of Joint: **NO**
Remarks:

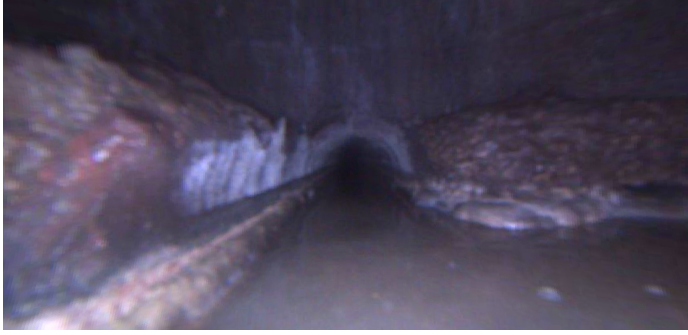
Code:	AMH
Description:	Manhole
Distance (ft):	53.5
Structural Grade:	0
O&M Grade:	0
Clock Start/From:	
Clock To:	
1st Value:	
2nd Value:	
Value Percent:	
Continuous Index:	
Within 8" of Joint:	NO
Remarks:	M-803-065
