Profile/Photo Observation Report

Street:	E 37TH AVE & N COLONIAL DR	Flow Control:	Not Controlled
City:	Hobart, IN	Year Renewed:	
Location:	Other	Tape/Media #:	
Purpose:	Not Known	Dia/Height:	10"
Use:	Sanitary	Material:	PVC
Drain Area:	NA	Lining:	
Category:	NA		
Comment:

Location Details:		Direction of Survey:	Downstream
US MH:	M-803-068	DS MH:	M-803-067
		Total Length Surveyed (ft):	115.5

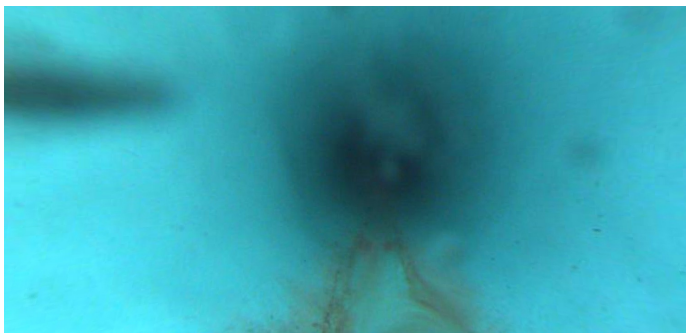
Code: **AMH**
Description: **Manhole**

Distance (ft): **.0**
Structural Grade: **0**
O&M Grade: **0**
Clock Start/From:
Clock To:
1st Value:
2nd Value:
Value Percent:
Continuous Index:
Within 8" of Joint: **NO**
Remarks: **M-803-068**

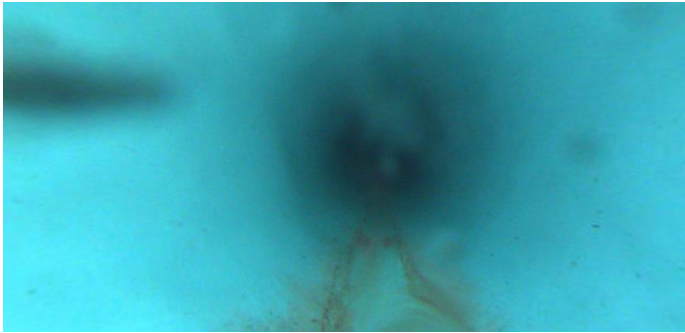
Code:	MWL
Description:	Water Level

Distance (ft):	.0
Structural Grade:	0
O&M Grade:	0
Clock Start/From:	
Clock To:	
1st Value:	
2nd Value:	
Value Percent:	5.000
Continuous Index:	
Within 8" of Joint:	NO
Remarks:

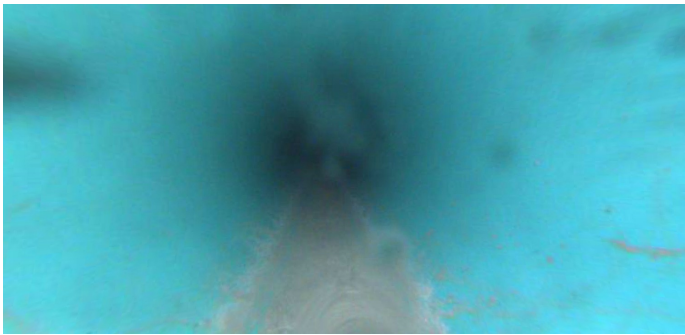
Code:	DSF
Description:	Deposits Settled Fine

Distance (ft):	41.0
Structural Grade:	0
O&M Grade:	2
Clock Start/From:	6
Clock To:	
1st Value:	
2nd Value:	
Value Percent:	5.000
Continuous Index:	S01
Within 8" of Joint:	NO
Remarks:

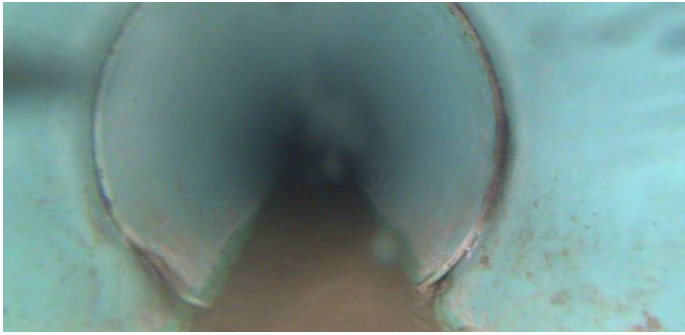
Code: **DSF**
Description: **Deposits Settled Fine**

Distance (ft): **108.2**
Structural Grade: **0**
O&M Grade: **2**
Clock Start/From: **6**
Clock To:
1st Value:
2nd Value:
Value Percent: **5.000**
Continuous Index: **F01**
Within 8" of Joint: **NO**
Remarks:

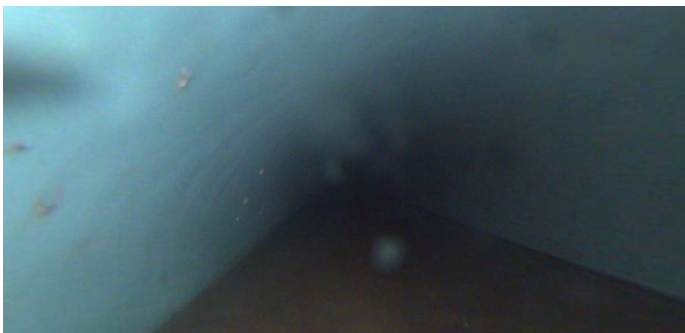
Code: **MWL**
Description: **Water Level**

Distance (ft): **115.5**
Structural Grade: **0**
O&M Grade: **0**
Clock Start/From:
Clock To:
1st Value:
2nd Value:
Value Percent: **30.000**
Continuous Index:
Within 8" of Joint: **NO**
Remarks:

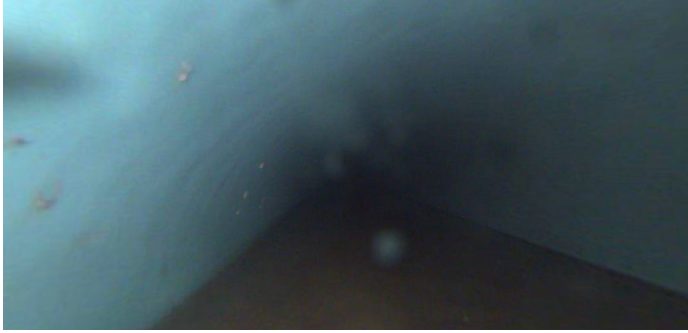
Code:	MSA
Description:	Abandoned Survey
Distance (ft):	115.5
Structural Grade:	0
O&M Grade:	0
Clock Start/From:	
Clock To:	
1st Value:	
2nd Value:	
Value Percent:	
Continuous Index:	
Within 8" of Joint:	NO
Remarks:	UNKNOWN
