Profile/Photo Observation Report

Date:	03/27/2018	Weather:		Coding:	PACP 6.0
Pipe Length (ft):	123.6	Owner:	NA	Pre Clean:	Not Known
P.O.#:		Surveyor:	Jen Costello	PSR:	P-803-067-068
Customer:		Clean Date:	01/01/1900	Shape:	C

Street:	N COLONIAL DR	Flow Control:	Not Controlled
City:	Hobart, IN	Year Renewed:	
Location:	Other	Tape/Media #:	
Purpose:	Not Known	Dia/Height:	10"
Use:	Sanitary	Material:	PVC
Drain Area:	NA	Lining:	
Category:	NA		
Comment:

Location Details:		Direction of Survey:	Downstream
US MH:	M-803-068	DS MH:	M-803-067
		Total Length Surveyed (ft):	115.5

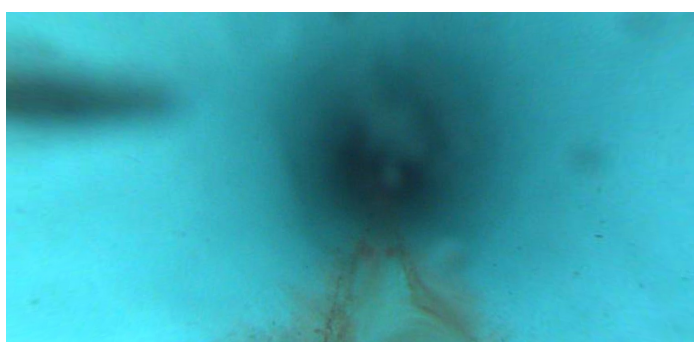
Code: **AMH**
Description: **Manhole**

Distance (ft): **.0**
Structural Grade: **0**
O&M Grade: **0**
Clock Start/From:
Clock To:
1st Value:
2nd Value:
Value Percent:
Continuous Index:
Within 8" of Joint: **NO**
Remarks: **M-803-068**

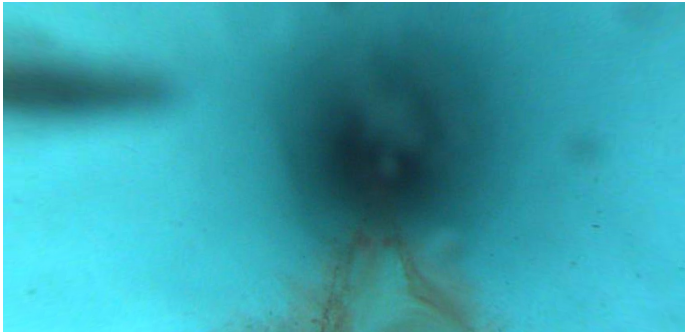
Code:	MWL
Description:	Water Level

Distance (ft):	.0
Structural Grade:	0
O&M Grade:	0
Clock Start/From:	
Clock To:	
1st Value:	
2nd Value:	
Value Percent:	5.000
Continuous Index:	
Within 8" of Joint:	NO
Remarks:

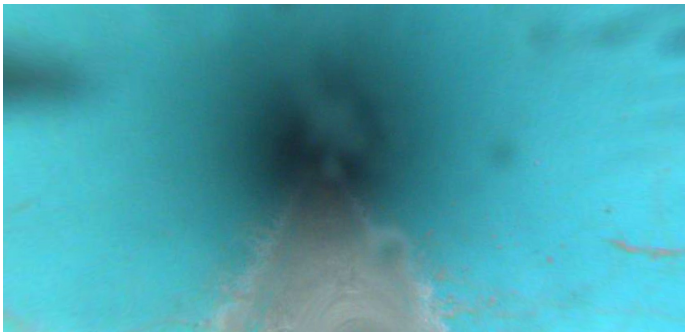
Code:	DSF
Description:	Deposits Settled Fine

Distance (ft):	41.0
Structural Grade:	0
O&M Grade:	2
Clock Start/From:	6
Clock To:	
1st Value:	
2nd Value:	
Value Percent:	5.000
Continuous Index:	S01
Within 8" of Joint:	NO
Remarks:

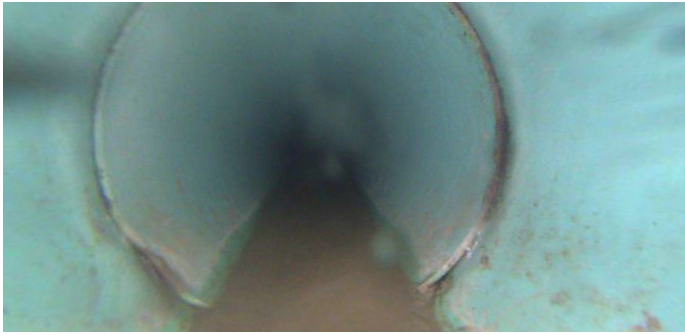
Code: **DSF**
Description: **Deposits Settled Fine**

Distance (ft): **108.2**
Structural Grade: **0**
O&M Grade: **2**
Clock Start/From: **6**
Clock To:
1st Value:
2nd Value:
Value Percent: **5.000**
Continuous Index: **F01**
Within 8" of Joint: **NO**
Remarks:

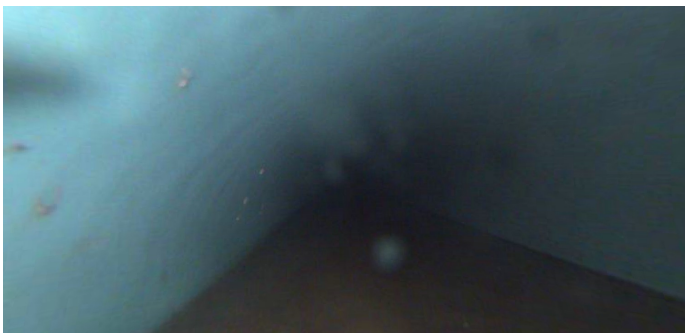
Code: **MWL**
Description: **Water Level**

Distance (ft): **115.5**
Structural Grade: **0**
O&M Grade: **0**
Clock Start/From:
Clock To:
1st Value:
2nd Value:
Value Percent: **30.000**
Continuous Index:
Within 8" of Joint: **NO**
Remarks:

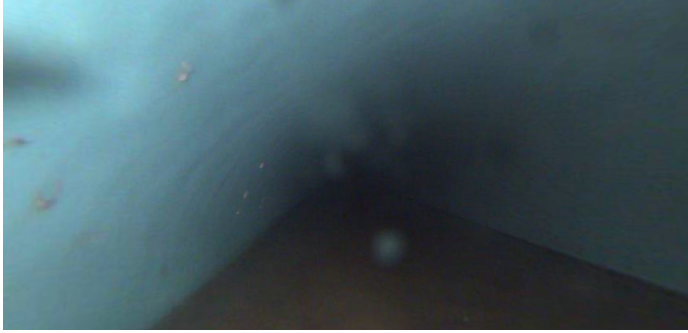
Code:	MSA
Description:	Abandoned Survey
Distance (ft):	115.5
Structural Grade:	0
O&M Grade:	0
Clock Start/From:	
Clock To:	
1st Value:	
2nd Value:	
Value Percent:	
Continuous Index:	
Within 8" of Joint:	NO
Remarks:	UNKNOWN
