Profile/Photo Observation Report

Street:	N COLONIAL DR	Flow Control:	Not Controlled
City:	Hobart, IN	Year Renewed:	
Location:	Other	Tape/Media #:	
Purpose:	Not Known	Dia/Height:	10"
Use:	Sanitary	Material:	PVC
Drain Area:	NA	Lining:	
Category:	NA		
Comment:			
Location Details:		Direction of Survey:	Downstream
US MH:	M-803-068	DS MH:	M-803-069
		Total Length Surveyed (ft):	11.9

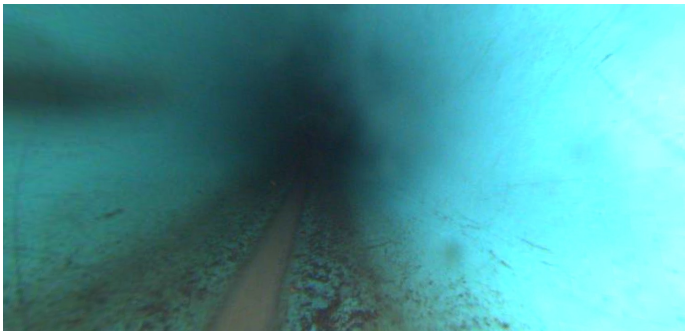
Code: **AMH**
Description: **Manhole**

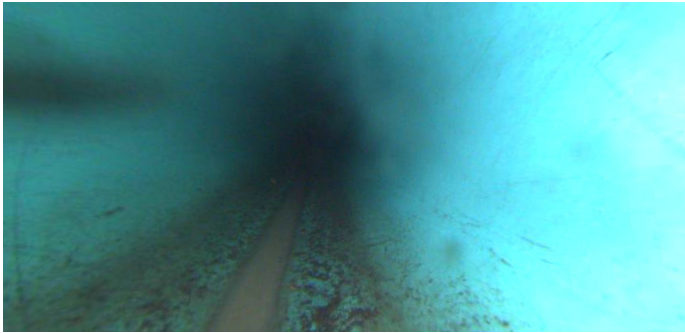
Code:	MWL
Description:	Water Level

Distance (ft):	.0
Structural Grade:	0
O&M Grade:	0
Clock Start/From:	
Clock To:	
1st Value:	
2nd Value:	
Value Percent:	5.000
Continuous Index:	
Within 8" of Joint:	NO
Remarks:

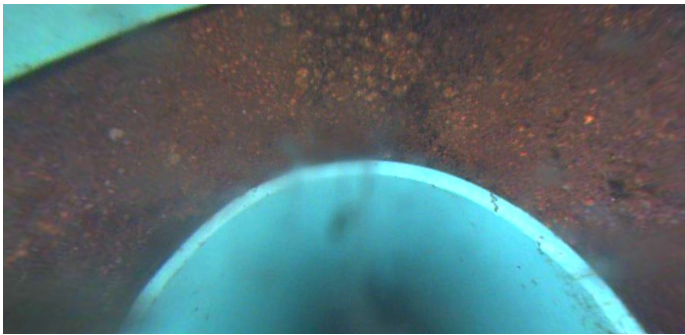
Code:	RPP
Description:	Repair Patch

Distance (ft):	6.3
Structural Grade:	0
O&M Grade:	0
Clock Start/From:	12
Clock To:	12
1st Value:	
2nd Value:	
Value Percent:	
Continuous Index:	
Within 8" of Joint:	NO
Remarks:	CP

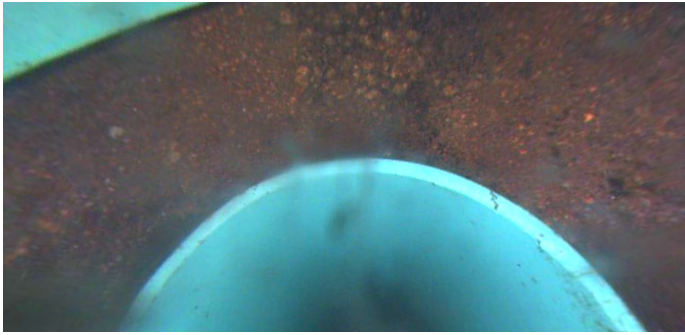
Code: **SAP**
Description: **Surface Aggregate Projecting**

Distance (ft): **6.3**
Structural Grade: **3**
O&M Grade: **0**
Clock Start/From: **12**
Clock To:
1st Value:
2nd Value:
Value Percent:
Continuous Index:
Within 8" of Joint:
Remarks:

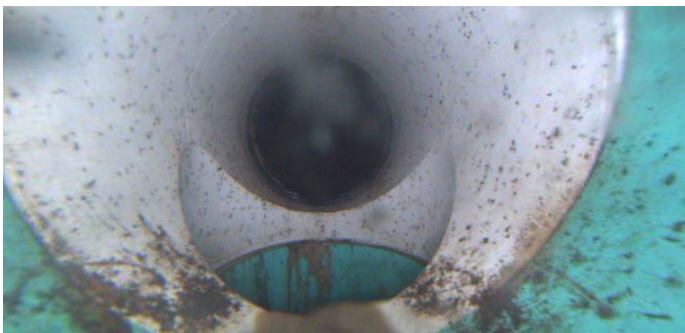
Code: **TF**
Description: **Tap Factory**

Distance (ft): **9.6**
Structural Grade: **0**
O&M Grade: **0**
Clock Start/From: **6**
Clock To:
1st Value: **6.000**
2nd Value:
Value Percent:
Continuous Index:
Within 8" of Joint:
Remarks: **DROP CONNECTION**

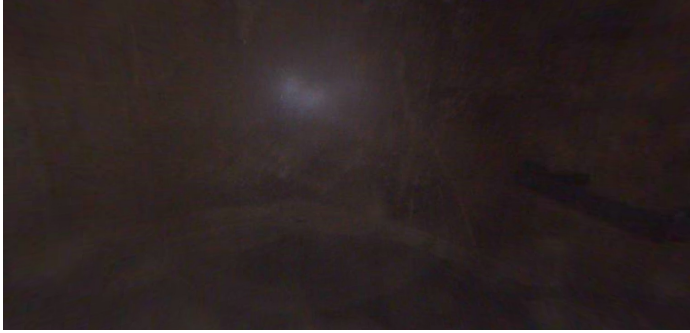
Code:	AMH
Description:	Manhole
Distance (ft):	11.9
Structural Grade:	0
O&M Grade:	0
Clock Start/From:	
Clock To:	
1st Value:	
2nd Value:	
Value Percent:	
Continuous Index:	
Within 8" of Joint:	NO
Remarks:	M-803-069
