Profile/Photo Observation Report

Street:	N COLONIAL DR	Flow Control:	Not Controlled
City:	Hobart, IN	Year Renewed:	
Location:	Other	Tape/Media #:	
Purpose:	Not Known	Dia/Height:	10"
Use:	Sanitary	Material:	PVC
Drain Area:	NA	Lining:	
Category:	NA		
Comment:

Location Details:		Direction of Survey:	Downstream
US MH:	M-803-068	DS MH:	M-803-069
		Total Length Surveyed (ft):	11.9

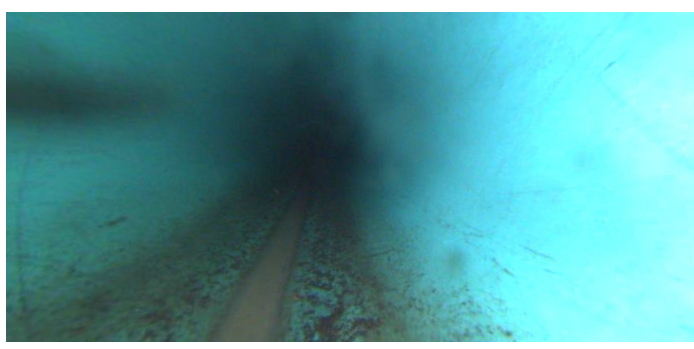
Code: **AMH**
Description: **Manhole**

Distance (ft): **.0**
Structural Grade: **0**
O&M Grade: **0**
Clock Start/From:
Clock To:
1st Value:
2nd Value:
Value Percent:
Continuous Index:
Within 8" of Joint: **NO**
Remarks: **M-803-068**

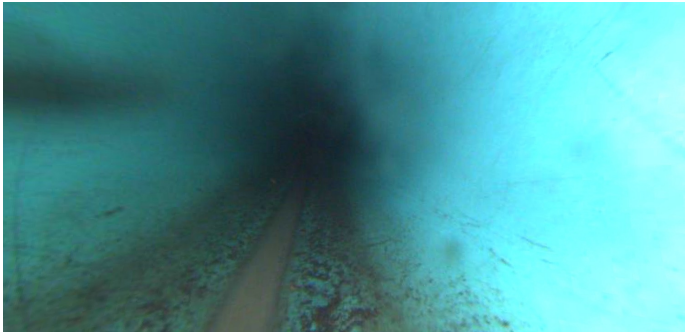
Code:	MWL
Description:	Water Level

Distance (ft):	.0
Structural Grade:	0
O&M Grade:	0
Clock Start/From:	
Clock To:	
1st Value:	
2nd Value:	
Value Percent:	5.000
Continuous Index:	
Within 8" of Joint:	NO
Remarks:

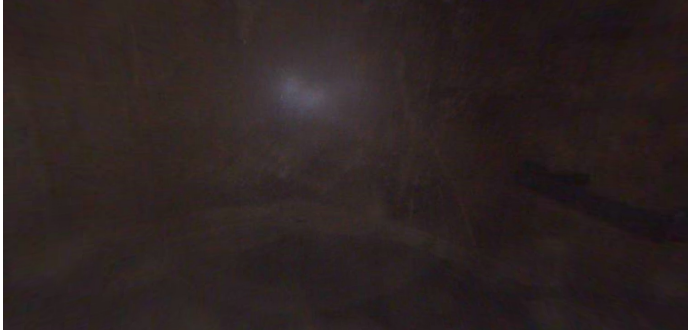
Code:	AMH
Description:	Manhole
Distance (ft):	11.9
Structural Grade:	0
O&M Grade:	0
Clock Start/From:	
Clock To:	
1st Value:	
2nd Value:	
Value Percent:	
Continuous Index:	
Within 8" of Joint:	NO
Remarks:	M-803-069
