Profile/Photo Observation Report

Street:	N COLONIAL DR	Flow Control:	Not Controlled
City:	Hobart, IN	Year Renewed:	
Location:	Other	Tape/Media #:	
Purpose:	Not Known	Dia/Height:	10"
Use:	Sanitary	Material:	PVC
Drain Area:	NA	Lining:	
Category:	NA		
Comment:

Location Details:		Direction of Survey:	Upstream
US MH:	M-803-068	DS MH:	M-803-069
		Total Length Surveyed (ft):	9.9

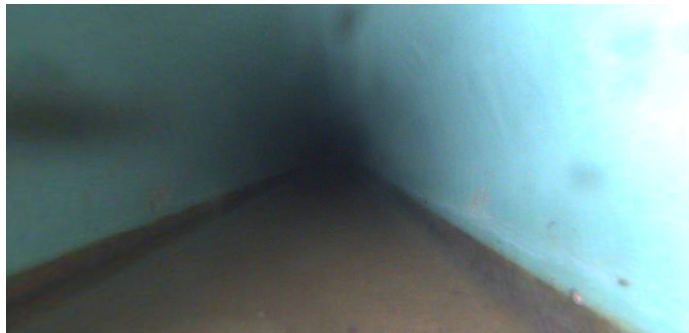
Code: **AMH**
 Description: **Manhole**
 Distance (ft): **.0**
 Structural Grade: **0**
 O&M Grade: **0**
 Clock Start/From:
 Clock To:
 1st Value:
 2nd Value:
 Value Percent:
 Continuous Index:
 Within 8" of Joint: **NO**
 Remarks: **M-803-069**

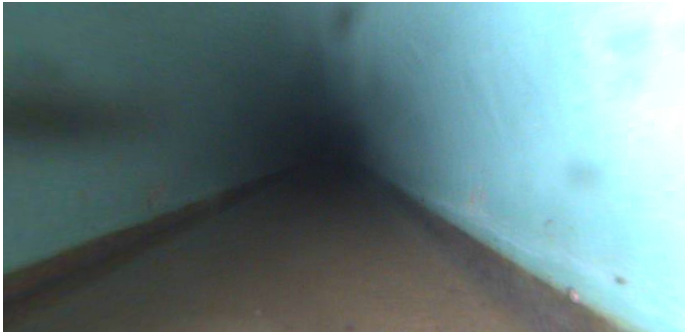
Code:	MWL
Description:	Water Level

Distance (ft):	.0
Structural Grade:	0
O&M Grade:	0
Clock Start/From:	
Clock To:	
1st Value:	
2nd Value:	
Value Percent:	40.000
Continuous Index:	
Within 8" of Joint:	NO
Remarks:

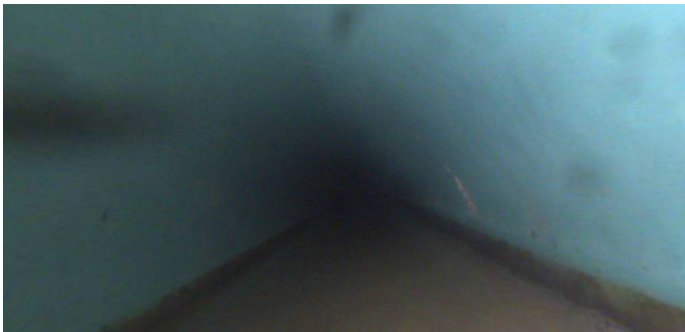
Code:	MSA
Description:	Abandoned Survey

Distance (ft):	9.9
Structural Grade:	0
O&M Grade:	0
Clock Start/From:	
Clock To:	
1st Value:	
2nd Value:	
Value Percent:	
Continuous Index:	
Within 8" of Joint:	NO
Remarks:	overturned
