Profile/Photo Observation Report

Street:	N COLONIAL DR	Flow Control:	Not Controlled
City:	Hobart, IN	Year Renewed:	
Location:	Other	Tape/Media #:	
Purpose:	Not Known	Dia/Height:	10"
Use:	Sanitary	Material:	PVC
Drain Area:	NA	Lining:	
Category:	NA		
Comment:

Location Details:		Direction of Survey:	Upstream
US MH:	M-803-071	DS MH:	M-803-070
		Total Length Surveyed (ft):	12.5

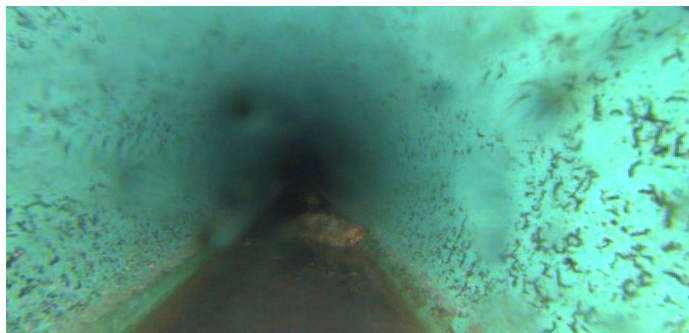
Code: **AMH**
 Description: **Manhole**
 Distance (ft): **.0**
 Structural Grade: **0**
 O&M Grade: **0**
 Clock Start/From:
 Clock To:
 1st Value:
 2nd Value:
 Value Percent:
 Continuous Index:
 Within 8" of Joint: **NO**
 Remarks: **M-803-070**

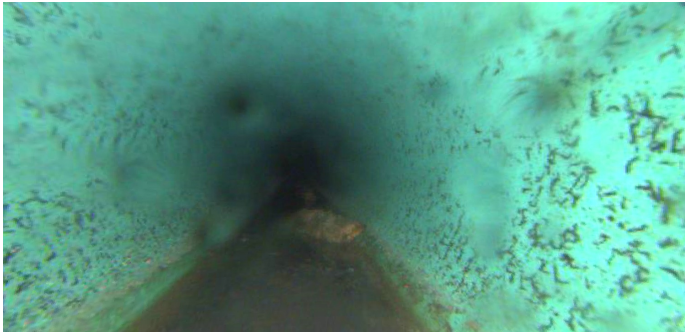
Code:	MWL
Description:	Water Level

Distance (ft):	.0
Structural Grade:	0
O&M Grade:	0
Clock Start/From:	
Clock To:	
1st Value:	
2nd Value:	
Value Percent:	5.000
Continuous Index:	
Within 8" of Joint:	NO
Remarks:

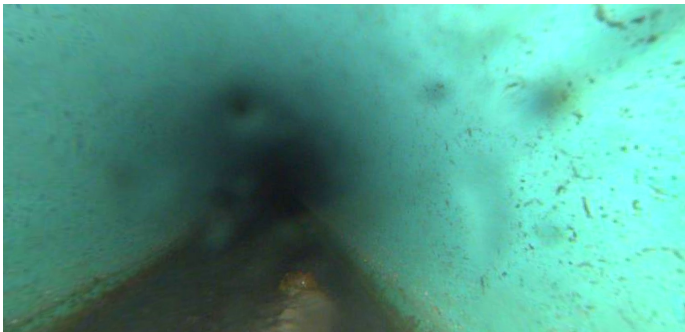
Code:	MSA
Description:	Abandoned Survey

Distance (ft):	12.5
Structural Grade:	0
O&M Grade:	0
Clock Start/From:	
Clock To:	
1st Value:	
2nd Value:	
Value Percent:	
Continuous Index:	
Within 8" of Joint:	NO
Remarks:	UNKNOWN
