Profile/Photo Observation Report

Street:	N COLONIAL DR	Flow Control:	Not Controlled
City:	Hobart, IN	Year Renewed:	
Location:	Other	Tape/Media #:	
Purpose:	Not Known	Dia/Height:	10"
Use:	Sanitary	Material:	PVC
Drain Area:	NA	Lining:	
Category:	NA		
Comment:

Location Details:		Direction of Survey:	Downstream
US MH:	M-803-071	DS MH:	M-803-070
		Total Length Surveyed (ft):	12.5

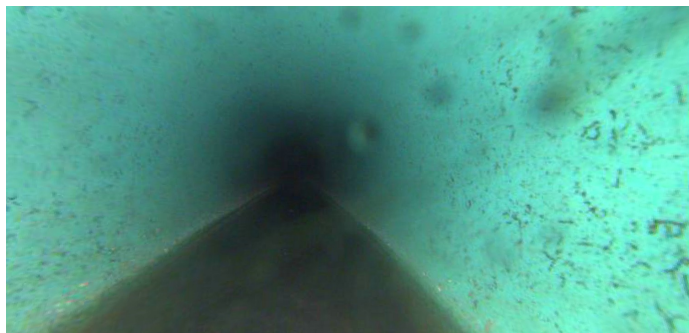
Code: **AMH**
Description: **Manhole**

Distance (ft): **.0**
Structural Grade: **0**
O&M Grade: **0**
Clock Start/From:
Clock To:
1st Value:
2nd Value:
Value Percent:
Continuous Index:
Within 8" of Joint: **NO**
Remarks: **M-803-071**

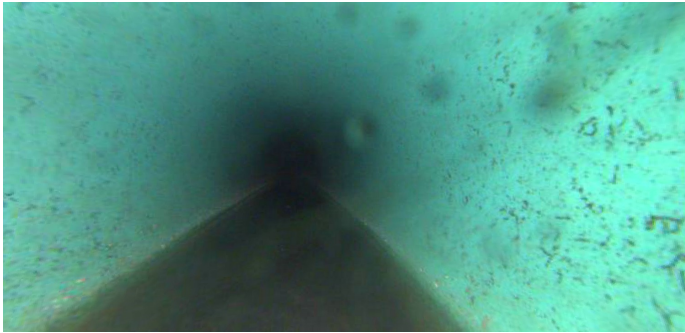
Code:	MWL
Description:	Water Level

Distance (ft):	.0
Structural Grade:	0
O&M Grade:	0
Clock Start/From:	
Clock To:	
1st Value:	
2nd Value:	
Value Percent:	10.000
Continuous Index:	
Within 8" of Joint:	NO
Remarks:

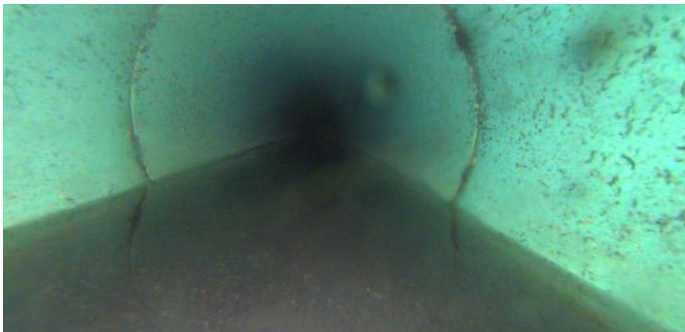
Code:	MSA
Description:	Abandoned Survey

Distance (ft):	12.5
Structural Grade:	0
O&M Grade:	0
Clock Start/From:	
Clock To:	
1st Value:	
2nd Value:	
Value Percent:	
Continuous Index:	
Within 8" of Joint:	NO
Remarks:	DEBRIS UNDER WATER
