## Profile/Photo Observation Report

Date:	<b>05/07/2018</b>	Weather:		Coding:	<b>PACP 4.2</b>
Pipe Length (ft):	<b>10.7</b>	Owner:	<b>City of Hobart</b>	Pre Clean:	<b>No Pre-Cleaning</b>
P.O.#:	<b>2004</b>	Surveyor:	<b>SAN</b>	PSR:	<b>P-803-071-LS022</b>
Customer:	<b>Red Zone</b>	Clean Date:		Shape:	<b>C</b>

Street:	<b>Colonial Dr</b>	Flow Control:	<b>Not Controlled</b>
City:	<b>Hobart In</b>	Year Renewed:	
Location:	<b>Other</b>	Tape/Media #:	<b>Deliverable 1</b>
Purpose:	<b>Routine Assessment</b>	Dia/Height:	<b>8"</b>
Use:	<b>Sanitary</b>	Material:	<b>PVC</b>
Drain Area:	<b>Northeast</b>	Lining:	
Category:	<b>NA</b>		
Comment:	<b>454-1</b>		
Location Details:	<b>Lift station</b>	Direction of Survey:	<b>Downstream</b>
US MH:	<b>M-803-071</b>	DS MH:	<b>LS 022</b>
		Total Length Surveyed (ft):	<b>10.7</b>

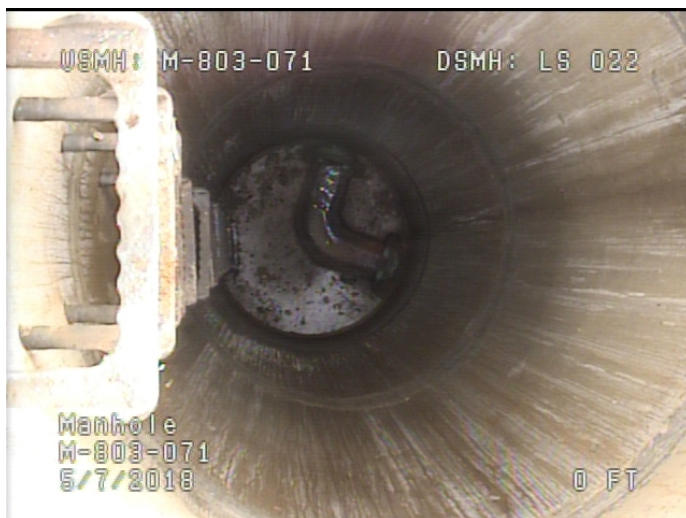
Code: **AMH**  
Description: **Manhole**

Distance (ft): **.0**  
Structural Grade: **0**  
O&M Grade: **0**  
Clock Start/From:  
Clock To:  
1st Value:  
2nd Value:  
Value Percent:  
Continuous Index:  
Within 8" of Joint: **NO**  
Remarks: **M-803-071**

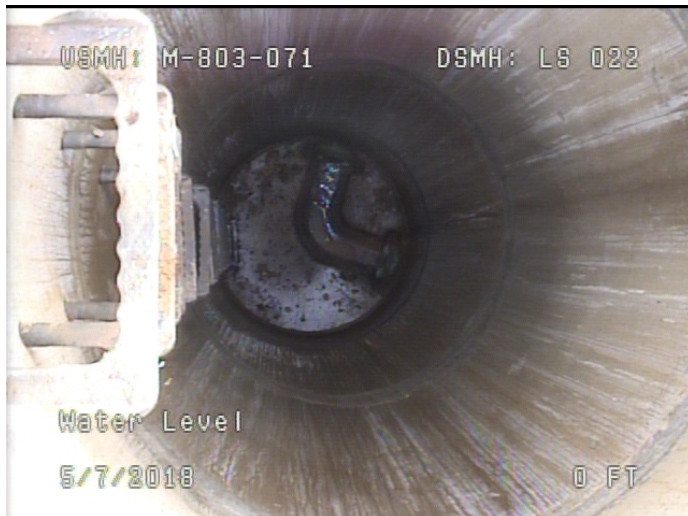
Code: **MWL**  
 Description: **Water Level**

Distance (ft): **.0**  
 Structural Grade: **0**  
 O&M Grade: **0**  
 Clock Start/From:  
 Clock To:  
 1st Value:  
 2nd Value:  
 Value Percent: **5.000**  
 Continuous Index:  
 Within 8" of Joint: **NO**  
 Remarks:

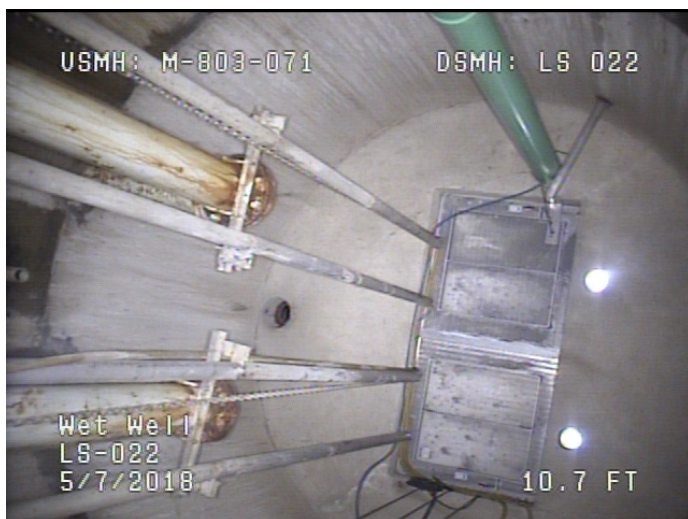
Code: **AWW**  
 Description: **Wet Well**

Distance (ft): **10.7**  
 Structural Grade: **0**  
 O&M Grade: **0**  
 Clock Start/From:  
 Clock To:  
 1st Value:  
 2nd Value:  
 Value Percent:  
 Continuous Index:  
 Within 8" of Joint: **NO**  
 Remarks: **LS-022**
