Profile/Photo Observation Report

Date:	04/16/2018	Weather:		Coding:	PACP 6.0
Pipe Length (ft):	491.3	Owner:	NA	Pre Clean:	Not Known
P.O.#:		Surveyor:	Selasie Honu	PSR:	P-804-001-002
Customer:		Clean Date:	01/01/1900	Shape:	C

Street:	S Liberty Pl.	Flow Control:	Not Controlled
City:	Hobart, IN	Year Renewed:	
Location:	Other	Tape/Media #:	
Purpose:	Not Known	Dia/Height:	8"
Use:	Sanitary	Material:	PVC
Drain Area:	NA	Lining:	
Category:	NA		
Comment:

Location Details:		Direction of Survey:	Upstream
US MH:	M-804-001	DS MH:	M-804-002
		Total Length Surveyed (ft):	10.9

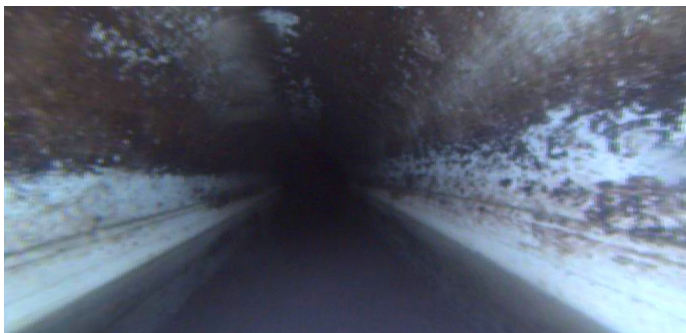
Code: **AMH**
Description: **Manhole**

Distance (ft): **.0**
Structural Grade: **0**
O&M Grade: **0**
Clock Start/From:
Clock To:
1st Value:
2nd Value:
Value Percent:
Continuous Index:
Within 8" of Joint: **NO**
Remarks: **M-804-002**

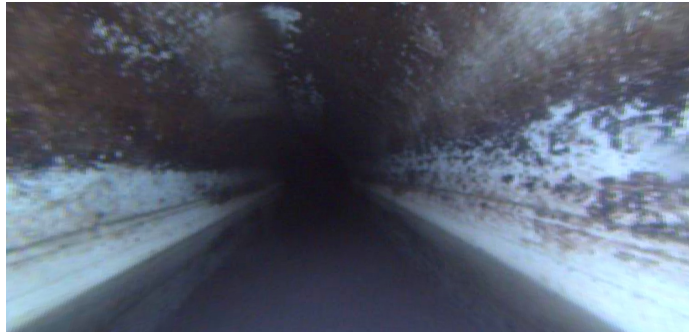
Code: **MWL**
Description: **Water Level**

Distance (ft): **.0**
Structural Grade: **0**
O&M Grade: **0**
Clock Start/From:
Clock To:
1st Value:
2nd Value:
Value Percent: **20.000**
Continuous Index:
Within 8" of Joint: **NO**
Remarks:

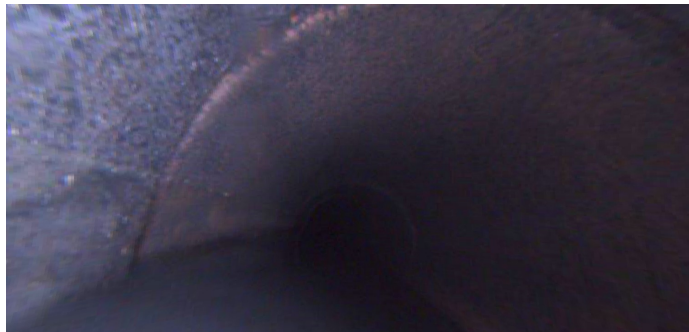
Code: **MSA**
Description: **Abandoned Survey**

Distance (ft): **10.9**
Structural Grade: **0**
O&M Grade: **0**
Clock Start/From:
Clock To:
1st Value:
2nd Value:
Value Percent:
Continuous Index:
Within 8" of Joint: **NO**
Remarks: **camera stopped**
