Profile/Photo Observation Report

Date:	09/11/2024	Weather:		Coding:	PACP 7.0
Pipe Length (ft):	147.0	Owner:	City of Hobart	Pre Clean:	Heavy Cleaning
P.O.#:	YES502259	Surveyor:	S. Bucklin	PSR:	P-804-004-003
Customer:	City of Hobart	Clean Date:	09/11/2024	Shape:	C

Street:	Jackson Street	Flow Control:	Not Controlled
City:	Hobart, IN	Year Renewed:	
Location:	Local rural streets with light traffic, t	Tape/Media #:	
Purpose:	Sewer System Evaluation Survey (SS	Dia/Height:	8"
Use:	Sanitary Sewage Pipe	Material:	PVC
Drain Area:		Lining:	None
Category:	NA		
Comment:			
Location Details:		Direction of Survey:	Upstream
US MH:	M-804-003	DS MH:	M-804-004
		Total Length Surveyed (ft):	150.2

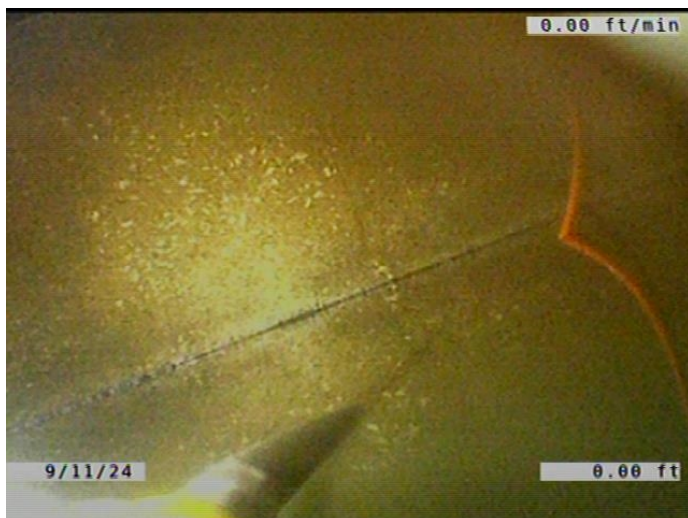
Code: **AMH**
Description: **Manhole**

Distance (ft): **.0**
Structural Grade: **0**
O&M Grade: **0**
Clock Start/From:
Clock To:
1st Value:
2nd Value:
Value Percent:
Continuous Index:
Within 8" of Joint: **NO**
Remarks: **M-804-004**

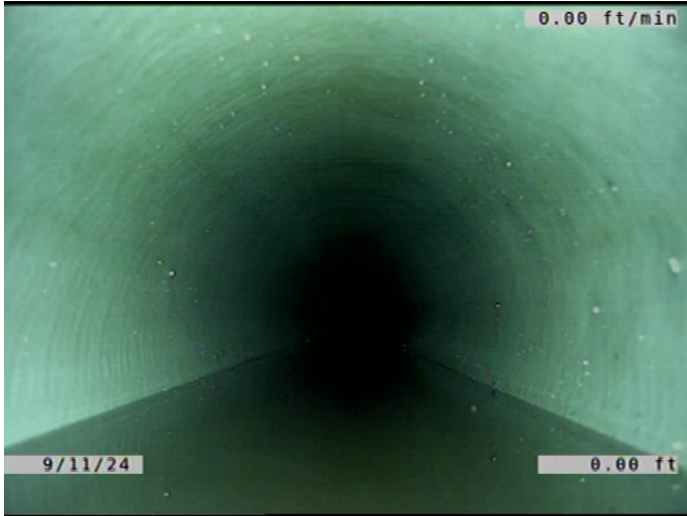
Code: **MWL**
Description: **Miscellaneous Water Level**

Distance (ft): **.0**
Structural Grade: **0**
O&M Grade: **0**
Clock Start/From:
Clock To:
1st Value:
2nd Value:
Value Percent: **20.000**
Continuous Index:
Within 8" of Joint: **NO**
Remarks:

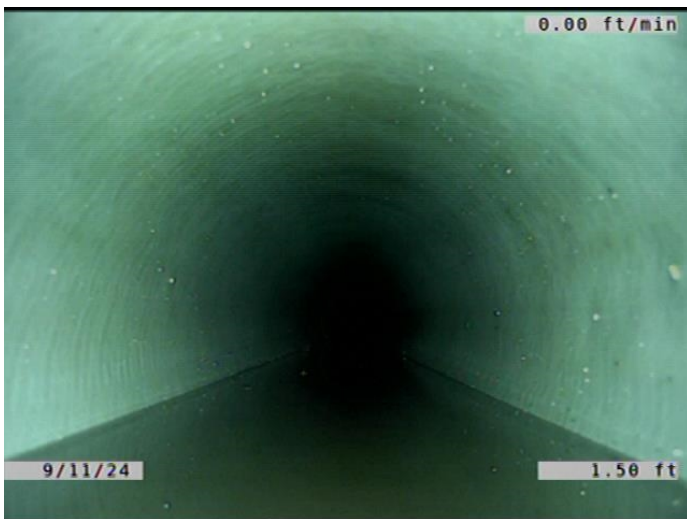
Code: **MGO**
Description: **Miscellaneous General Observation**

Distance (ft): **1.5**
Structural Grade: **0**
O&M Grade: **0**
Clock Start/From:
Clock To:
1st Value:
2nd Value:
Value Percent:
Continuous Index:
Within 8" of Joint: **NO**
Remarks: **HAD TO START IN THE PIPE DUE TO THERE NOT BEING A CHANNEL IN TH**

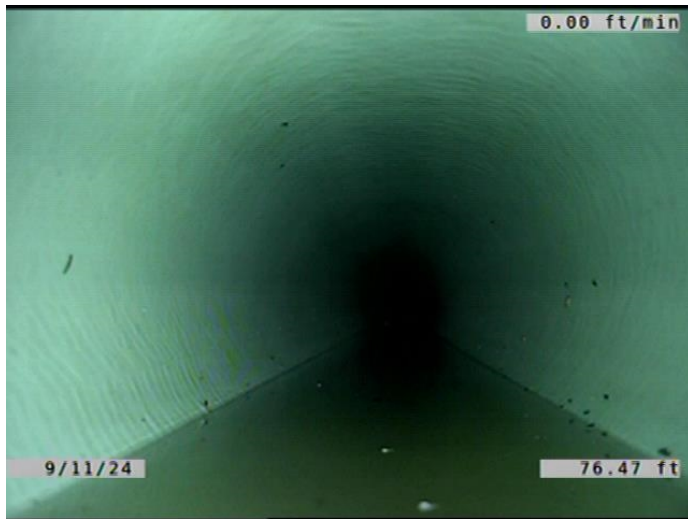
Code: **LR**
Description: **Line Right**

Distance (ft): **76.5**
Structural Grade: **0**
O&M Grade: **1**
Clock Start/From:
Clock To:
1st Value:
2nd Value:
Value Percent: **5.000**
Continuous Index:
Within 8" of Joint: **NO**
Remarks:

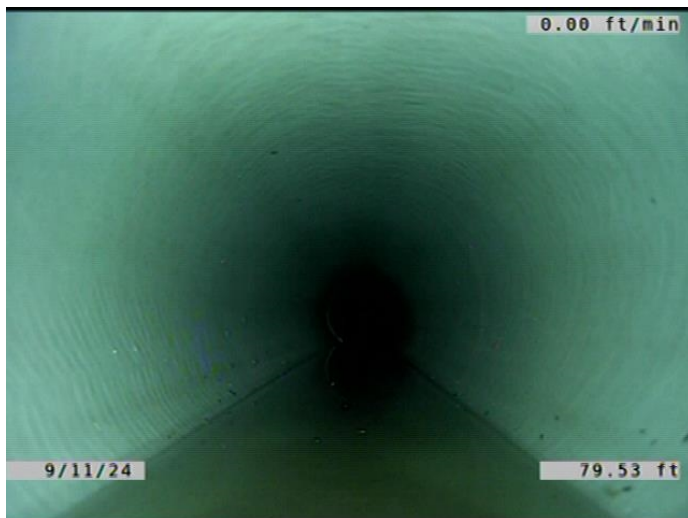
Code: **MWL**
Description: **Miscellaneous Water Level**

Distance (ft): **79.5**
Structural Grade: **0**
O&M Grade: **0**
Clock Start/From:
Clock To:
1st Value:
2nd Value:
Value Percent: **10.000**
Continuous Index:
Within 8" of Joint: **NO**
Remarks:

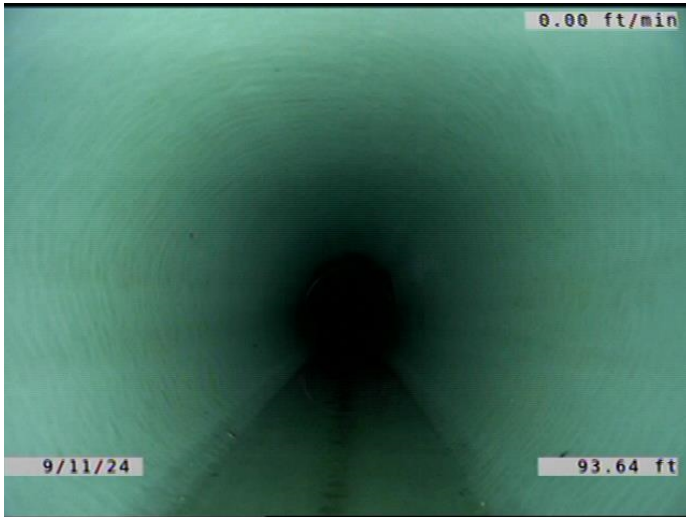
Code: **MWL**
Description: **Miscellaneous Water Level**

Distance (ft): **93.6**
Structural Grade: **0**
O&M Grade: **0**
Clock Start/From:
Clock To:
1st Value:
2nd Value:
Value Percent: **5.000**
Continuous Index:
Within 8" of Joint: **NO**
Remarks:

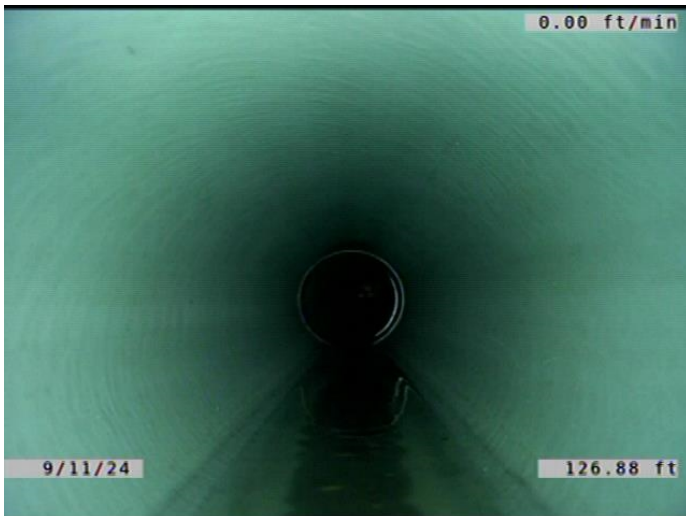
Code: **MWLS**
Description: **Miscellaneous Water Level Sag**

Distance (ft): **126.9**
Structural Grade: **2**
O&M Grade: **0**
Clock Start/From:
Clock To:
1st Value:
2nd Value:
Value Percent: **5.000**
Continuous Index: **S01**
Within 8" of Joint: **NO**
Remarks:

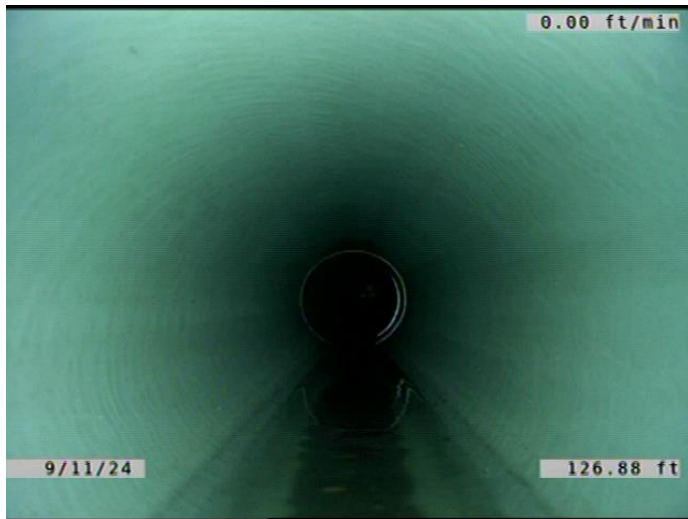
Code: **DSF**
Description: **Deposits Settled Fine**

Distance (ft): **126.9**
Structural Grade: **0**
O&M Grade: **2**
Clock Start/From: **6**
Clock To:
1st Value:
2nd Value:
Value Percent: **5.000**
Continuous Index: **S02**
Within 8" of Joint: **YES**
Remarks:

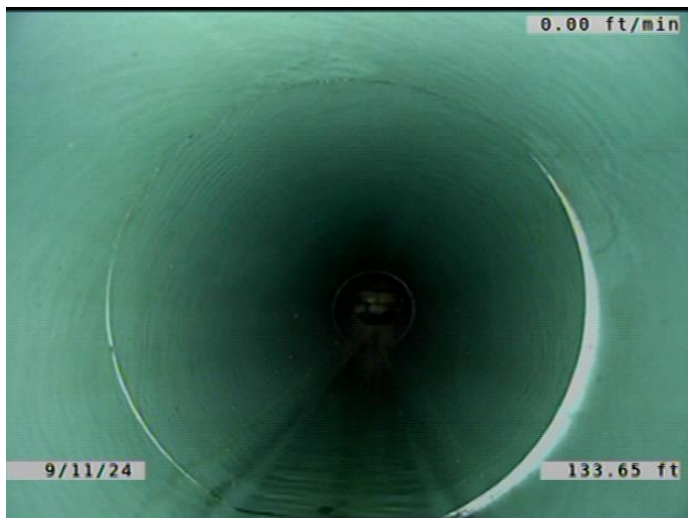
Code: **MWLS**
Description: **Miscellaneous Water Level Sag**

Distance (ft): **133.6**
Structural Grade: **2**
O&M Grade: **0**
Clock Start/From:
Clock To:
1st Value:
2nd Value:
Value Percent: **5.000**
Continuous Index: **F01**
Within 8" of Joint: **NO**
Remarks:

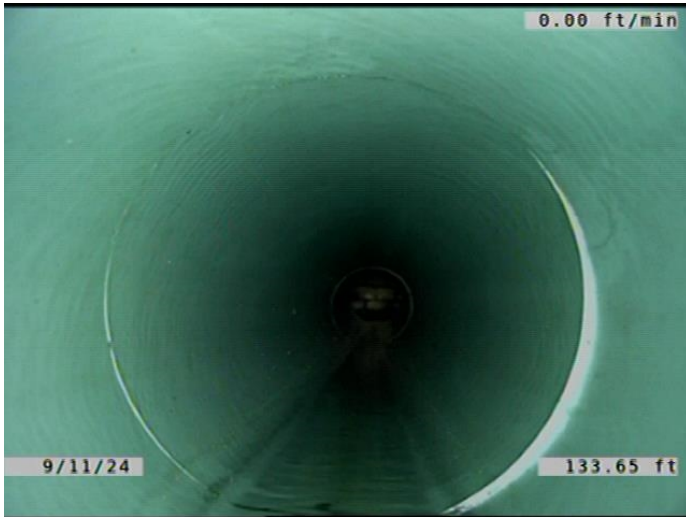
Code: **DSF**
 Description: **Deposits Settled Fine**

Distance (ft): **133.6**
 Structural Grade: **0**
 O&M Grade: **2**
 Clock Start/From: **6**
 Clock To:
 1st Value:
 2nd Value:
 Value Percent: **5.000**
 Continuous Index: **F02**
 Within 8" of Joint: **YES**
 Remarks:

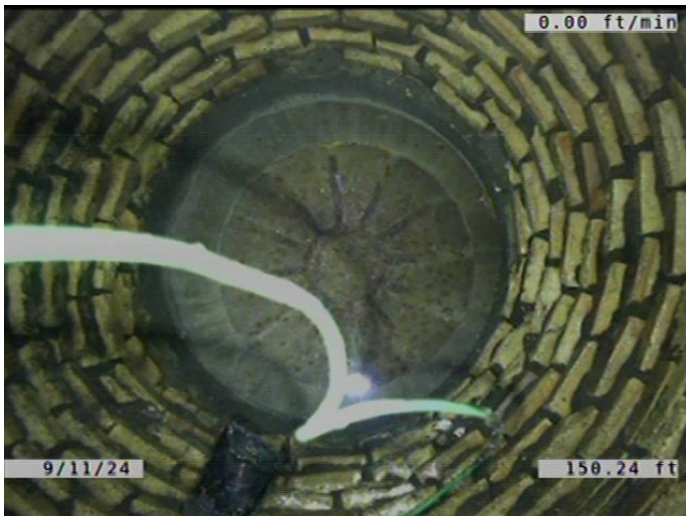
Code: **AMH**
 Description: **Manhole**

Distance (ft): **150.2**
 Structural Grade: **0**
 O&M Grade: **0**
 Clock Start/From:
 Clock To:
 1st Value:
 2nd Value:
 Value Percent:
 Continuous Index:
 Within 8" of Joint: **NO**
 Remarks: **M-804-003**
