## Profile/Photo Observation Report

Street:	<b>E CLEVELAND AVE</b>	Flow Control:	<b>Not Controlled</b>
City:	<b>Hobart, IN</b>	Year Renewed:	
Location:	<b>Other</b>	Tape/Media #:	
Purpose:	<b>Not Known</b>	Dia/Height:	<b>8"</b>
Use:	<b>Sanitary</b>	Material:	<b>VCP</b>
Drain Area:	<b>NA</b>	Lining:	
Category:	<b>NA</b>		
Comment:

Location Details:		Direction of Survey:	<b>Upstream</b>
US MH:	<b>M-804-009</b>	DS MH:	<b>M-804-010</b>
		Total Length Surveyed (ft):	<b>5.1</b>

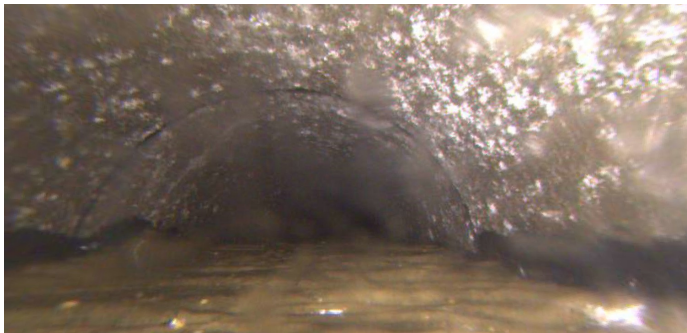
Code: **AMH**  
Description: **Manhole**

Distance (ft): **.0**  
Structural Grade: **0**  
O&M Grade: **0**  
Clock Start/From:  
Clock To:  
1st Value:  
2nd Value:  
Value Percent:  
Continuous Index:  
Within 8" of Joint: **NO**  
Remarks: **M-804-010**

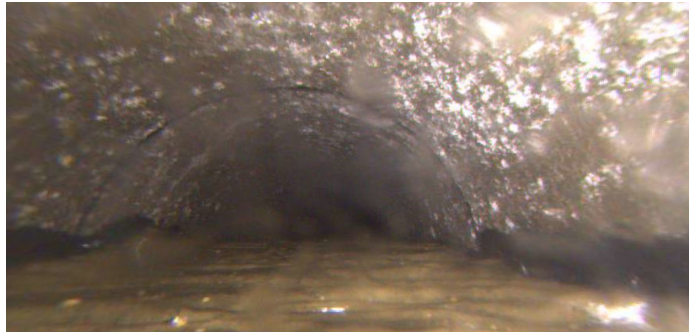
Code:	MWL
Description:	Water Level
Distance (ft):	.0
Structural Grade:	0
O&M Grade:	0
Clock Start/From:	
Clock To:	
1st Value:	
2nd Value:	
Value Percent:	40.000
Continuous Index:	
Within 8" of Joint:	NO
Remarks:
