Profile/Photo Observation Report

Street:	E Cleveland Ave.	Flow Control:	Not Controlled
City:	Hobart, IN	Year Renewed:	
Location:	Other	Tape/Media #:	
Purpose:	Not Known	Dia/Height:	8"
Use:	Sanitary	Material:	VCP
Drain Area:	NA	Lining:	
Category:	NA		
Comment:

Location Details:		Direction of Survey:	Upstream
US MH:	M-804-009	DS MH:	M-804-010
		Total Length Surveyed (ft):	5.1

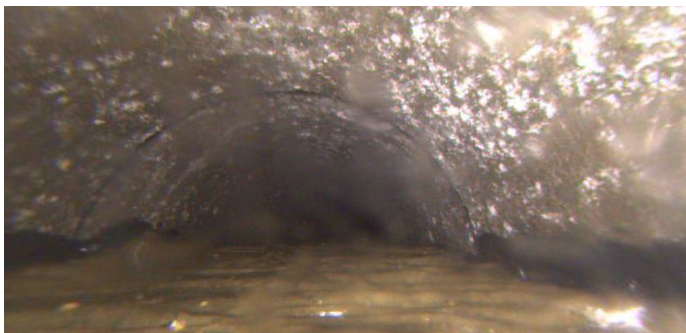
Code: **AMH**
Description: **Manhole**

Distance (ft): **.0**
Structural Grade: **0**
O&M Grade: **0**
Clock Start/From:
Clock To:
1st Value:
2nd Value:
Value Percent:
Continuous Index:
Within 8" of Joint: **NO**
Remarks: **M-804-010**

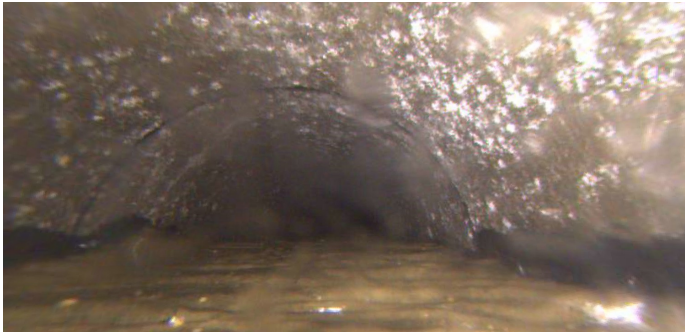
Code:	MWL
Description:	Water Level

Distance (ft):	.0
Structural Grade:	0
O&M Grade:	0
Clock Start/From:	
Clock To:	
1st Value:	
2nd Value:	
Value Percent:	40.000
Continuous Index:	
Within 8" of Joint:	NO
Remarks:
