Profile/Photo Observation Report

Street:	S Ohio St.	Flow Control:	Not Controlled
City:	Hobart, IN	Year Renewed:	
Location:	Other	Tape/Media #:	
Purpose:	Not Known	Dia/Height:	8"
Use:	Sanitary	Material:	VCP
Drain Area:	NA	Lining:	
Category:	NA		
Comment:

Location Details:		Direction of Survey:	Upstream
US MH:	M-804-010	DS MH:	M-805-061
		Total Length Surveyed (ft):	18.8

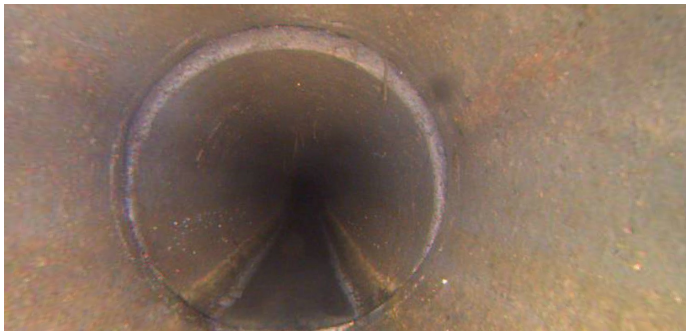
Code:	MWL
Description:	Water Level

Distance (ft):	.0
Structural Grade:	0
O&M Grade:	0
Clock Start/From:	
Clock To:	
1st Value:	
2nd Value:	
Value Percent:	5.000
Continuous Index:	
Within 8" of Joint:	NO
Remarks:

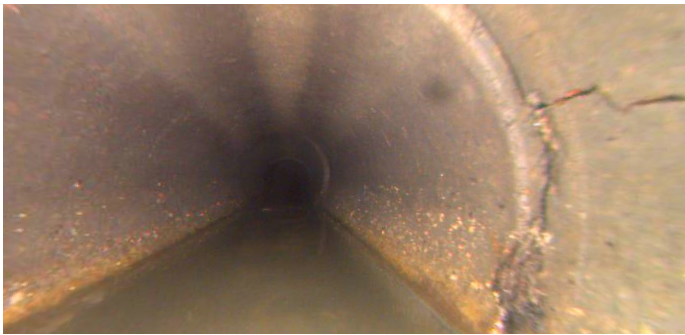
Code:	FL
Description:	Fracture Longitudinal

Distance (ft):	7.3
Structural Grade:	3
O&M Grade:	0
Clock Start/From:	2
Clock To:	
1st Value:	
2nd Value:	
Value Percent:	
Continuous Index:	
Within 8" of Joint:	YES
Remarks:

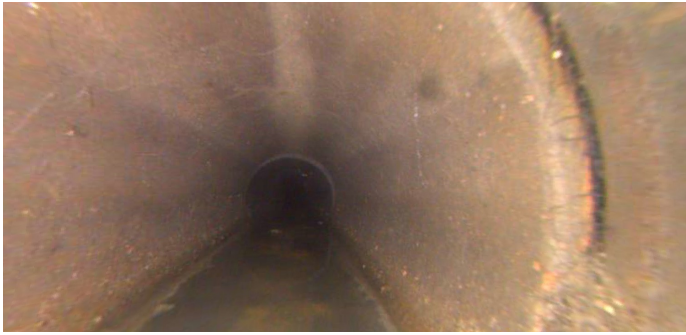
Code: **RFJ**
Description: **Roots Fine Joint**

Distance (ft): **9.4**
Structural Grade: **0**
O&M Grade: **1**
Clock Start/From: **2**
Clock To: **3**
1st Value:
2nd Value:
Value Percent:
Continuous Index:
Within 8" of Joint: **YES**
Remarks:

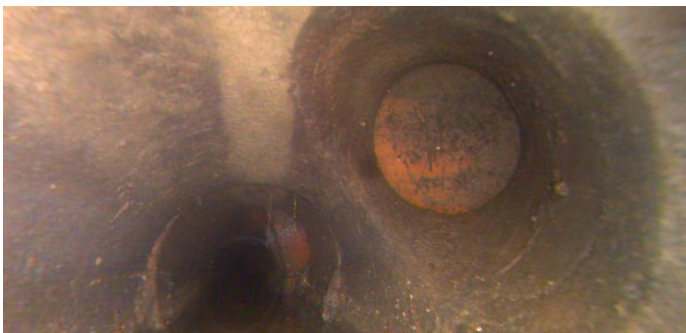
Code: **TFC**
Description: **Tap Factory Capped**

Distance (ft): **14.5**
Structural Grade: **0**
O&M Grade: **0**
Clock Start/From: **2**
Clock To:
1st Value: **4.000**
2nd Value:
Value Percent:
Continuous Index:
Within 8" of Joint:
Remarks:

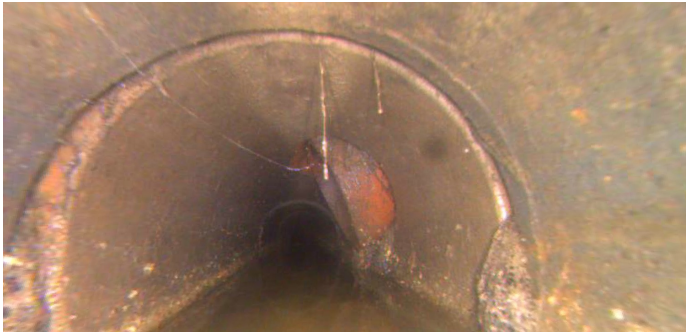
Code: **RFJ**
Description: **Roots Fine Joint**

Distance (ft): **15.2**
Structural Grade: **0**
O&M Grade: **1**
Clock Start/From: **7**
Clock To: **5**
1st Value:
2nd Value:
Value Percent:
Continuous Index:
Within 8" of Joint: **YES**
Remarks:

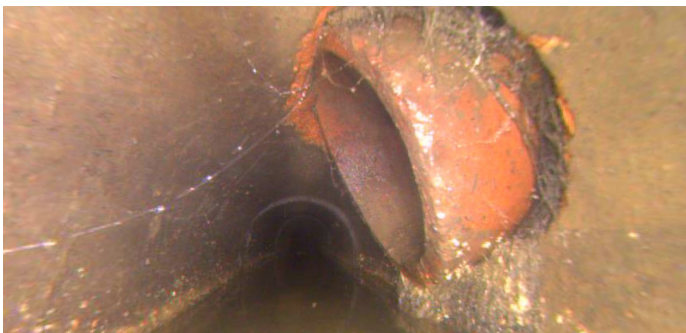
Code: **TBI**
Description: **Tap Break-in Intruding**

Distance (ft): **16.0**
Structural Grade: **0**
O&M Grade: **2**
Clock Start/From: **2**
Clock To:
1st Value: **4.000**
2nd Value: **2.000**
Value Percent:
Continuous Index:
Within 8" of Joint:
Remarks: **rfc**

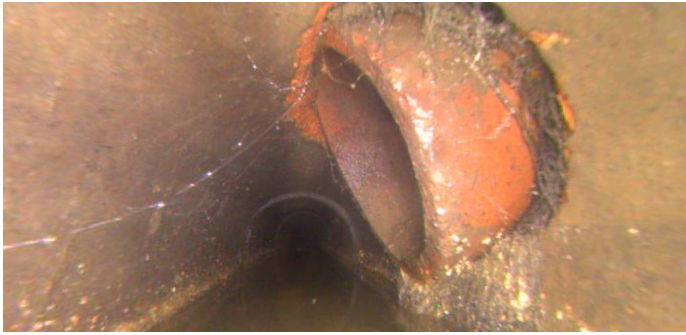
Code: **RFB**
Description: **Roots Fine Barrel**

Distance (ft): **16.0**
Structural Grade: **0**
O&M Grade: **2**
Clock Start/From: **12**
Clock To: **4**
1st Value:
2nd Value:
Value Percent:
Continuous Index:
Within 8" of Joint: **NO**
Remarks:

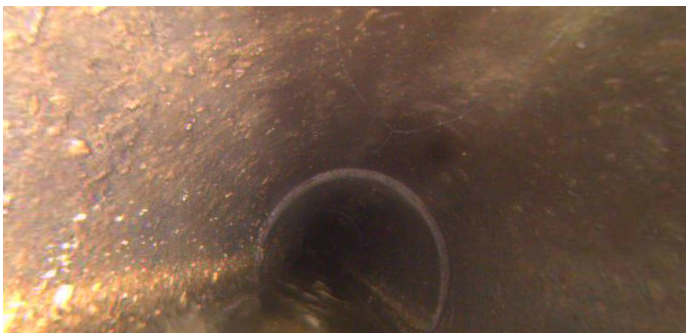
Code: **MSA**
Description: **Abandoned Survey**

Distance (ft): **18.8**
Structural Grade: **0**
O&M Grade: **0**
Clock Start/From:
Clock To:
1st Value:
2nd Value:
Value Percent:
Continuous Index:
Within 8" of Joint: **NO**
Remarks: **tbi**
