Profile/Photo Observation Report

Street:	E CLEVELAND AVE	Flow Control:	Not Controlled
City:	Hobart, IN	Year Renewed:	
Location:	Other	Tape/Media #:	
Purpose:	Not Known	Dia/Height:	8"
Use:	Sanitary	Material:	VCP
Drain Area:	NA	Lining:	
Category:	NA		
Comment:

Location Details:		Direction of Survey:	Downstream
US MH:	M-804-011	DS MH:	M-804-012
		Total Length Surveyed (ft):	162.2

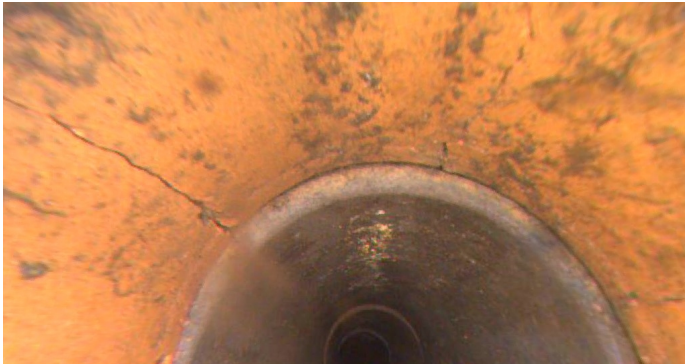
Code:	CS
Description:	Crack Spiral

Distance (ft):	28.1
Structural Grade:	2
O&M Grade:	0
Clock Start/From:	10
Clock To:	1
1st Value:	
2nd Value:	
Value Percent:	
Continuous Index:	
Within 8" of Joint:	YES
Remarks:

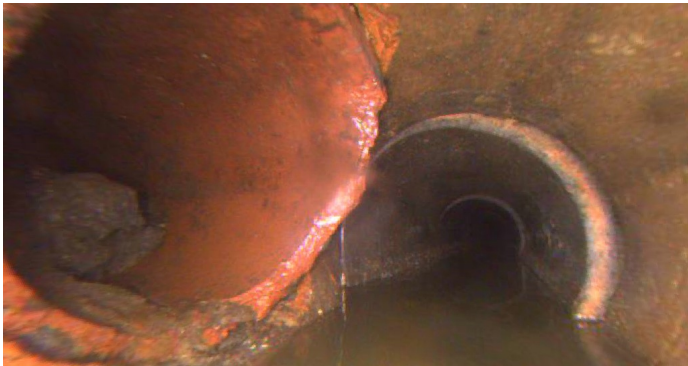
Code: **TB**
Description: **Tap Break-in**

Distance (ft): **37.9**
Structural Grade: **0**
O&M Grade: **0**
Clock Start/From: **8**
Clock To:
1st Value: **4.000**
2nd Value:
Value Percent:
Continuous Index:
Within 8" of Joint:
Remarks:

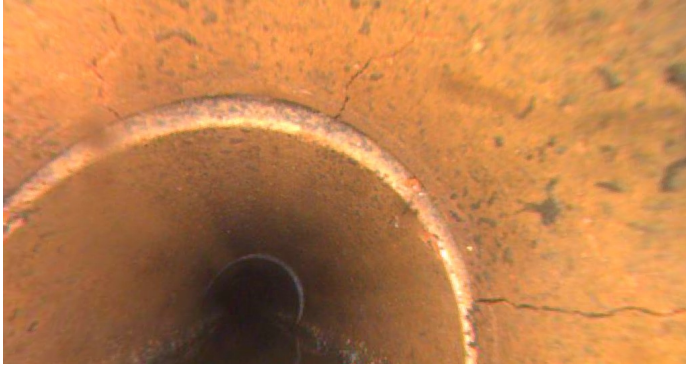
Code: **CM**
Description: **Crack Multiple**

Distance (ft): **60.7**
Structural Grade: **3**
O&M Grade: **0**
Clock Start/From: **11**
Clock To: **4**
1st Value:
2nd Value:
Value Percent:
Continuous Index:
Within 8" of Joint: **YES**
Remarks:

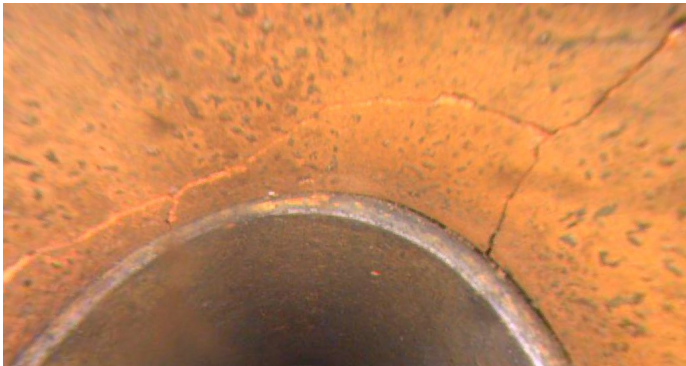
Code: **FM**
Description: **Fracture Multiple**

Distance (ft): **62.8**
Structural Grade: **4**
O&M Grade: **0**
Clock Start/From: **7**
Clock To: **1**
1st Value:
2nd Value:
Value Percent:
Continuous Index:
Within 8" of Joint: **YES**
Remarks:

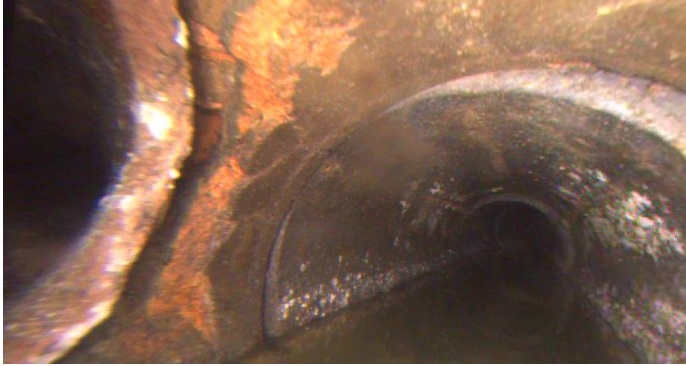
Code: **TB**
Description: **Tap Break-in**

Distance (ft): **71.0**
Structural Grade: **0**
O&M Grade: **0**
Clock Start/From: **8**
Clock To:
1st Value: **4.000**
2nd Value:
Value Percent:
Continuous Index:
Within 8" of Joint:
Remarks:

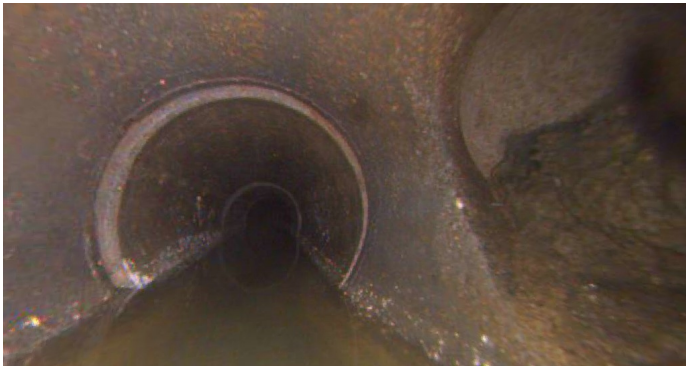
Code: **TFC**
Description: **Tap Factory Capped**

Distance (ft): **74.6**
Structural Grade: **0**
O&M Grade: **0**
Clock Start/From: **3**
Clock To:
1st Value: **4.000**
2nd Value:
Value Percent:
Continuous Index:
Within 8" of Joint:
Remarks:

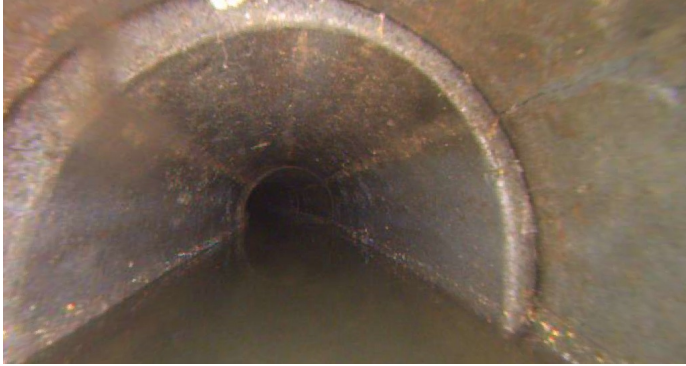
Code: **CL**
Description: **Crack Longitudinal**

Distance (ft): **77.2**
Structural Grade: **2**
O&M Grade: **0**
Clock Start/From: **3**
Clock To:
1st Value:
2nd Value:
Value Percent:
Continuous Index:
Within 8" of Joint: **YES**
Remarks:

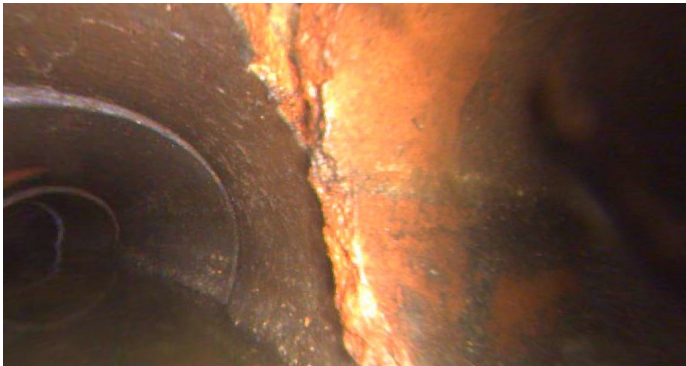
Code: **TB**
Description: **Tap Break-in**

Distance (ft): **100.8**
Structural Grade: **0**
O&M Grade: **0**
Clock Start/From: **4**
Clock To:
1st Value: **4.000**
2nd Value:
Value Percent:
Continuous Index:
Within 8" of Joint:
Remarks:

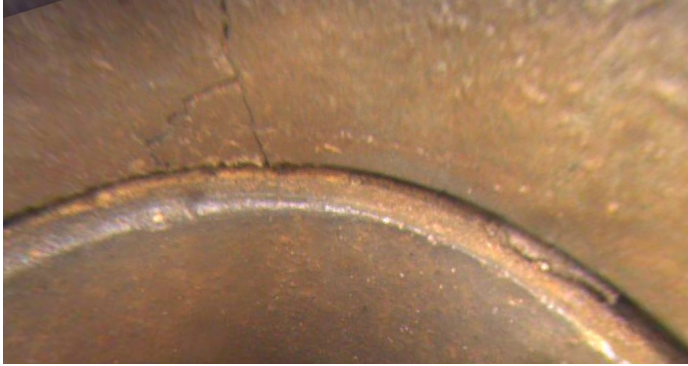
Code:	CL
Description:	Crack Longitudinal
Distance (ft):	101.3
Structural Grade:	2
O&M Grade:	0
Clock Start/From:	12
Clock To:	
1st Value:	
2nd Value:	
Value Percent:	
Continuous Index:	
Within 8" of Joint:	YES
Remarks:

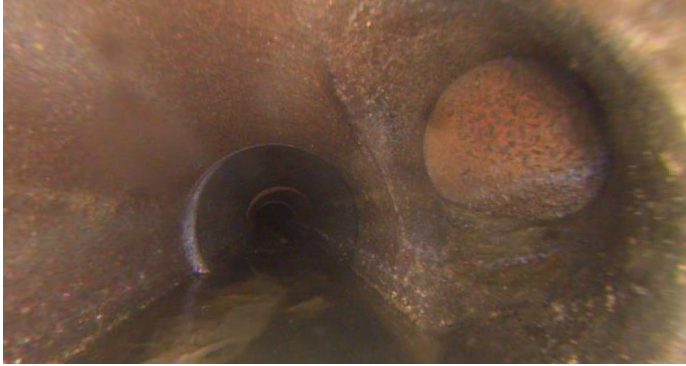
Code: **TFC**
Description: **Tap Factory Capped**

Distance (ft): **122.4**
Structural Grade: **0**
O&M Grade: **0**
Clock Start/From: **3**
Clock To:
1st Value: **4.000**
2nd Value:
Value Percent:
Continuous Index:
Within 8" of Joint:
Remarks:

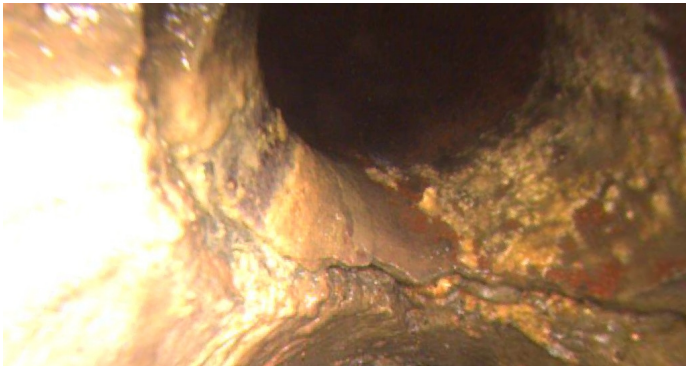
Code: **TB**
Description: **Tap Break-in**

Distance (ft): **141.2**
Structural Grade: **0**
O&M Grade: **0**
Clock Start/From: **12**
Clock To:
1st Value: **4.000**
2nd Value:
Value Percent:
Continuous Index:
Within 8" of Joint:
Remarks:
