## Profile/Photo Observation Report

Street:	<b>E Cleveland Ave.</b>	Flow Control:	<b>Not Controlled</b>
City:	<b>Hobart, IN</b>	Year Renewed:	
Location:	<b>Other</b>	Tape/Media #:	
Purpose:	<b>Not Known</b>	Dia/Height:	<b>8"</b>
Use:	<b>Sanitary</b>	Material:	<b>VCP</b>
Drain Area:	<b>NA</b>	Lining:	
Category:	<b>NA</b>		
Comment:

Location Details:		Direction of Survey:	<b>Downstream</b>
US MH:	<b>M-804-011</b>	DS MH:	<b>M-804-012</b>
		Total Length Surveyed (ft):	<b>162.2</b>

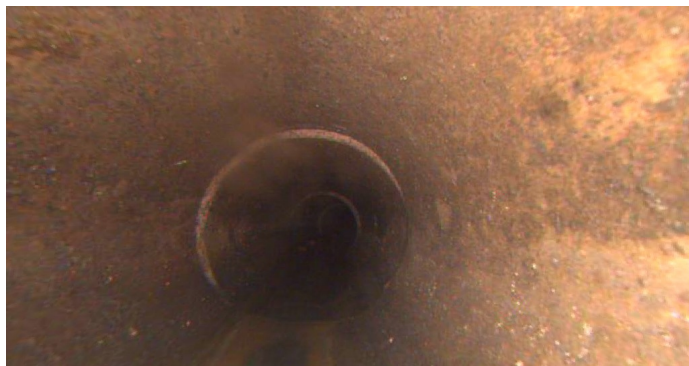
Code: **AMH**  
 Description: **Manhole**

Distance (ft): **.0**  
 Structural Grade: **0**  
 O&M Grade: **0**  
 Clock Start/From:  
 Clock To:  
 1st Value:  
 2nd Value:  
 Value Percent:  
 Continuous Index:  
 Within 8" of Joint: **NO**  
 Remarks: **M-804-011**

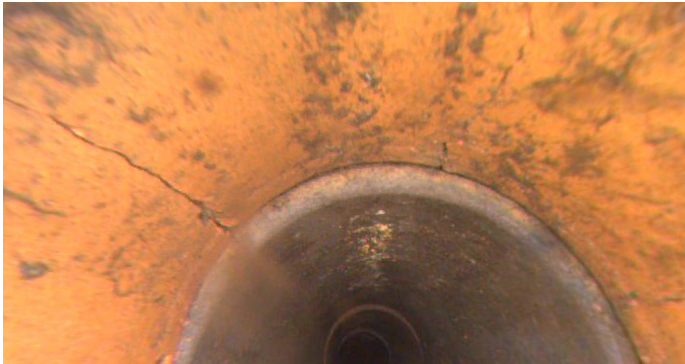
Code:	<b>CS</b>
Description:	<b>Crack Spiral</b>

Distance (ft):	<b>28.1</b>
Structural Grade:	<b>2</b>
O&M Grade:	<b>0</b>
Clock Start/From:	<b>10</b>
Clock To:	<b>1</b>
1st Value:	
2nd Value:	
Value Percent:	
Continuous Index:	
Within 8" of Joint:	<b>YES</b>
Remarks:

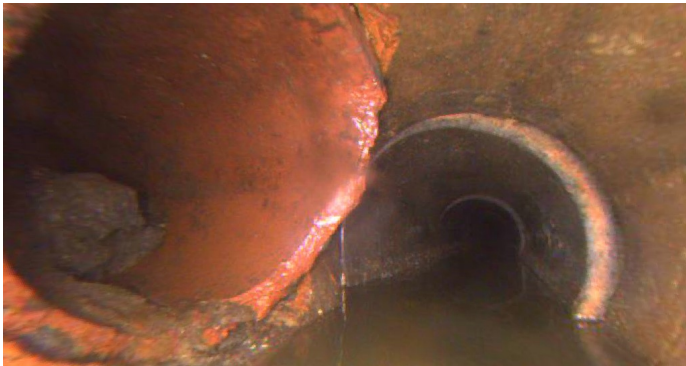
Code: **TB**  
Description: **Tap Break-in**

Distance (ft): **37.9**  
Structural Grade: **0**  
O&M Grade: **0**  
Clock Start/From: **8**  
Clock To:  
1st Value: **4.000**  
2nd Value:  
Value Percent:  
Continuous Index:  
Within 8" of Joint:  
Remarks:

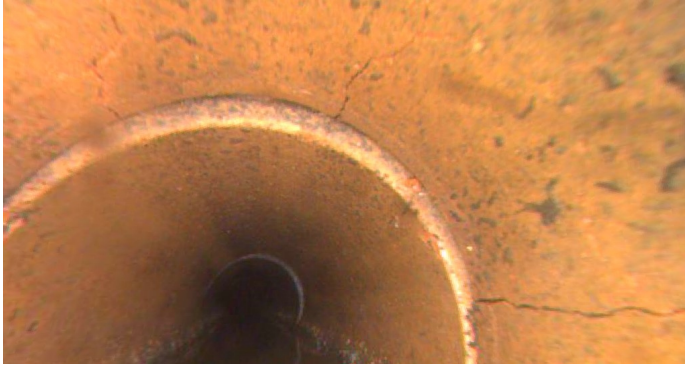
Code: **CM**  
Description: **Crack Multiple**

Distance (ft): **60.7**  
Structural Grade: **3**  
O&M Grade: **0**  
Clock Start/From: **11**  
Clock To: **4**  
1st Value:  
2nd Value:  
Value Percent:  
Continuous Index:  
Within 8" of Joint: **YES**  
Remarks:

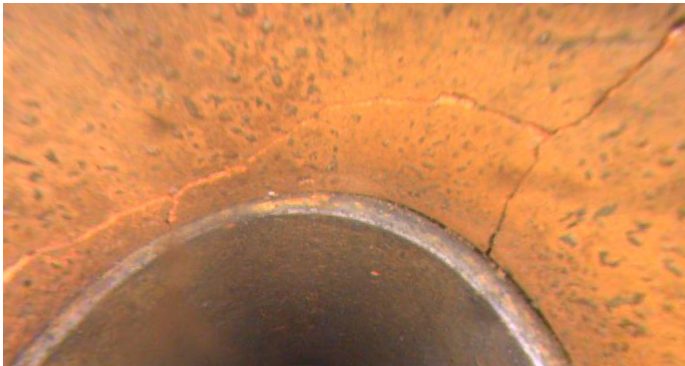
Code: **FM**  
Description: **Fracture Multiple**

Distance (ft): **62.8**  
Structural Grade: **4**  
O&M Grade: **0**  
Clock Start/From: **7**  
Clock To: **1**  
1st Value:  
2nd Value:  
Value Percent:  
Continuous Index:  
Within 8" of Joint: **YES**  
Remarks:

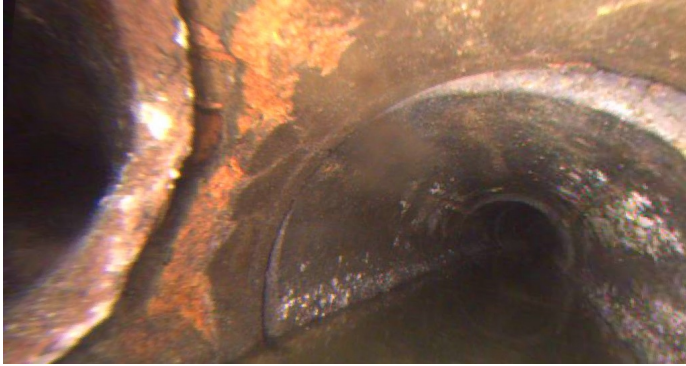
Code: **TB**  
Description: **Tap Break-in**

Distance (ft): **71.0**  
Structural Grade: **0**  
O&M Grade: **0**  
Clock Start/From: **8**  
Clock To:  
1st Value: **4.000**  
2nd Value:  
Value Percent:  
Continuous Index:  
Within 8" of Joint:  
Remarks:

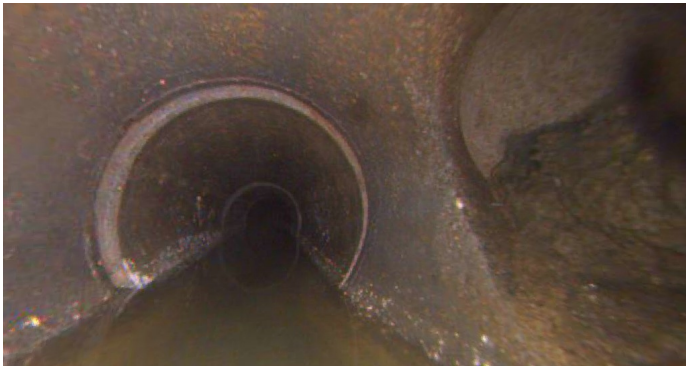
Code: **TFC**  
Description: **Tap Factory Capped**

Distance (ft): **74.6**  
Structural Grade: **0**  
O&M Grade: **0**  
Clock Start/From: **3**  
Clock To:  
1st Value: **4.000**  
2nd Value:  
Value Percent:  
Continuous Index:  
Within 8" of Joint:  
Remarks:

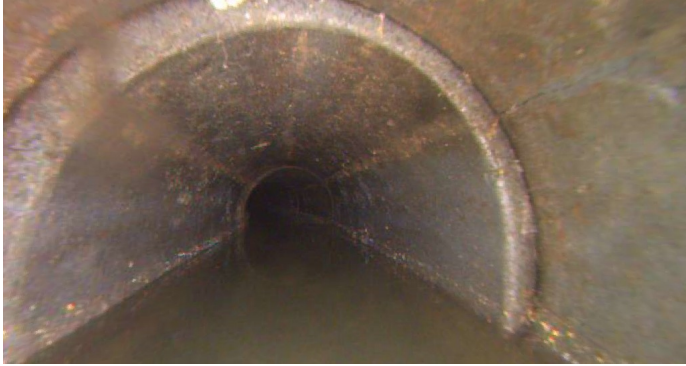
Code: **CL**  
Description: **Crack Longitudinal**

Distance (ft): **77.2**  
Structural Grade: **2**  
O&M Grade: **0**  
Clock Start/From: **3**  
Clock To:  
1st Value:  
2nd Value:  
Value Percent:  
Continuous Index:  
Within 8" of Joint: **YES**  
Remarks:

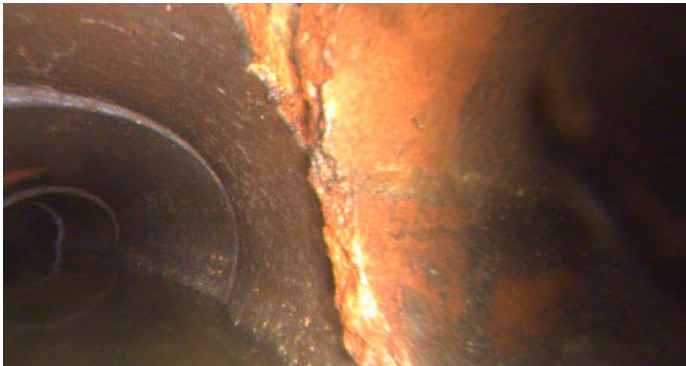
Code: **TB**  
Description: **Tap Break-in**

Distance (ft): **100.8**  
Structural Grade: **0**  
O&M Grade: **0**  
Clock Start/From: **4**  
Clock To:  
1st Value: **4.000**  
2nd Value:  
Value Percent:  
Continuous Index:  
Within 8" of Joint:  
Remarks:

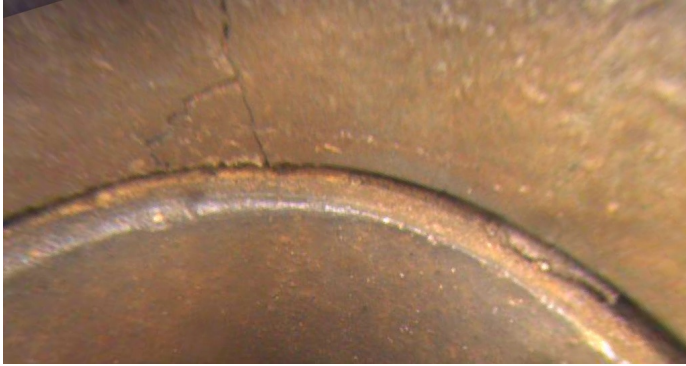
Code:	<b>CL</b>
Description:	<b>Crack Longitudinal</b>
Distance (ft):	<b>101.3</b>
Structural Grade:	<b>2</b>
O&M Grade:	<b>0</b>
Clock Start/From:	<b>12</b>
Clock To:	
1st Value:	
2nd Value:	
Value Percent:	
Continuous Index:	
Within 8" of Joint:	<b>YES</b>
Remarks:

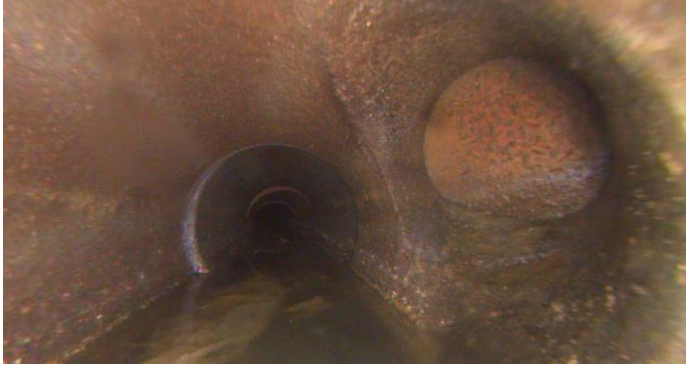
Code: **TFC**  
Description: **Tap Factory Capped**

Distance (ft): **122.4**  
Structural Grade: **0**  
O&M Grade: **0**  
Clock Start/From: **3**  
Clock To:  
1st Value: **4.000**  
2nd Value:  
Value Percent:  
Continuous Index:  
Within 8" of Joint:  
Remarks:

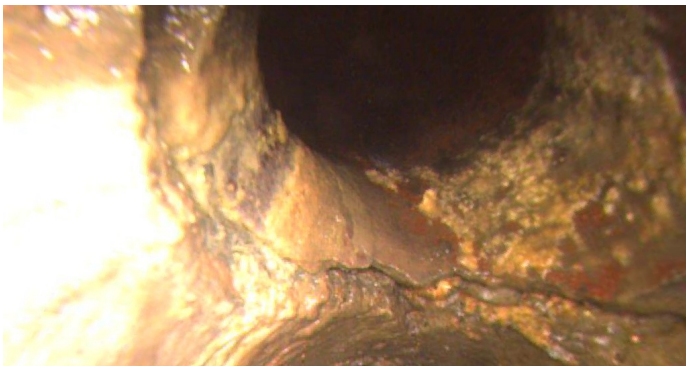
Code: **TB**  
Description: **Tap Break-in**

Distance (ft): **141.2**  
Structural Grade: **0**  
O&M Grade: **0**  
Clock Start/From: **12**  
Clock To:  
1st Value: **4.000**  
2nd Value:  
Value Percent:  
Continuous Index:  
Within 8" of Joint:  
Remarks:
