Profile/Photo Observation Report

Street:	Devonshire St.	Flow Control:	Not Controlled
City:	Hobart, IN	Year Renewed:	
Location:	Other	Tape/Media #:	
Purpose:	Not Known	Dia/Height:	12"
Use:	Sanitary	Material:	VCP
Drain Area:	NA	Lining:	
Category:	NA		
Comment:

Location Details:		Direction of Survey:	Downstream
US MH:	M-804-013	DS MH:	M-804-024
		Total Length Surveyed (ft):	28.5

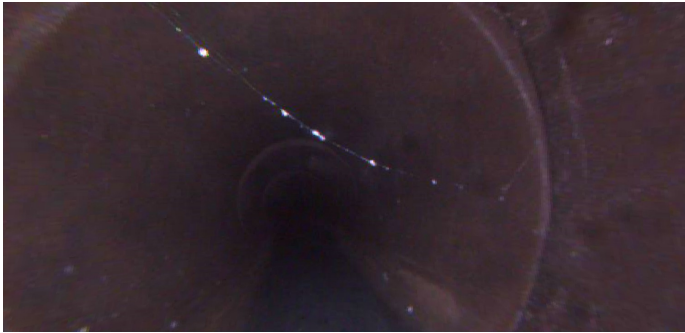
Code:	MWL
Description:	Water Level

Distance (ft):	.0
Structural Grade:	0
O&M Grade:	0
Clock Start/From:	
Clock To:	
1st Value:	
2nd Value:	
Value Percent:	5.000
Continuous Index:	
Within 8" of Joint:	NO
Remarks:

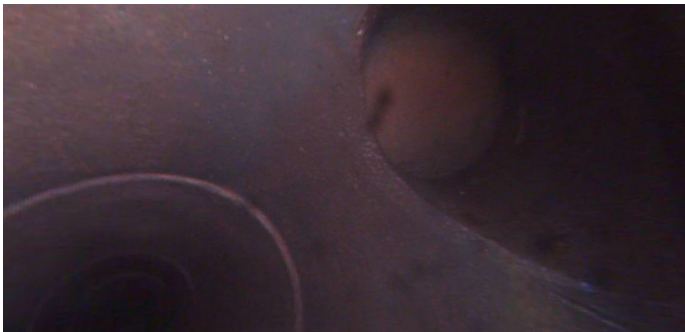
Code:	TFC
Description:	Tap Factory Capped

Distance (ft):	26.0
Structural Grade:	0
O&M Grade:	0
Clock Start/From:	1
Clock To:	
1st Value:	4.000
2nd Value:	
Value Percent:	
Continuous Index:	
Within 8" of Joint:	YES
Remarks:

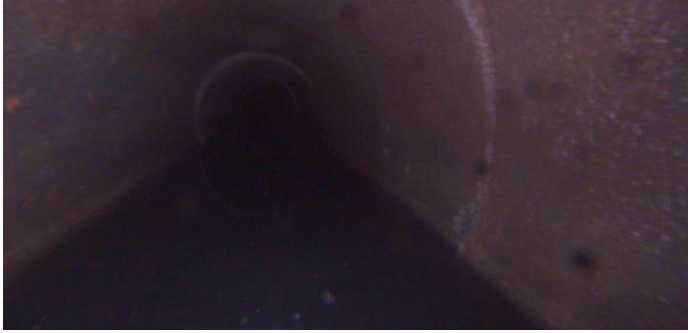
Code:	MSA
Description:	Abandoned Survey
Distance (ft):	28.5
Structural Grade:	0
O&M Grade:	0
Clock Start/From:	
Clock To:	
1st Value:	
2nd Value:	
Value Percent:	
Continuous Index:	
Within 8" of Joint:	NO
Remarks:	no blockage
