## Profile/Photo Observation Report

Street:	<b>E Home Ave</b>	Flow Control:	<b>Not Controlled</b>
City:	<b>Hobart, IN</b>	Year Renewed:	
Location:	<b>Other</b>	Tape/Media #:	
Purpose:	<b>Not Known</b>	Dia/Height:	<b>12"</b>
Use:	<b>Sanitary</b>	Material:	<b>VCP</b>
Drain Area:	<b>NA</b>	Lining:	
Category:	<b>NA</b>		
Comment:

Location Details:		Direction of Survey:	<b>Downstream</b>
US MH:	<b>M-804-014</b>	DS MH:	<b>M-804-013</b>
		Total Length Surveyed (ft):	<b>22.0</b>

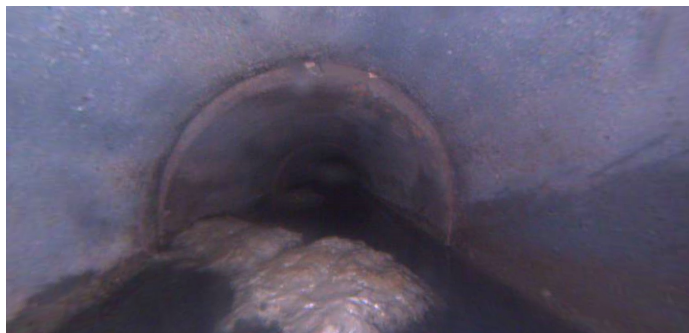
Code: **AMH**  
 Description: **Manhole**

Distance (ft): **.0**  
 Structural Grade: **0**  
 O&M Grade: **0**  
 Clock Start/From:  
 Clock To:  
 1st Value:  
 2nd Value:  
 Value Percent:  
 Continuous Index:  
 Within 8" of Joint: **NO**  
 Remarks: **M-804-014**

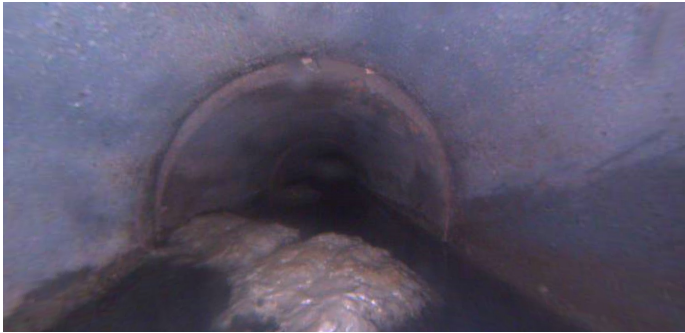
Code:	<b>MWL</b>
Description:	<b>Water Level</b>

Distance (ft):	<b>.0</b>
Structural Grade:	<b>0</b>
O&M Grade:	<b>0</b>
Clock Start/From:	
Clock To:	
1st Value:	
2nd Value:	
Value Percent:	<b>20.000</b>
Continuous Index:	
Within 8" of Joint:	<b>NO</b>
Remarks:

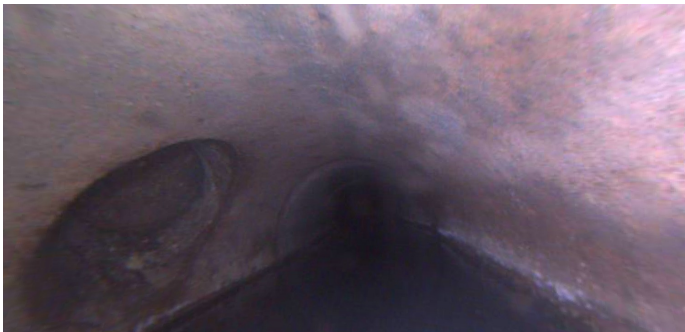
Code:	<b>TFC</b>
Description:	<b>Tap Factory Capped</b>

Distance (ft):	<b>5.4</b>
Structural Grade:	<b>0</b>
O&M Grade:	<b>0</b>
Clock Start/From:	<b>10</b>
Clock To:	
1st Value:	<b>4.000</b>
2nd Value:	
Value Percent:	
Continuous Index:	
Within 8" of Joint:	
Remarks:
