Profile/Photo Observation Report

Date:	10/11/2021	Weather:		Coding:	PACP 7.0
Pipe Length (ft):	38.3	Owner:	City of Hobart	Pre Clean:	Heavy Cleaning
P.O.#:	YES502259	Surveyor:	S. Bucklin	PSR:	P-804-015-016
Customer:	City of Hobart	Clean Date:	10/09/2021	Shape:	C

Street:	East Home Avenue	Flow Control:	Not Controlled
City:	Hobart, IN	Year Renewed:	
Location:	Local rural streets with light traffic, t	Tape/Media #:	
Purpose:	Routine Assessment	Dia/Height:	12"
Use:	Sanitary Sewage Pipe	Material:	VCP
Drain Area:		Lining:	
Category:	NA		
Comment:			
Location Details:		Direction of Survey:	Upstream
US MH:	M-804-016	DS MH:	M-804-015
		Total Length Surveyed (ft):	38.3

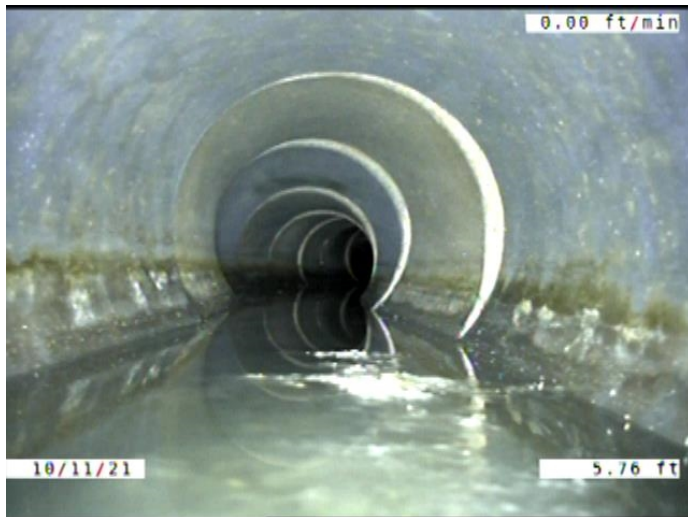
Code: **DSF**
 Description: **Deposits Settled Fine**

Distance (ft): **5.8**
 Structural Grade: **0**
 O&M Grade: **2**
 Clock Start/From: **5**
 Clock To: **7**
 1st Value:
 2nd Value:
 Value Percent: **5.000**
 Continuous Index: **S01**
 Within 8" of Joint: **YES**
 Remarks:

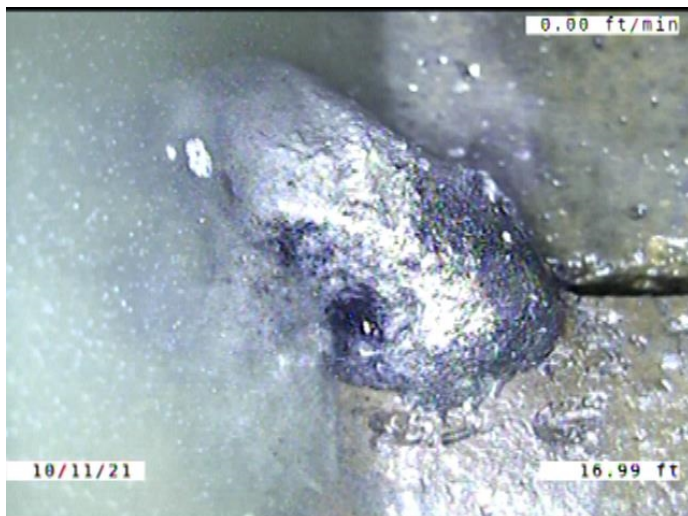
Code: **DAE**
 Description: **Deposits Attached Encrustation**

Distance (ft): **17.0**
 Structural Grade: **0**
 O&M Grade: **2**
 Clock Start/From: **4**
 Clock To:
 1st Value:
 2nd Value:
 Value Percent: **5.000**
 Continuous Index:
 Within 8" of Joint: **YES**
 Remarks:

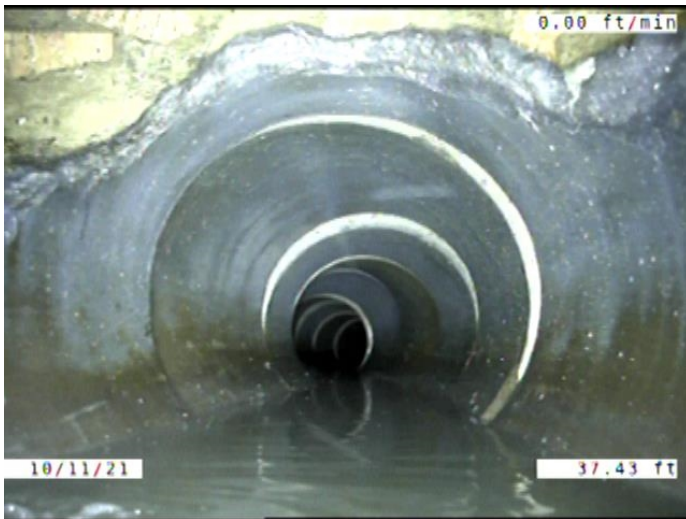
Code: **DSF**
 Description: **Deposits Settled Fine**

Distance (ft): **37.4**
 Structural Grade: **0**
 O&M Grade: **2**
 Clock Start/From: **5**
 Clock To: **7**
 1st Value:
 2nd Value:
 Value Percent: **5.000**
 Continuous Index: **F01**
 Within 8" of Joint: **YES**
 Remarks:

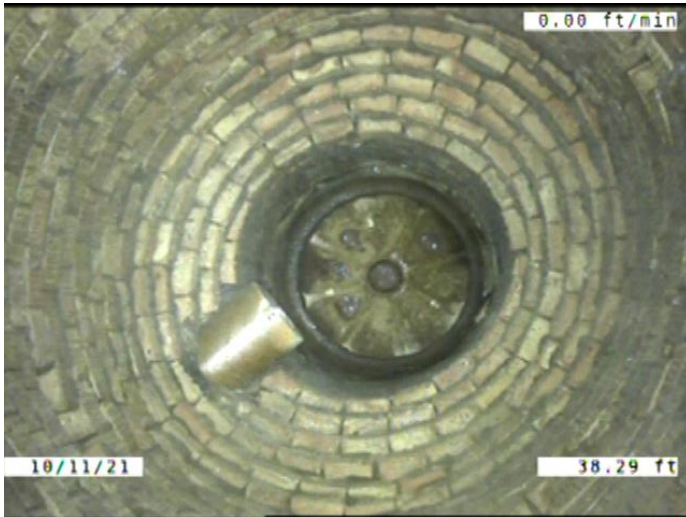
Code:	AMH
Description:	Manhole
Distance (ft):	38.3
Structural Grade:	0
O&M Grade:	0
Clock Start/From:	
Clock To:	
1st Value:	
2nd Value:	
Value Percent:	
Continuous Index:	
Within 8" of Joint:	NO
Remarks:	M-804-016
