## Profile/Photo Observation Report

Street:	<b>E HOME AVE</b>	Flow Control:	<b>Not Controlled</b>
City:	<b>Hobart, IN</b>	Year Renewed:	
Location:	<b>Other</b>	Tape/Media #:	
Purpose:	<b>Not Known</b>	Dia/Height:	<b>12"</b>
Use:	<b>Sanitary</b>	Material:	<b>PVC</b>
Drain Area:	<b>NA</b>	Lining:	
Category:	<b>NA</b>		
Comment:

Location Details:		Direction of Survey:	<b>Downstream</b>
US MH:	<b>M-804-016</b>	DS MH:	<b>M-804-017</b>
		Total Length Surveyed (ft):	<b>344.3</b>

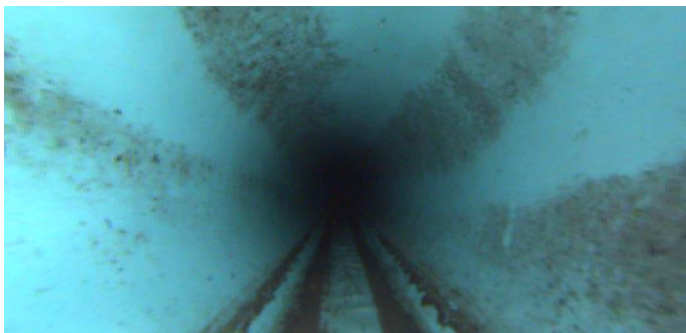
Code: **AMH**  
Description: **Manhole**

Distance (ft): **.0**  
Structural Grade: **0**  
O&M Grade: **0**  
Clock Start/From:  
Clock To:  
1st Value:  
2nd Value:  
Value Percent:  
Continuous Index:  
Within 8" of Joint: **NO**  
Remarks: **M-804-016**

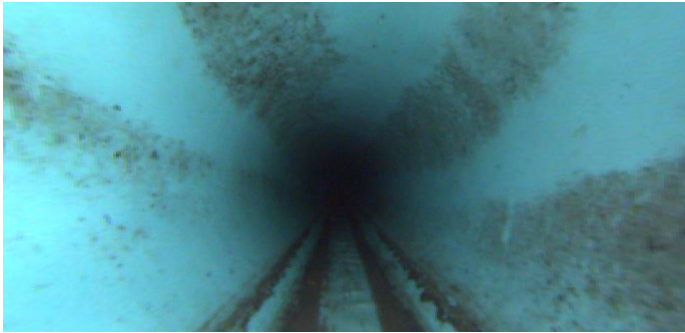
Code:	<b>MWL</b>
Description:	<b>Water Level</b>

Distance (ft):	<b>.0</b>
Structural Grade:	<b>0</b>
O&M Grade:	<b>0</b>
Clock Start/From:	
Clock To:	
1st Value:	
2nd Value:	
Value Percent:	<b>5.000</b>
Continuous Index:	
Within 8" of Joint:	<b>NO</b>
Remarks:

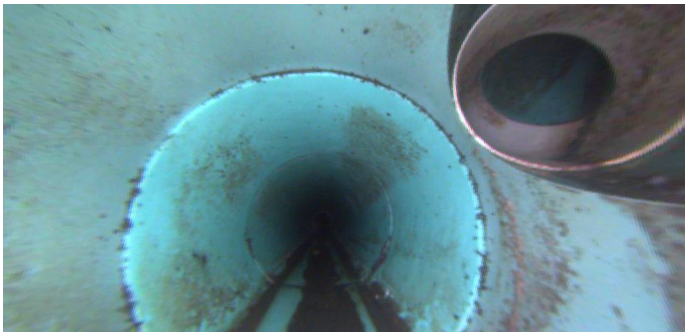
Code:	<b>TF</b>
Description:	<b>Tap Factory</b>

Distance (ft):	<b>53.0</b>
Structural Grade:	<b>0</b>
O&M Grade:	<b>0</b>
Clock Start/From:	<b>1</b>
Clock To:	
1st Value:	<b>4.000</b>
2nd Value:	
Value Percent:	
Continuous Index:	
Within 8" of Joint:	<b>YES</b>
Remarks:

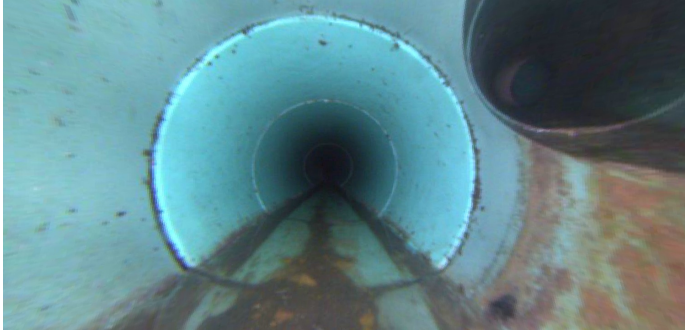
Code: **TF**  
Description: **Tap Factory**

Distance (ft): **63.8**  
Structural Grade: **0**  
O&M Grade: **0**  
Clock Start/From: **1**  
Clock To:  
1st Value: **4.000**  
2nd Value:  
Value Percent:  
Continuous Index:  
Within 8" of Joint: **YES**  
Remarks:

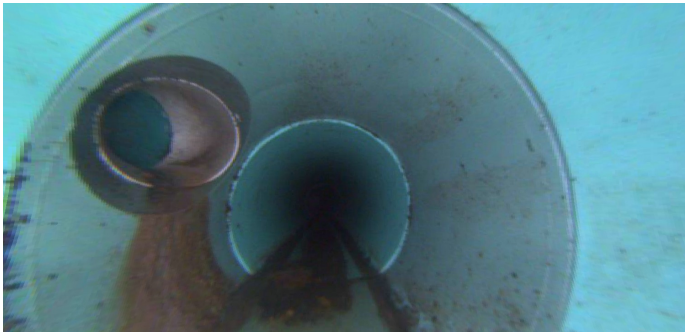
Code: **TF**  
Description: **Tap Factory**

Distance (ft): **104.5**  
Structural Grade: **0**  
O&M Grade: **0**  
Clock Start/From: **11**  
Clock To:  
1st Value: **4.000**  
2nd Value:  
Value Percent:  
Continuous Index:  
Within 8" of Joint: **YES**  
Remarks:

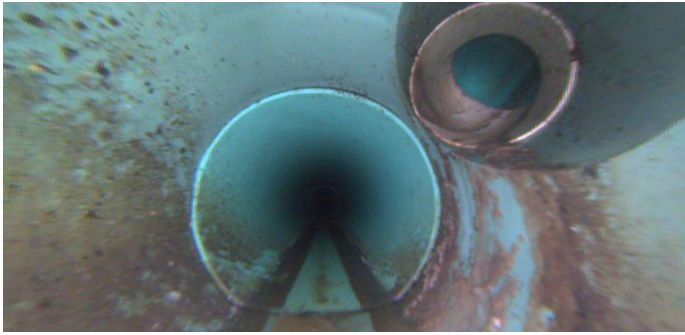
Code: **TF**  
Description: **Tap Factory**

Distance (ft): **146.1**  
Structural Grade: **0**  
O&M Grade: **0**  
Clock Start/From: **1**  
Clock To:  
1st Value: **4.000**  
2nd Value:  
Value Percent:  
Continuous Index:  
Within 8" of Joint: **YES**  
Remarks:

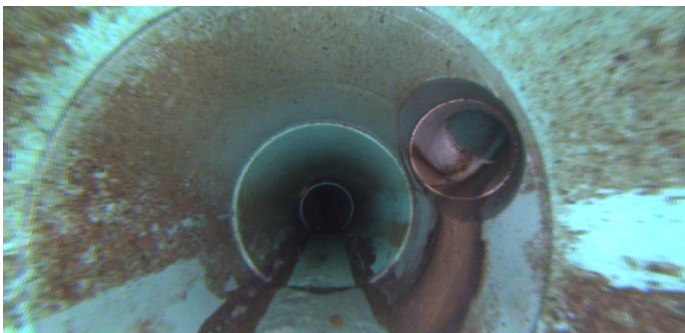
Code: **TF**  
Description: **Tap Factory**

Distance (ft): **186.5**  
Structural Grade: **0**  
O&M Grade: **0**  
Clock Start/From: **1**  
Clock To:  
1st Value: **4.000**  
2nd Value:  
Value Percent:  
Continuous Index:  
Within 8" of Joint: **YES**  
Remarks:

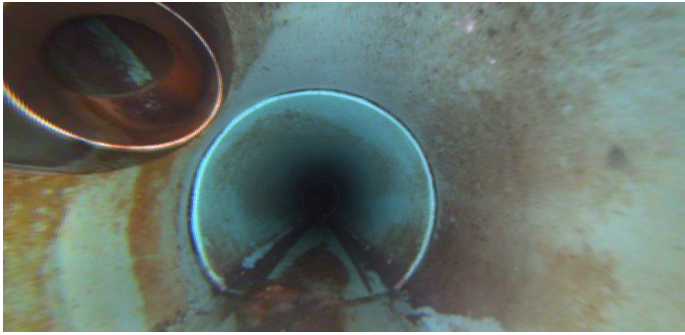
Code: **TF**  
Description: **Tap Factory**

Distance (ft): **189.7**  
Structural Grade: **0**  
O&M Grade: **0**  
Clock Start/From: **11**  
Clock To:  
1st Value: **4.000**  
2nd Value:  
Value Percent:  
Continuous Index:  
Within 8" of Joint: **YES**  
Remarks:

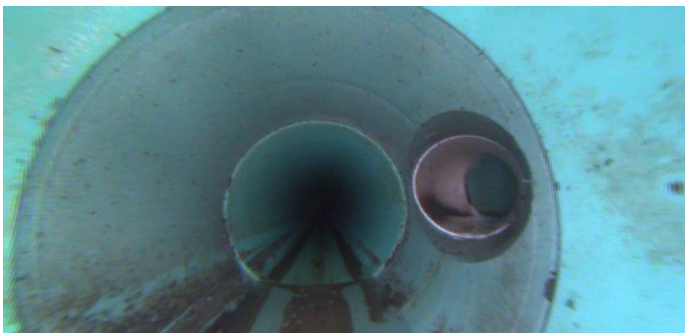
Code: **TF**  
Description: **Tap Factory**

Distance (ft): **242.2**  
Structural Grade: **0**  
O&M Grade: **0**  
Clock Start/From: **3**  
Clock To:  
1st Value: **4.000**  
2nd Value:  
Value Percent:  
Continuous Index:  
Within 8" of Joint: **YES**  
Remarks:

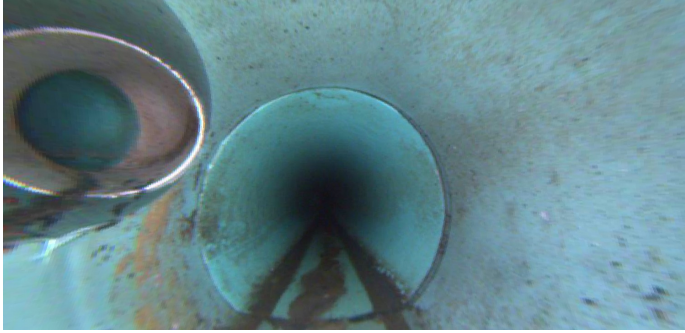
Code: **TF**  
Description: **Tap Factory**

Distance (ft): **253.2**  
Structural Grade: **0**  
O&M Grade: **0**  
Clock Start/From: **10**  
Clock To:  
1st Value: **4.000**  
2nd Value:  
Value Percent:  
Continuous Index:  
Within 8" of Joint: **YES**  
Remarks:

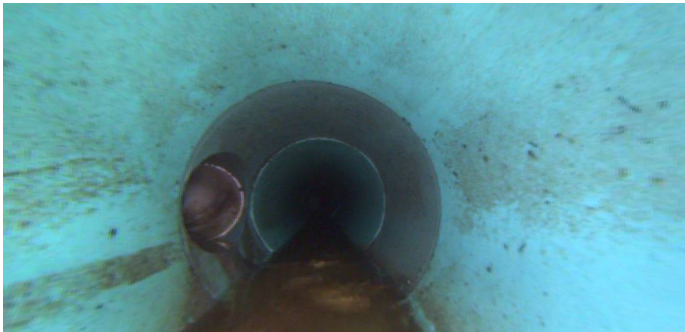
Code: **TF**  
Description: **Tap Factory**

Distance (ft): **293.5**  
Structural Grade: **0**  
O&M Grade: **0**  
Clock Start/From: **9**  
Clock To:  
1st Value: **4.000**  
2nd Value:  
Value Percent:  
Continuous Index:  
Within 8" of Joint: **YES**  
Remarks:

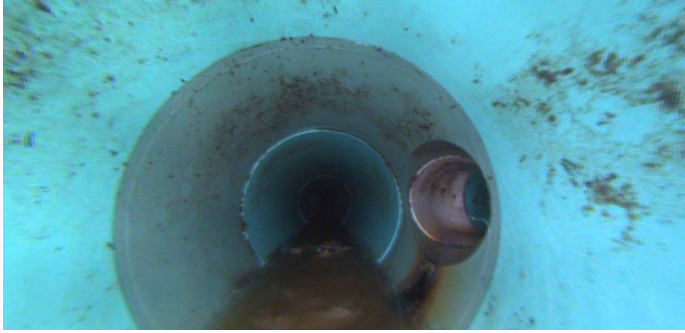
Code: **TF**  
Description: **Tap Factory**

Distance (ft): **310.1**  
Structural Grade: **0**  
O&M Grade: **0**  
Clock Start/From: **3**  
Clock To:  
1st Value: **4.000**  
2nd Value:  
Value Percent:  
Continuous Index:  
Within 8" of Joint: **YES**  
Remarks:

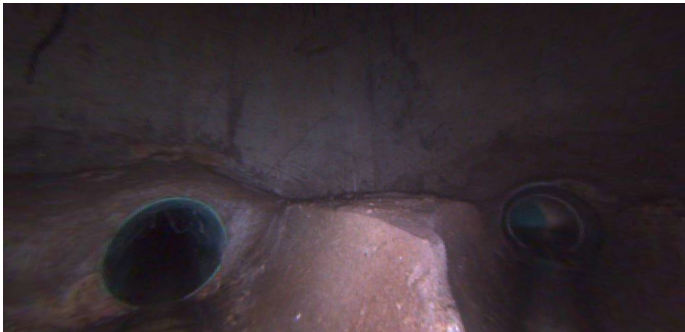
Code: **AMH**  
Description: **Manhole**

Distance (ft): **344.3**  
Structural Grade: **0**  
O&M Grade: **0**  
Clock Start/From:  
Clock To:  
1st Value:  
2nd Value:  
Value Percent:  
Continuous Index:  
Within 8" of Joint: **NO**  
Remarks: **M-804-017**
