## Profile/Photo Observation Report

Street:	<b>E Home Ave</b>	Flow Control:	<b>Not Controlled</b>
City:	<b>Hobart, IN</b>	Year Renewed:	
Location:	<b>Other</b>	Tape/Media #:	
Purpose:	<b>Not Known</b>	Dia/Height:	<b>12"</b>
Use:	<b>Sanitary</b>	Material:	<b>PVC</b>
Drain Area:	<b>NA</b>	Lining:	
Category:	<b>NA</b>		
Comment:

Location Details:		Direction of Survey:	<b>Downstream</b>
US MH:	<b>M-804-016</b>	DS MH:	<b>M-804-017</b>
		Total Length Surveyed (ft):	<b>344.3</b>

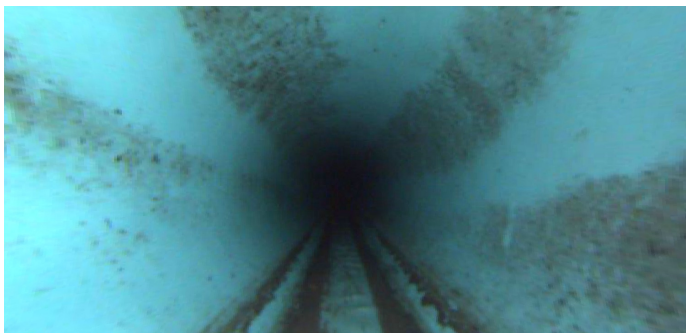
Code: **AMH**  
Description: **Manhole**

Distance (ft): **.0**  
Structural Grade: **0**  
O&M Grade: **0**  
Clock Start/From:  
Clock To:  
1st Value:  
2nd Value:  
Value Percent:  
Continuous Index:  
Within 8" of Joint: **NO**  
Remarks: **M-804-016**

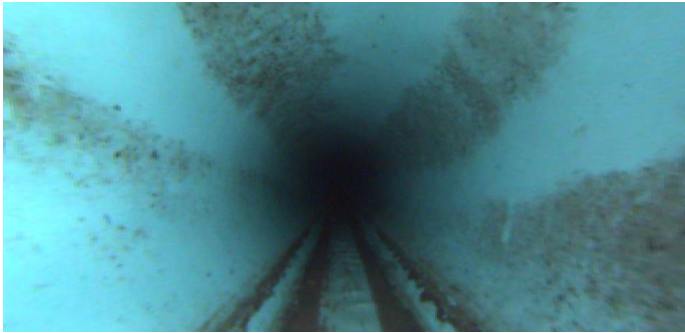
Code:	<b>MWL</b>
Description:	<b>Water Level</b>

Distance (ft):	<b>.0</b>
Structural Grade:	<b>0</b>
O&M Grade:	<b>0</b>
Clock Start/From:	
Clock To:	
1st Value:	
2nd Value:	
Value Percent:	<b>5.000</b>
Continuous Index:	
Within 8" of Joint:	<b>NO</b>
Remarks:

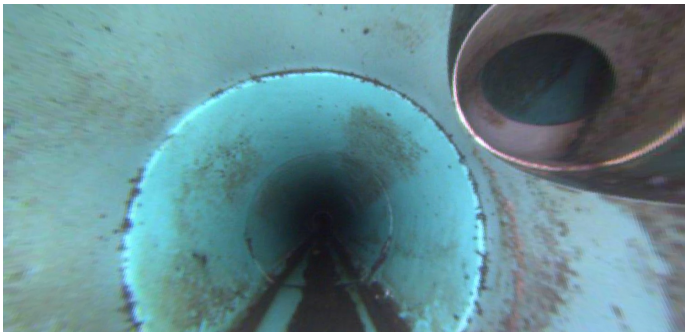
Code:	<b>TF</b>
Description:	<b>Tap Factory</b>

Distance (ft):	<b>53.0</b>
Structural Grade:	<b>0</b>
O&M Grade:	<b>0</b>
Clock Start/From:	<b>1</b>
Clock To:	
1st Value:	<b>4.000</b>
2nd Value:	
Value Percent:	
Continuous Index:	
Within 8" of Joint:	<b>YES</b>
Remarks:

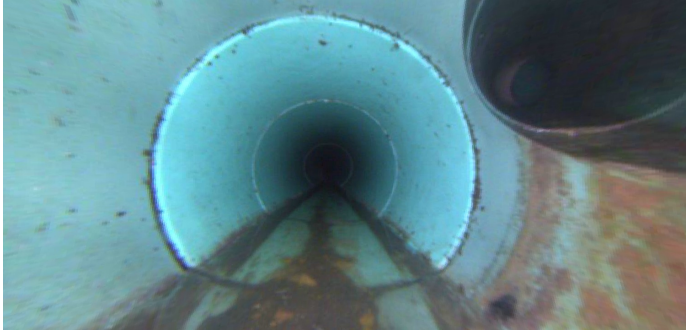
Code: **TF**  
Description: **Tap Factory**

Distance (ft): **63.8**  
Structural Grade: **0**  
O&M Grade: **0**  
Clock Start/From: **1**  
Clock To:  
1st Value: **4.000**  
2nd Value:  
Value Percent:  
Continuous Index:  
Within 8" of Joint: **YES**  
Remarks:

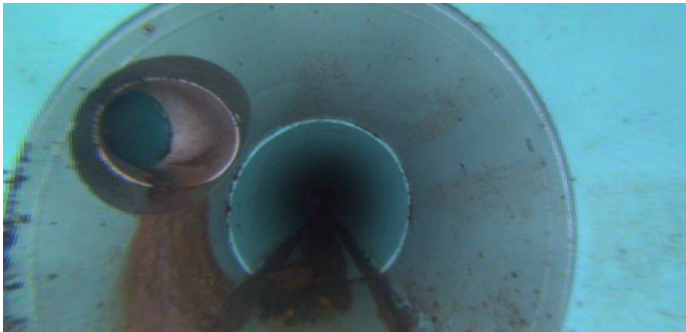
Code: **TF**  
Description: **Tap Factory**

Distance (ft): **104.5**  
Structural Grade: **0**  
O&M Grade: **0**  
Clock Start/From: **11**  
Clock To:  
1st Value: **4.000**  
2nd Value:  
Value Percent:  
Continuous Index:  
Within 8" of Joint: **YES**  
Remarks:

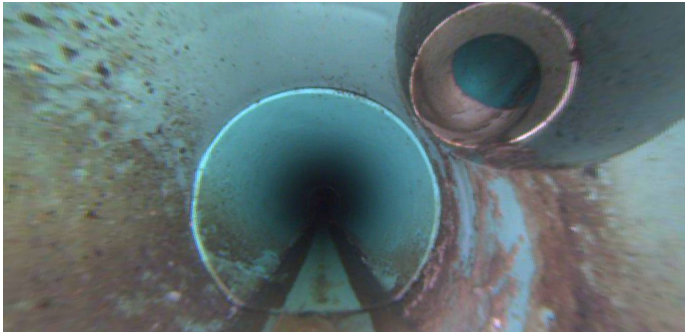
Code: **TF**  
Description: **Tap Factory**

Distance (ft): **146.1**  
Structural Grade: **0**  
O&M Grade: **0**  
Clock Start/From: **1**  
Clock To:  
1st Value: **4.000**  
2nd Value:  
Value Percent:  
Continuous Index:  
Within 8" of Joint: **YES**  
Remarks:

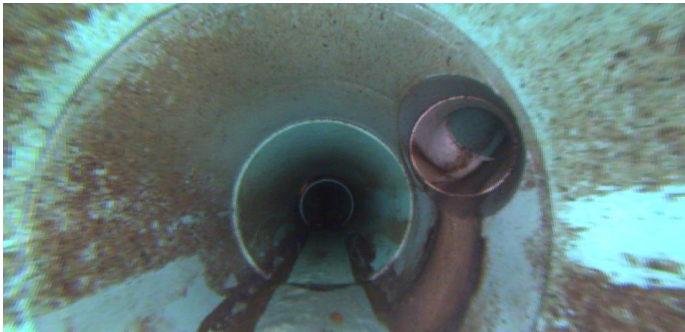
Code: **TF**  
Description: **Tap Factory**

Distance (ft): **186.5**  
Structural Grade: **0**  
O&M Grade: **0**  
Clock Start/From: **1**  
Clock To:  
1st Value: **4.000**  
2nd Value:  
Value Percent:  
Continuous Index:  
Within 8" of Joint: **YES**  
Remarks:

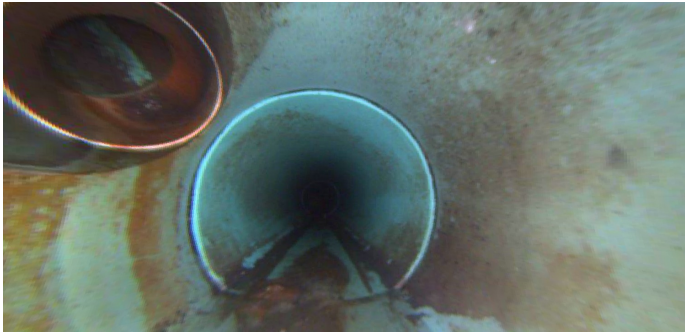
Code: **TF**  
Description: **Tap Factory**

Distance (ft): **189.7**  
Structural Grade: **0**  
O&M Grade: **0**  
Clock Start/From: **11**  
Clock To:  
1st Value: **4.000**  
2nd Value:  
Value Percent:  
Continuous Index:  
Within 8" of Joint: **YES**  
Remarks:

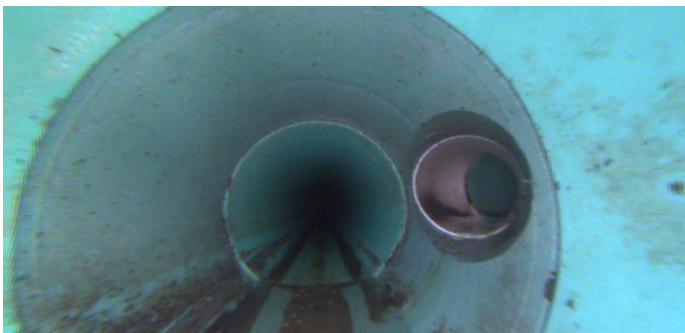
Code: **TF**  
Description: **Tap Factory**

Distance (ft): **242.2**  
Structural Grade: **0**  
O&M Grade: **0**  
Clock Start/From: **3**  
Clock To:  
1st Value: **4.000**  
2nd Value:  
Value Percent:  
Continuous Index:  
Within 8" of Joint: **YES**  
Remarks:

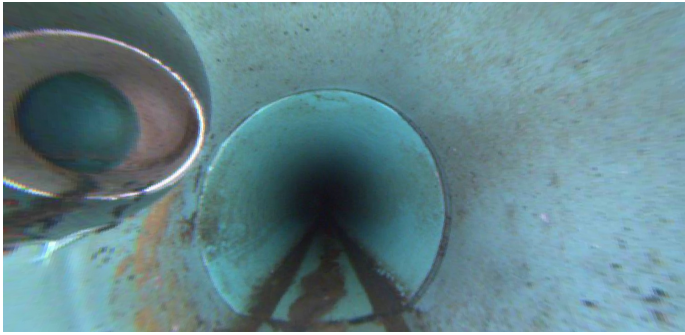
Code: **TF**  
Description: **Tap Factory**

Distance (ft): **253.2**  
Structural Grade: **0**  
O&M Grade: **0**  
Clock Start/From: **10**  
Clock To:  
1st Value: **4.000**  
2nd Value:  
Value Percent:  
Continuous Index:  
Within 8" of Joint: **YES**  
Remarks:

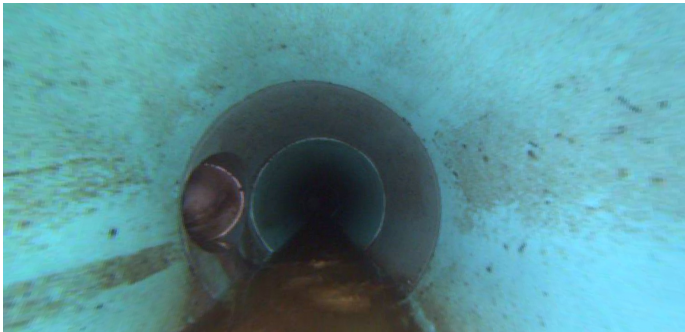
Code: **TF**  
Description: **Tap Factory**

Distance (ft): **293.5**  
Structural Grade: **0**  
O&M Grade: **0**  
Clock Start/From: **9**  
Clock To:  
1st Value: **4.000**  
2nd Value:  
Value Percent:  
Continuous Index:  
Within 8" of Joint: **YES**  
Remarks:

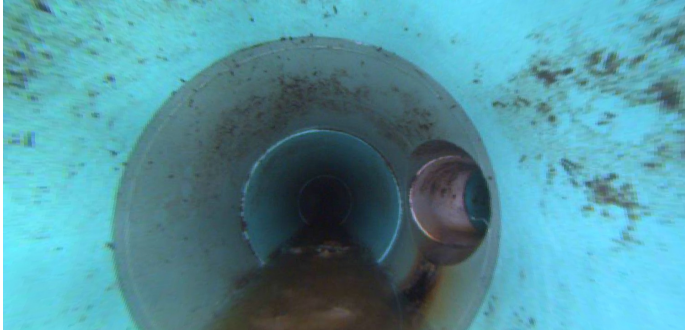
Code: **TF**  
Description: **Tap Factory**

Distance (ft): **310.1**  
Structural Grade: **0**  
O&M Grade: **0**  
Clock Start/From: **3**  
Clock To:  
1st Value: **4.000**  
2nd Value:  
Value Percent:  
Continuous Index:  
Within 8" of Joint: **YES**  
Remarks:

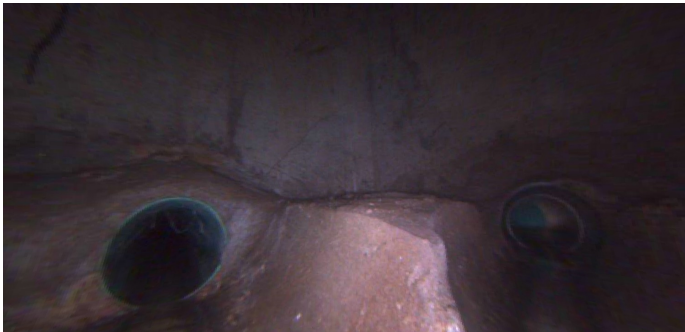
Code: **AMH**  
Description: **Manhole**

Distance (ft): **344.3**  
Structural Grade: **0**  
O&M Grade: **0**  
Clock Start/From:  
Clock To:  
1st Value:  
2nd Value:  
Value Percent:  
Continuous Index:  
Within 8" of Joint: **NO**  
Remarks: **M-804-017**
