Profile/Photo Observation Report

Street:	E Hickey St. Alley	Flow Control:	Not Controlled
City:	Hobart, IN	Year Renewed:	
Location:	Other	Tape/Media #:	
Purpose:	Not Known	Dia/Height:	8"
Use:	Sanitary	Material:	VCP
Drain Area:	NA	Lining:	
Category:	NA		
Comment:

Location Details:		Direction of Survey:	Downstream
US MH:	M-804-020	DS MH:	M-804-015
		Total Length Surveyed (ft):	146.9

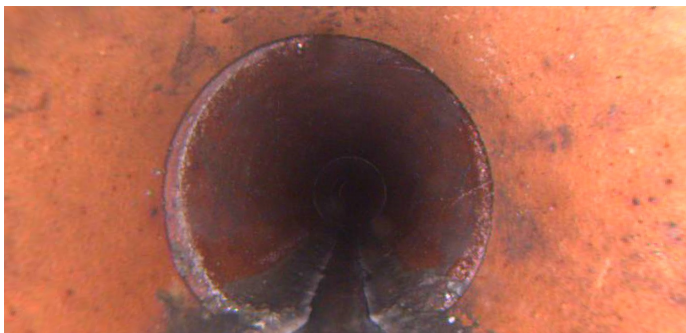
Code: **RFJ**
Description: **Roots Fine Joint**

Distance (ft): **.0**
Structural Grade: **0**
O&M Grade: **1**
Clock Start/From: **1**
Clock To: **4**
1st Value:
2nd Value:
Value Percent:
Continuous Index:
Within 8" of Joint: **YES**
Remarks:

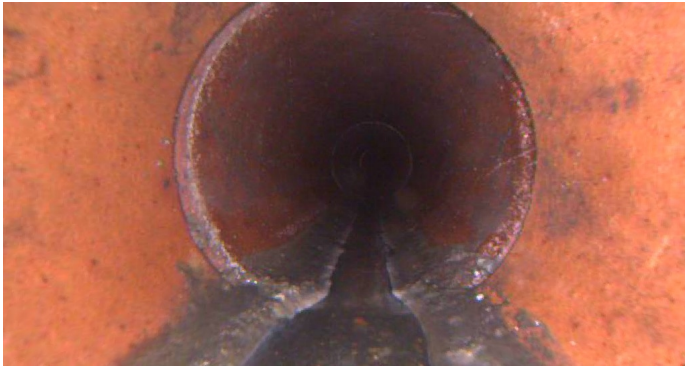
Code: **AMH**
Description: **Manhole**

Distance (ft): **.0**
Structural Grade: **0**
O&M Grade: **0**
Clock Start/From:
Clock To:
1st Value:
2nd Value:
Value Percent:
Continuous Index:
Within 8" of Joint: **NO**
Remarks: **M-804-020**

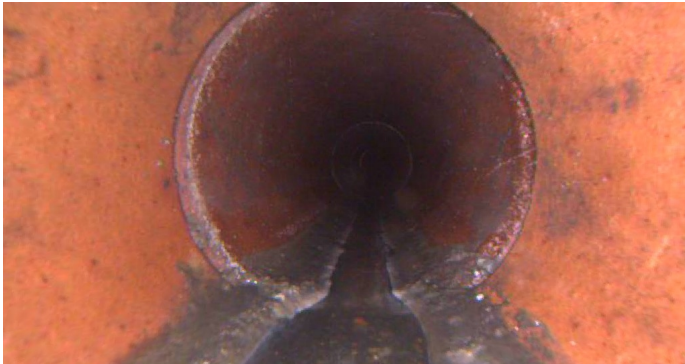
Code: **MWL**
Description: **Water Level**

Distance (ft): **.0**
Structural Grade: **0**
O&M Grade: **0**
Clock Start/From:
Clock To:
1st Value:
2nd Value:
Value Percent: **10.000**
Continuous Index:
Within 8" of Joint: **NO**
Remarks:

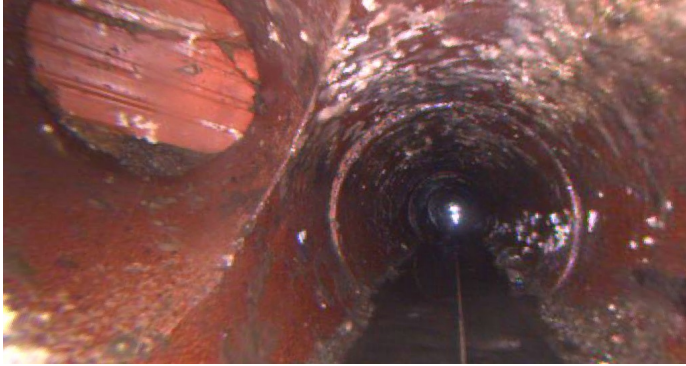
Code: **TFC**
Description: **Tap Factory Capped**

Distance (ft): **33.1**
Structural Grade: **0**
O&M Grade: **0**
Clock Start/From: **3**
Clock To:
1st Value: **4.000**
2nd Value:
Value Percent:
Continuous Index:
Within 8" of Joint:
Remarks:

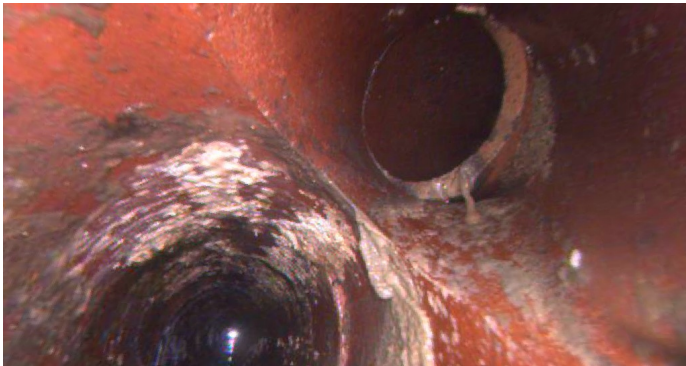
Code: **TF**
Description: **Tap Factory**

Distance (ft): **35.2**
Structural Grade: **0**
O&M Grade: **0**
Clock Start/From: **10**
Clock To:
1st Value: **4.000**
2nd Value:
Value Percent:
Continuous Index:
Within 8" of Joint:
Remarks:

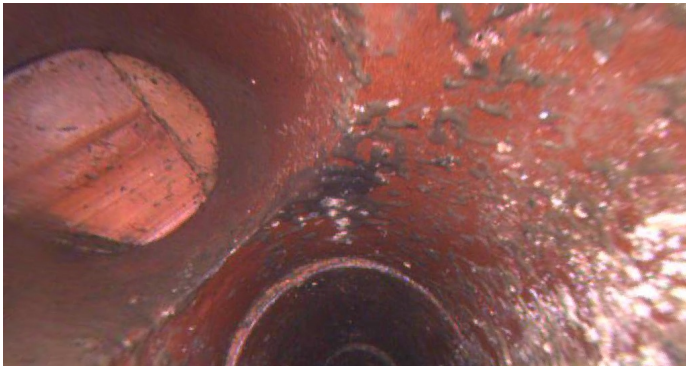
Code: **TFC**
Description: **Tap Factory Capped**

Distance (ft): **73.6**
Structural Grade: **0**
O&M Grade: **0**
Clock Start/From: **2**
Clock To:
1st Value: **4.000**
2nd Value:
Value Percent:
Continuous Index:
Within 8" of Joint:
Remarks:

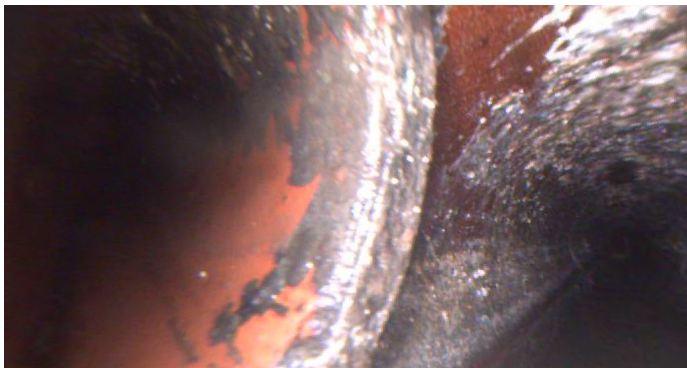
Code: **TBI**
Description: **Tap Break-in Intruding**

Distance (ft): **107.4**
Structural Grade: **0**
O&M Grade: **2**
Clock Start/From: **9**
Clock To:
1st Value: **4.000**
2nd Value: **1.000**
Value Percent:
Continuous Index:
Within 8" of Joint:
Remarks:

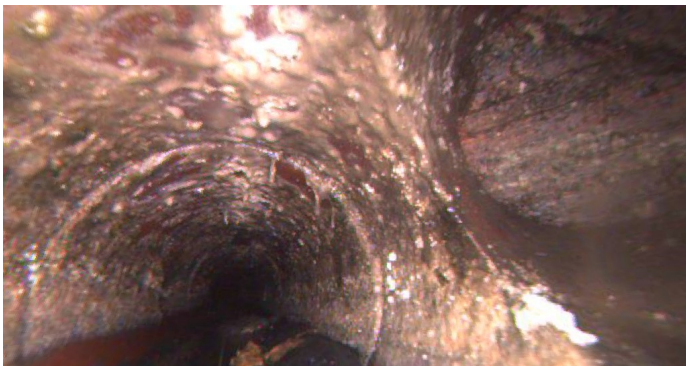
Code: **TFC**
Description: **Tap Factory Capped**

Distance (ft): **115.5**
Structural Grade: **0**
O&M Grade: **0**
Clock Start/From: **10**
Clock To:
1st Value: **4.000**
2nd Value:
Value Percent:
Continuous Index:
Within 8" of Joint:
Remarks:

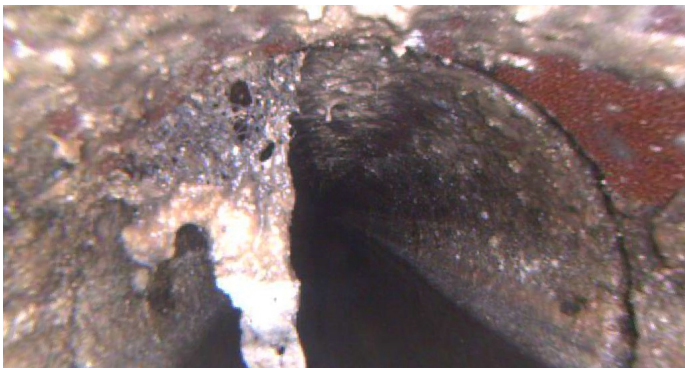
Code: **RFJ**
Description: **Roots Fine Joint**

Distance (ft): **118.4**
Structural Grade: **0**
O&M Grade: **1**
Clock Start/From: **10**
Clock To:
1st Value:
2nd Value:
Value Percent:
Continuous Index:
Within 8" of Joint: **YES**
Remarks:

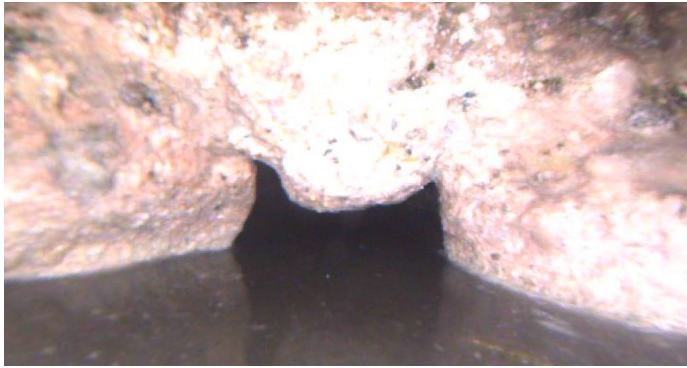
Code: **DAGS**
Description: **Deposits Attached Grease**

Distance (ft): **140.5**
Structural Grade: **0**
O&M Grade: **2**
Clock Start/From: **8**
Clock To: **4**
1st Value:
2nd Value:
Value Percent: **10.000**
Continuous Index:
Within 8" of Joint: **NO**
Remarks:
