Profile/Photo Observation Report

Street:	E HICKEY ST	Flow Control:	Not Controlled
City:	Hobart, IN	Year Renewed:	
Location:	Other	Tape/Media #:	
Purpose:	Not Known	Dia/Height:	8"
Use:	Sanitary	Material:	VCP
Drain Area:	NA	Lining:	
Category:	NA		
Comment:

Location Details:		Direction of Survey:	Upstream
US MH:	M-804-021	DS MH:	M-804-020
		Total Length Surveyed (ft):	4.6

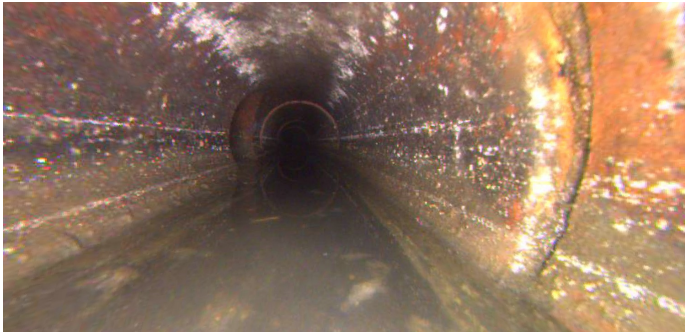
Code:	MWL
Description:	Water Level

Distance (ft):	.0
Structural Grade:	0
O&M Grade:	0
Clock Start/From:	
Clock To:	
1st Value:	
2nd Value:	
Value Percent:	20.000
Continuous Index:	
Within 8" of Joint:	NO
Remarks:

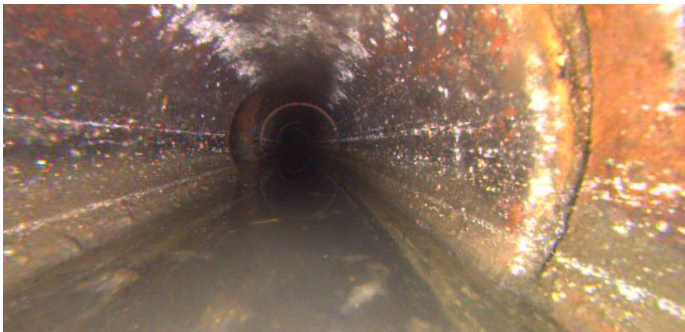
Code:	DAGS
Description:	Deposits Attached Grease

Distance (ft):	.0
Structural Grade:	0
O&M Grade:	2
Clock Start/From:	8
Clock To:	4
1st Value:	
2nd Value:	
Value Percent:	5.000
Continuous Index:	
Within 8" of Joint:	NO
Remarks:

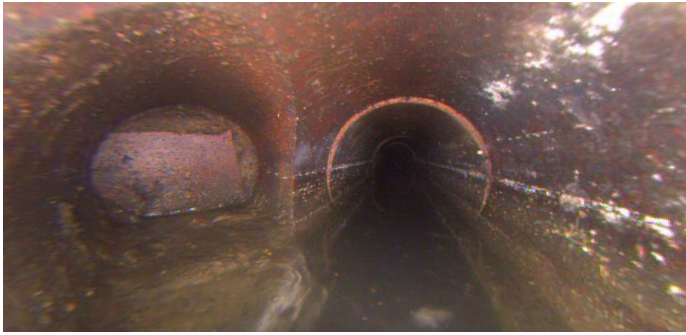
Code: **TFC**
Description: **Tap Factory Capped**

Distance (ft): **2.5**
Structural Grade: **0**
O&M Grade: **0**
Clock Start/From: **9**
Clock To:
1st Value: **4.000**
2nd Value:
Value Percent:
Continuous Index:
Within 8" of Joint:
Remarks:

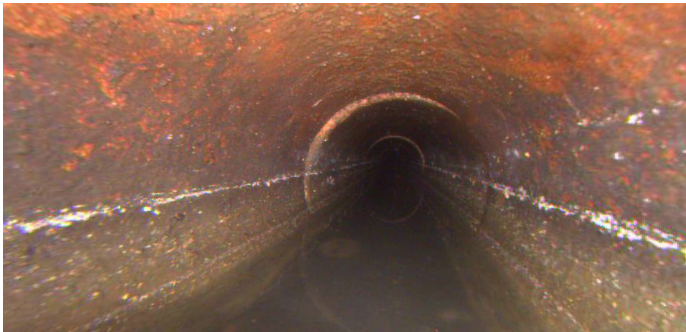
Code: **MSA**
Description: **Abandoned Survey**

Distance (ft): **4.6**
Structural Grade: **0**
O&M Grade: **0**
Clock Start/From:
Clock To:
1st Value:
2nd Value:
Value Percent:
Continuous Index:
Within 8" of Joint: **NO**
Remarks: **unknown**
