## Profile/Photo Observation Report

Street:	<b>N INDIANA ST &amp; E HICKEY ST</b>	Flow Control:	<b>Not Controlled</b>
City:	<b>Hobart, IN</b>	Year Renewed:	
Location:	<b>Light Highway</b>	Tape/Media #:	
Purpose:	<b>Routine Assessment</b>	Dia/Height:	<b>10"</b>
Use:	<b>Sanitary</b>	Material:	<b>VCP</b>
Drain Area:	<b>NA</b>	Lining:	
Category:	<b>NA</b>		
Comment:

Location Details:		Direction of Survey:	<b>Upstream</b>
US MH:	<b>M-804-025</b>	DS MH:	<b>M-804-074</b>
		Total Length Surveyed (ft):	<b>190.1</b>

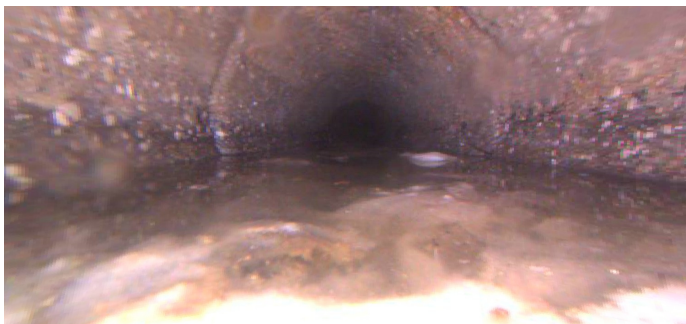
Code: **AMH**  
Description: **Manhole**

Distance (ft): **.0**  
Structural Grade: **0**  
O&M Grade: **0**  
Clock Start/From:  
Clock To:  
1st Value:  
2nd Value:  
Value Percent:  
Continuous Index:  
Within 8" of Joint: **NO**  
Remarks: **M-804-074**

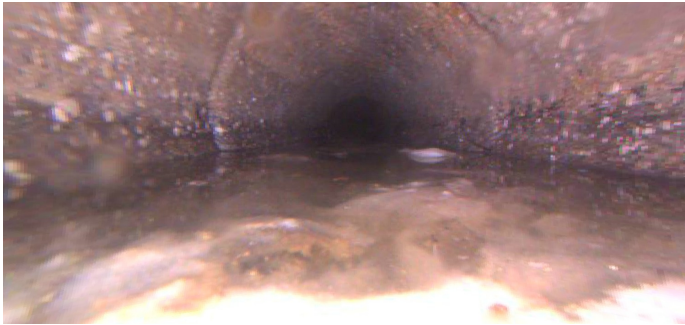
Code:	<b>MWL</b>
Description:	<b>Water Level</b>

Distance (ft):	<b>.0</b>
Structural Grade:	<b>0</b>
O&M Grade:	<b>0</b>
Clock Start/From:	
Clock To:	
1st Value:	
2nd Value:	
Value Percent:	<b>15.000</b>
Continuous Index:	
Within 8" of Joint:	<b>NO</b>
Remarks:

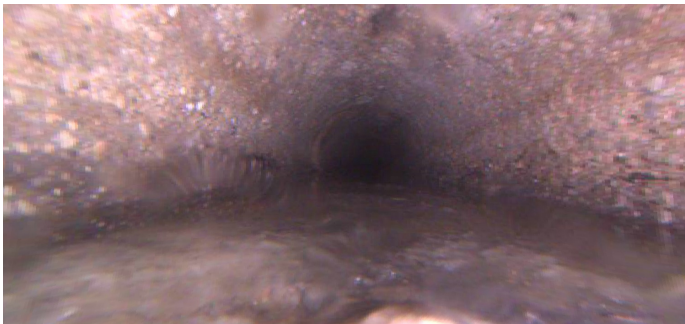
Code:	<b>DAGS</b>
Description:	<b>Deposits Attached Grease</b>

Distance (ft):	<b>5.6</b>
Structural Grade:	<b>0</b>
O&M Grade:	<b>2</b>
Clock Start/From:	<b>7</b>
Clock To:	<b>5</b>
1st Value:	
2nd Value:	
Value Percent:	<b>5.000</b>
Continuous Index:	<b>S01</b>
Within 8" of Joint:	<b>YES</b>
Remarks:	<b>WANDER</b>

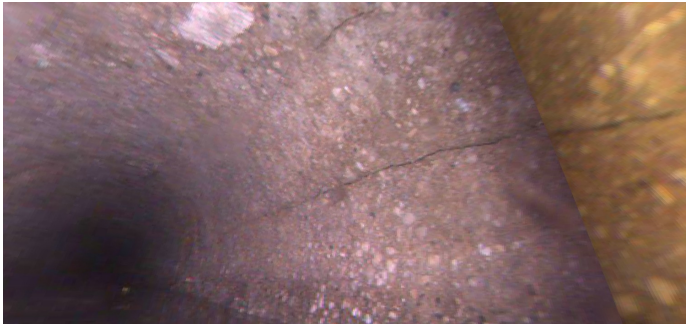
Code: **FM**  
Description: **Fracture Multiple**

Distance (ft): **11.9**  
Structural Grade: **4**  
O&M Grade: **0**  
Clock Start/From: **2**  
Clock To: **3**  
1st Value:  
2nd Value:  
Value Percent:  
Continuous Index:  
Within 8" of Joint: **YES**  
Remarks:

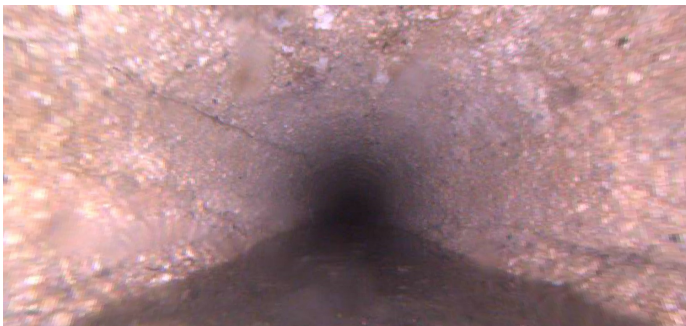
Code: **FM**  
Description: **Fracture Multiple**

Distance (ft): **16.8**  
Structural Grade: **4**  
O&M Grade: **0**  
Clock Start/From: **9**  
Clock To: **12**  
1st Value:  
2nd Value:  
Value Percent:  
Continuous Index:  
Within 8" of Joint: **YES**  
Remarks:

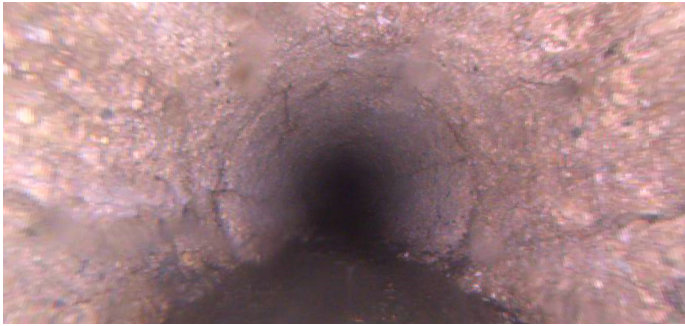
Code: **FM**  
Description: **Fracture Multiple**

Distance (ft): **21.7**  
Structural Grade: **4**  
O&M Grade: **0**  
Clock Start/From: **7**  
Clock To: **5**  
1st Value:  
2nd Value:  
Value Percent:  
Continuous Index:  
Within 8" of Joint: **YES**  
Remarks:

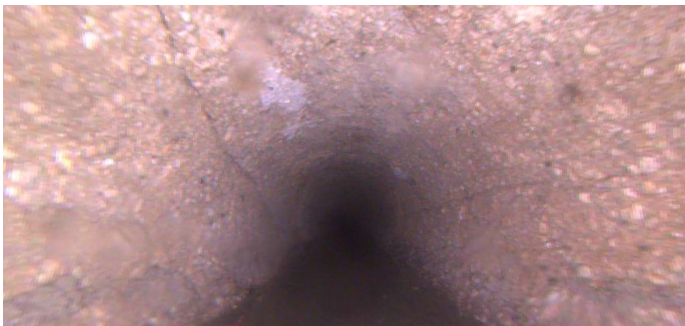
Code: **FM**  
Description: **Fracture Multiple**

Distance (ft): **29.2**  
Structural Grade: **4**  
O&M Grade: **0**  
Clock Start/From: **7**  
Clock To: **3**  
1st Value:  
2nd Value:  
Value Percent:  
Continuous Index:  
Within 8" of Joint: **YES**  
Remarks:

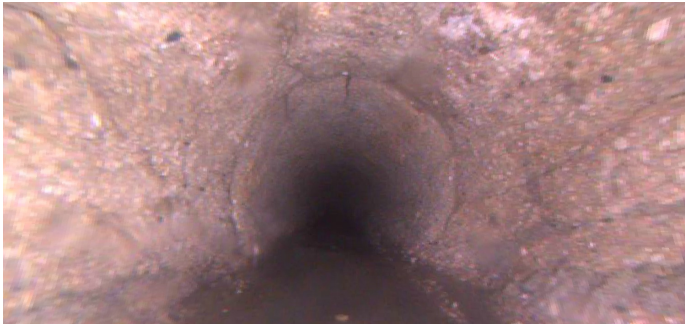
Code: **FM**  
Description: **Fracture Multiple**

Distance (ft): **33.6**  
Structural Grade: **4**  
O&M Grade: **0**  
Clock Start/From: **7**  
Clock To: **5**  
1st Value:  
2nd Value:  
Value Percent:  
Continuous Index:  
Within 8" of Joint: **YES**  
Remarks:

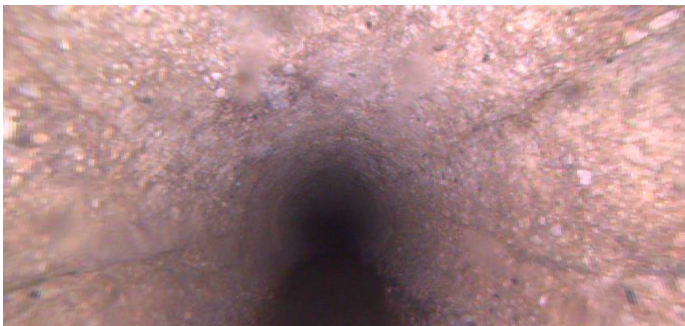
Code: **FM**  
Description: **Fracture Multiple**

Distance (ft): **38.5**  
Structural Grade: **4**  
O&M Grade: **0**  
Clock Start/From: **8**  
Clock To: **4**  
1st Value:  
2nd Value:  
Value Percent:  
Continuous Index:  
Within 8" of Joint: **YES**  
Remarks:

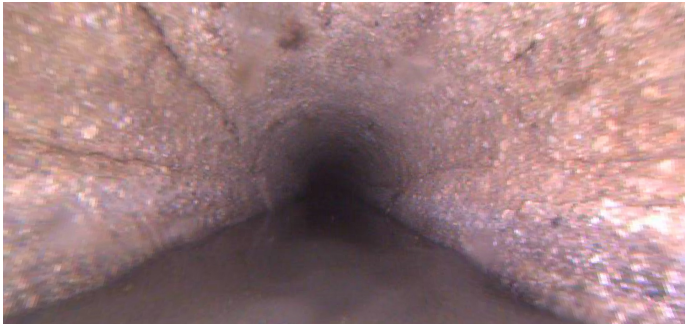
Code: **FM**  
Description: **Fracture Multiple**

Distance (ft): **51.0**  
Structural Grade: **4**  
O&M Grade: **0**  
Clock Start/From: **9**  
Clock To: **3**  
1st Value:  
2nd Value:  
Value Percent:  
Continuous Index:  
Within 8" of Joint: **YES**  
Remarks:

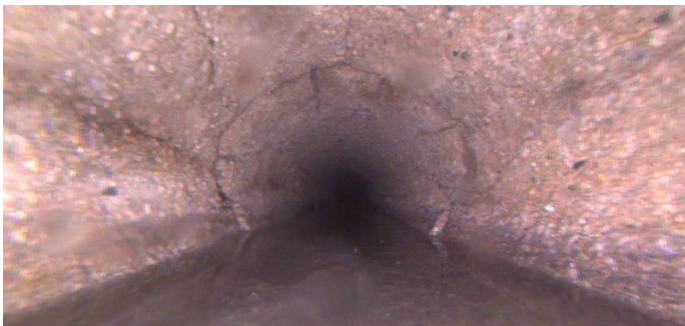
Code: **FM**  
Description: **Fracture Multiple**

Distance (ft): **57.8**  
Structural Grade: **4**  
O&M Grade: **0**  
Clock Start/From: **9**  
Clock To: **3**  
1st Value:  
2nd Value:  
Value Percent:  
Continuous Index:  
Within 8" of Joint: **YES**  
Remarks:

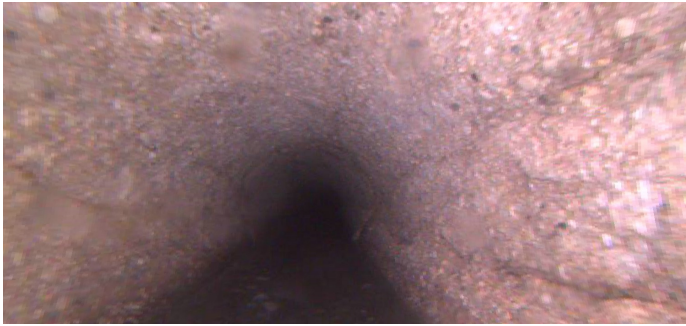
Code: **FM**  
Description: **Fracture Multiple**

Distance (ft): **65.8**  
Structural Grade: **4**  
O&M Grade: **0**  
Clock Start/From: **9**  
Clock To: **4**  
1st Value:  
2nd Value:  
Value Percent:  
Continuous Index:  
Within 8" of Joint:  
Remarks:

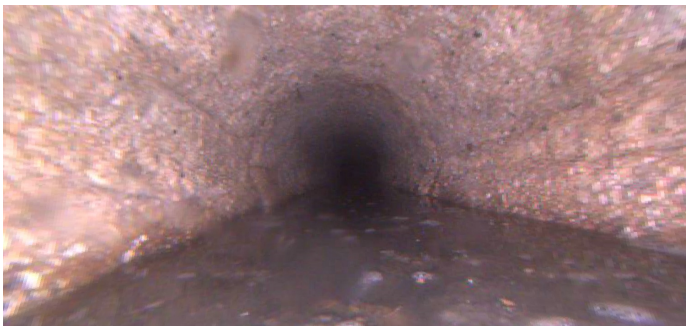
Code: **FM**  
Description: **Fracture Multiple**

Distance (ft): **69.5**  
Structural Grade: **4**  
O&M Grade: **0**  
Clock Start/From: **7**  
Clock To: **4**  
1st Value:  
2nd Value:  
Value Percent:  
Continuous Index:  
Within 8" of Joint: **YES**  
Remarks:

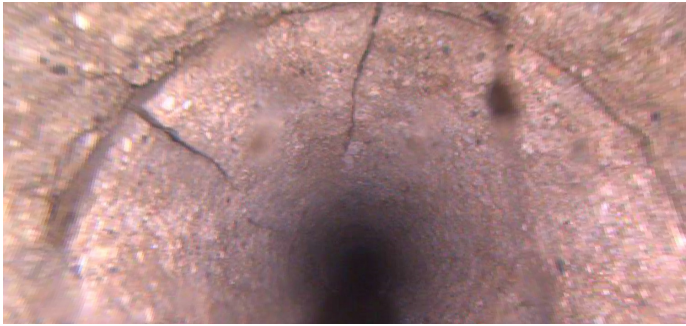
Code: **FM**  
Description: **Fracture Multiple**

Distance (ft): **79.5**  
Structural Grade: **4**  
O&M Grade: **0**  
Clock Start/From: **10**  
Clock To: **12**  
1st Value:  
2nd Value:  
Value Percent:  
Continuous Index:  
Within 8" of Joint: **YES**  
Remarks:

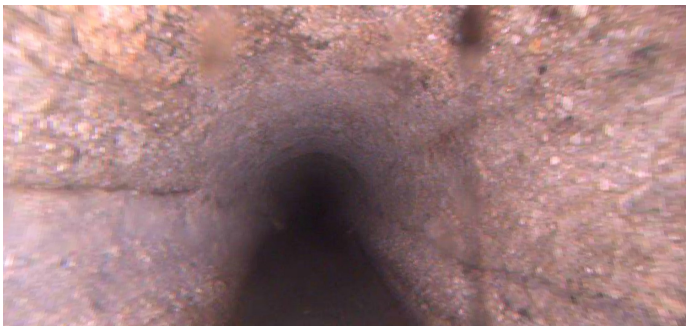
Code: **FM**  
Description: **Fracture Multiple**

Distance (ft): **83.5**  
Structural Grade: **4**  
O&M Grade: **0**  
Clock Start/From: **9**  
Clock To: **4**  
1st Value:  
2nd Value:  
Value Percent:  
Continuous Index:  
Within 8" of Joint:  
Remarks:

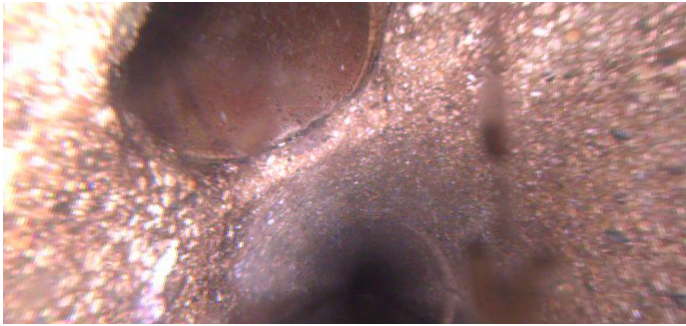
Code: **TF**  
Description: **Tap Factory**

Distance (ft): **126.2**  
Structural Grade: **0**  
O&M Grade: **0**  
Clock Start/From: **10**  
Clock To:  
1st Value: **4.000**  
2nd Value:  
Value Percent:  
Continuous Index:  
Within 8" of Joint:  
Remarks:

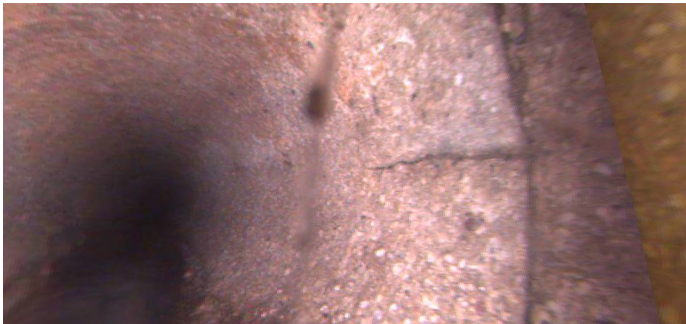
Code: **FL**  
Description: **Fracture Longitudinal**

Distance (ft): **157.7**  
Structural Grade: **3**  
O&M Grade: **0**  
Clock Start/From: **3**  
Clock To:  
1st Value:  
2nd Value:  
Value Percent:  
Continuous Index:  
Within 8" of Joint: **YES**  
Remarks:

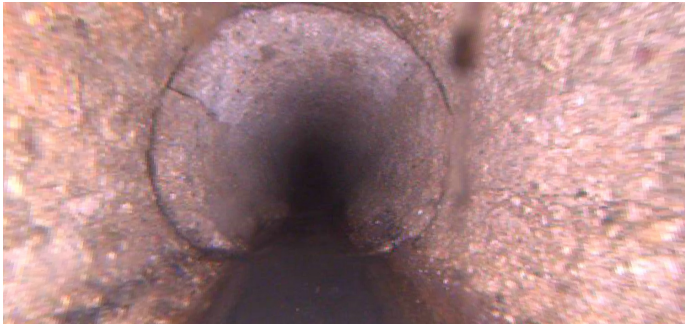
Code: **FL**  
Description: **Fracture Longitudinal**

Distance (ft): **163.1**  
Structural Grade: **3**  
O&M Grade: **0**  
Clock Start/From: **10**  
Clock To:  
1st Value:  
2nd Value:  
Value Percent:  
Continuous Index:  
Within 8" of Joint: **YES**  
Remarks:

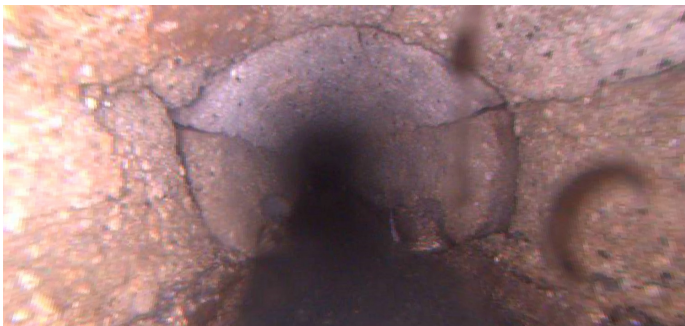
Code: **FM**  
Description: **Fracture Multiple**

Distance (ft): **172.3**  
Structural Grade: **4**  
O&M Grade: **0**  
Clock Start/From: **9**  
Clock To: **3**  
1st Value:  
2nd Value:  
Value Percent:  
Continuous Index:  
Within 8" of Joint: **YES**  
Remarks:

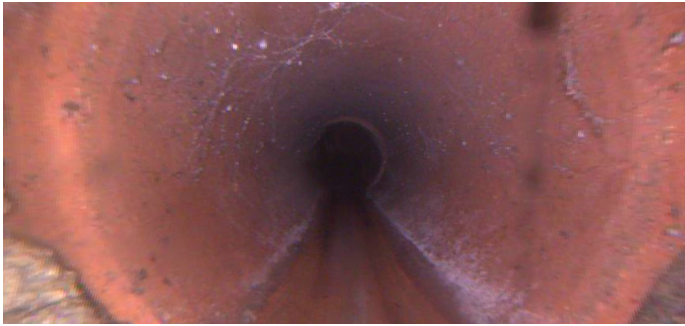
Code: **DAGS**  
Description: **Deposits Attached Grease**

Distance (ft): **182.0**  
Structural Grade: **0**  
O&M Grade: **2**  
Clock Start/From: **7**  
Clock To: **5**  
1st Value:  
2nd Value:  
Value Percent: **5.000**  
Continuous Index: **F01**  
Within 8" of Joint: **YES**  
Remarks: **WANDER**

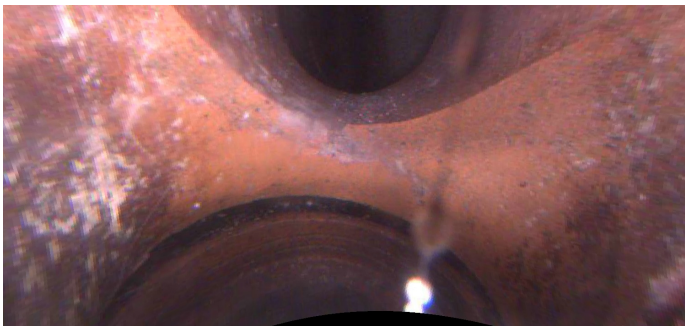
Code: **TF**  
Description: **Tap Factory**

Distance (ft): **188.2**  
Structural Grade: **0**  
O&M Grade: **0**  
Clock Start/From: **6**  
Clock To:  
1st Value: **6.000**  
2nd Value:  
Value Percent:  
Continuous Index:  
Within 8" of Joint:  
Remarks: **DROP CONNECTION**

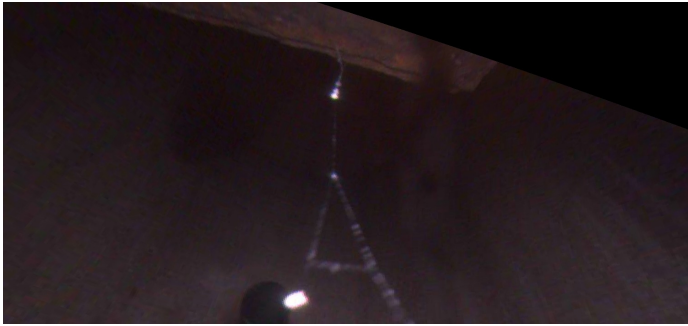
Code:	<b>AMH</b>
Description:	<b>Manhole</b>
Distance (ft):	<b>190.1</b>
Structural Grade:	<b>0</b>
O&M Grade:	<b>0</b>
Clock Start/From:	
Clock To:	
1st Value:	
2nd Value:	
Value Percent:	
Continuous Index:	
Within 8" of Joint:	<b>NO</b>
Remarks:	<b>M-804-025</b>
