Profile/Photo Observation Report

Street:	Indiana St.	Flow Control:	Not Controlled
City:	Hobart, IN	Year Renewed:	
Location:	Light Highway	Tape/Media #:	
Purpose:	Routine Assessment	Dia/Height:	10"
Use:	Sanitary	Material:	VCP
Drain Area:	NA	Lining:	
Category:	NA		
Comment:

Location Details:		Direction of Survey:	Upstream
US MH:	M-804-025	DS MH:	M-804-074
		Total Length Surveyed (ft):	190.1

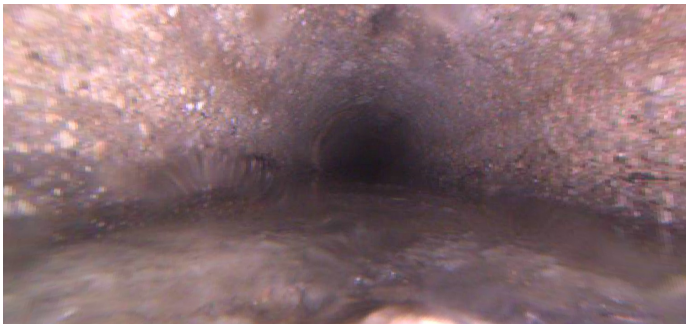
Code:	DAGS
Description:	Deposits Attached Grease

Distance (ft):	5.6
Structural Grade:	0
O&M Grade:	2
Clock Start/From:	7
Clock To:	5
1st Value:	
2nd Value:	
Value Percent:	5.000
Continuous Index:	S01
Within 8" of Joint:	YES
Remarks:	WANDER

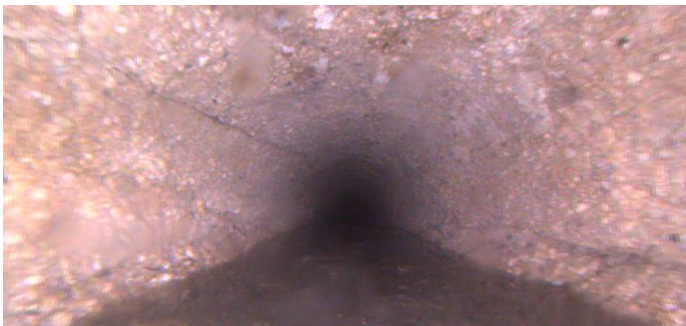
Code: **FM**
Description: **Fracture Multiple**

Distance (ft): **16.8**
Structural Grade: **4**
O&M Grade: **0**
Clock Start/From: **9**
Clock To: **12**
1st Value:
2nd Value:
Value Percent:
Continuous Index:
Within 8" of Joint: **YES**
Remarks:

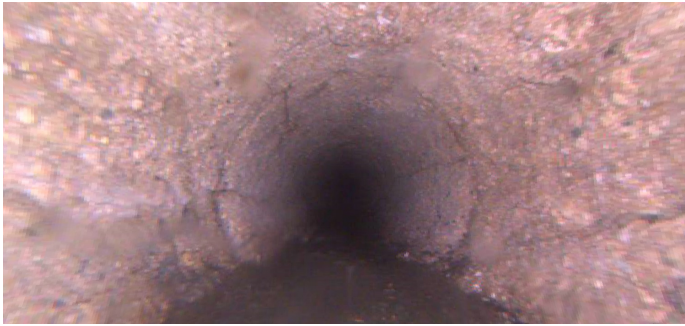
Code: **FM**
Description: **Fracture Multiple**

Distance (ft): **21.7**
Structural Grade: **4**
O&M Grade: **0**
Clock Start/From: **7**
Clock To: **5**
1st Value:
2nd Value:
Value Percent:
Continuous Index:
Within 8" of Joint: **YES**
Remarks:

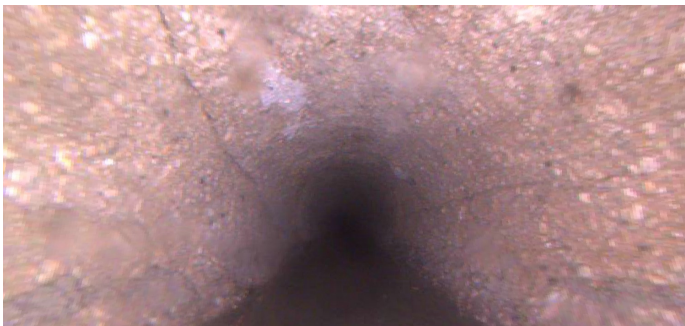
Code: **FM**
Description: **Fracture Multiple**

Distance (ft): **29.2**
Structural Grade: **4**
O&M Grade: **0**
Clock Start/From: **7**
Clock To: **3**
1st Value:
2nd Value:
Value Percent:
Continuous Index:
Within 8" of Joint: **YES**
Remarks:

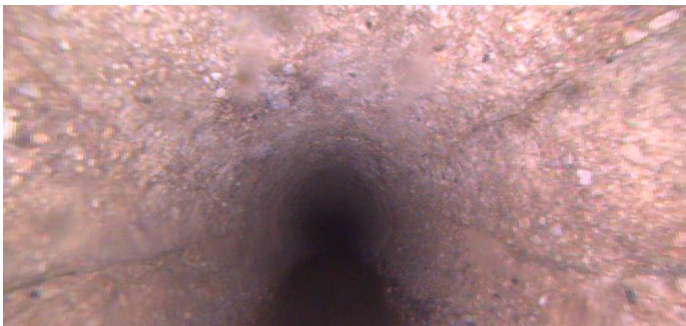
Code: **FM**
Description: **Fracture Multiple**

Distance (ft): **38.5**
Structural Grade: **4**
O&M Grade: **0**
Clock Start/From: **8**
Clock To: **4**
1st Value:
2nd Value:
Value Percent:
Continuous Index:
Within 8" of Joint: **YES**
Remarks:

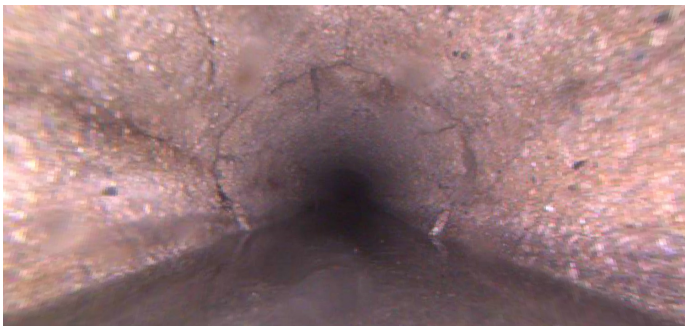
Code: **FM**
Description: **Fracture Multiple**

Distance (ft): **57.8**
Structural Grade: **4**
O&M Grade: **0**
Clock Start/From: **9**
Clock To: **3**
1st Value:
2nd Value:
Value Percent:
Continuous Index:
Within 8" of Joint: **YES**
Remarks:

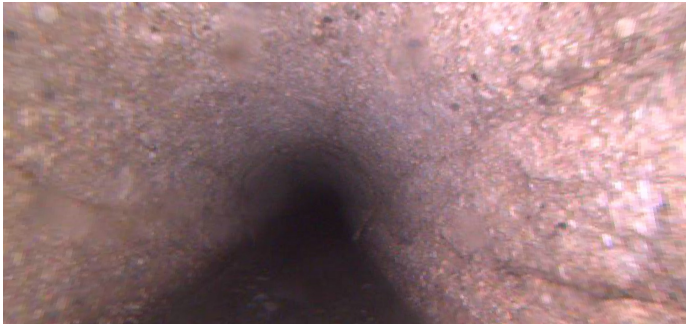
Code: **FM**
Description: **Fracture Multiple**

Distance (ft): **65.8**
Structural Grade: **4**
O&M Grade: **0**
Clock Start/From: **9**
Clock To: **4**
1st Value:
2nd Value:
Value Percent:
Continuous Index:
Within 8" of Joint:
Remarks:

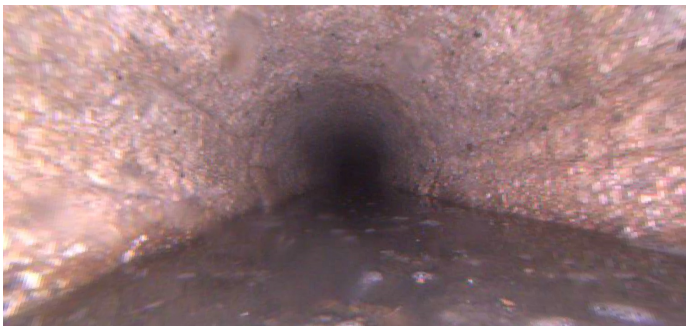
Code: **FM**
Description: **Fracture Multiple**

Distance (ft): **69.5**
Structural Grade: **4**
O&M Grade: **0**
Clock Start/From: **7**
Clock To: **4**
1st Value:
2nd Value:
Value Percent:
Continuous Index:
Within 8" of Joint: **YES**
Remarks:

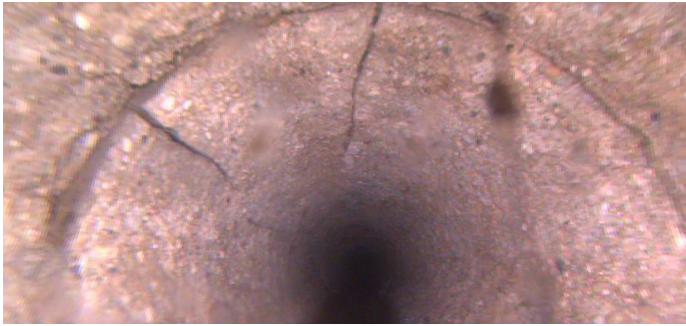
Code: **FM**
Description: **Fracture Multiple**

Distance (ft): **79.5**
Structural Grade: **4**
O&M Grade: **0**
Clock Start/From: **10**
Clock To: **12**
1st Value:
2nd Value:
Value Percent:
Continuous Index:
Within 8" of Joint: **YES**
Remarks:

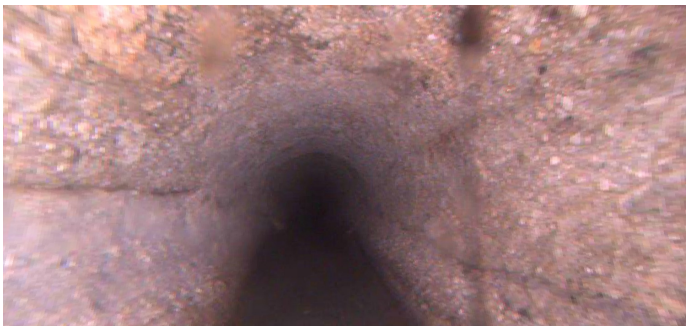
Code: **FM**
Description: **Fracture Multiple**

Distance (ft): **83.5**
Structural Grade: **4**
O&M Grade: **0**
Clock Start/From: **9**
Clock To: **4**
1st Value:
2nd Value:
Value Percent:
Continuous Index:
Within 8" of Joint:
Remarks:

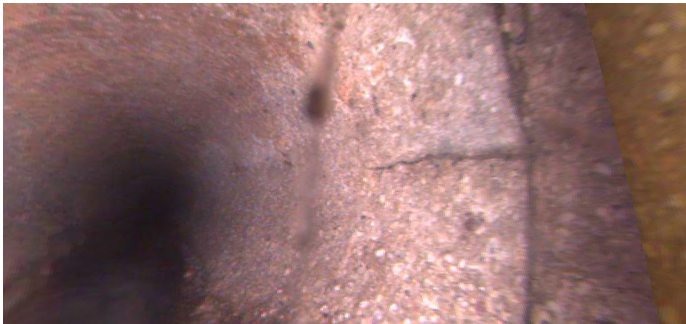
Code: **FL**
Description: **Fracture Longitudinal**

Distance (ft): **157.7**
Structural Grade: **3**
O&M Grade: **0**
Clock Start/From: **3**
Clock To:
1st Value:
2nd Value:
Value Percent:
Continuous Index:
Within 8" of Joint: **YES**
Remarks:

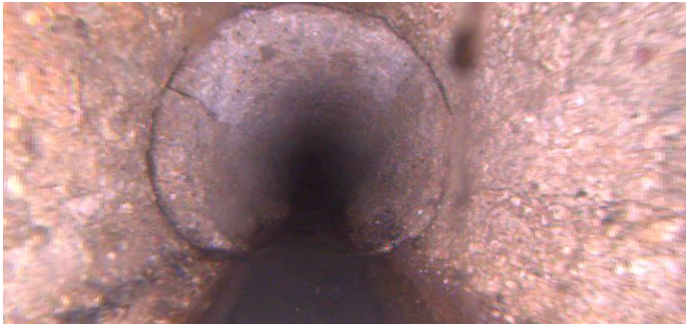
Code: **FL**
Description: **Fracture Longitudinal**

Distance (ft): **163.1**
Structural Grade: **3**
O&M Grade: **0**
Clock Start/From: **10**
Clock To:
1st Value:
2nd Value:
Value Percent:
Continuous Index:
Within 8" of Joint: **YES**
Remarks:

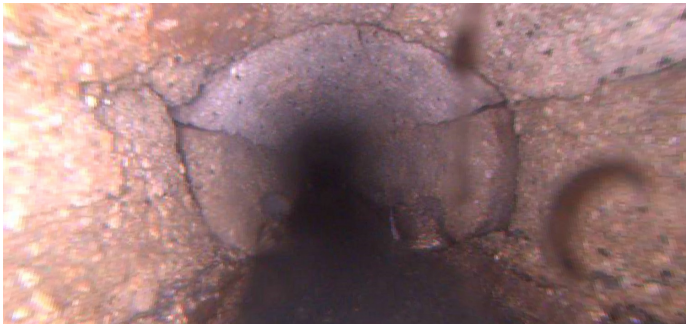
Code: **FM**
Description: **Fracture Multiple**

Distance (ft): **172.3**
Structural Grade: **4**
O&M Grade: **0**
Clock Start/From: **9**
Clock To: **3**
1st Value:
2nd Value:
Value Percent:
Continuous Index:
Within 8" of Joint: **YES**
Remarks:

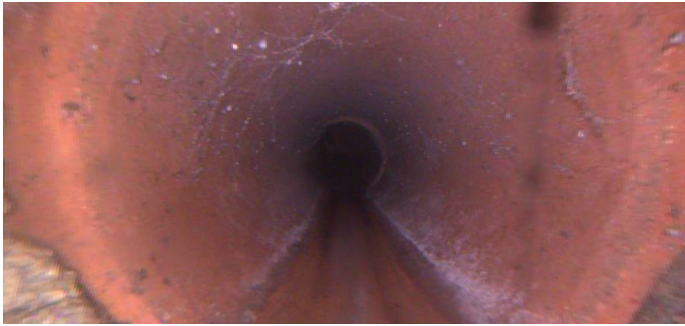
Code: **DAGS**
Description: **Deposits Attached Grease**

Distance (ft): **182.0**
Structural Grade: **0**
O&M Grade: **2**
Clock Start/From: **7**
Clock To: **5**
1st Value:
2nd Value:
Value Percent: **5.000**
Continuous Index: **F01**
Within 8" of Joint: **YES**
Remarks: **WANDER**

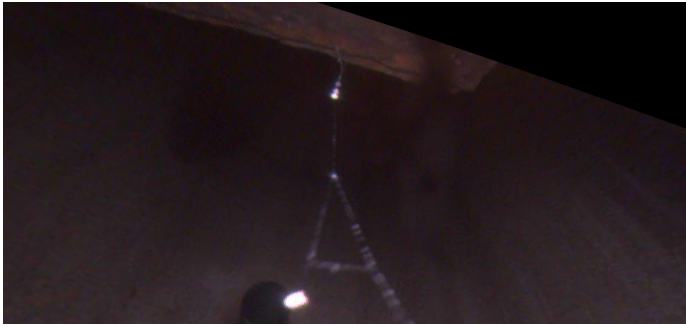
Code: **AMH**
Description: **Manhole**

Distance (ft): **190.1**
Structural Grade: **0**
O&M Grade: **0**
Clock Start/From:
Clock To:
1st Value:
2nd Value:
Value Percent:
Continuous Index:
Within 8" of Joint: **NO**
Remarks: **M-804-025**
