Profile/Photo Observation Report

Street:	N Liberty St.	Flow Control:	Not Controlled
City:	Hobart, IN	Year Renewed:	
Location:	Other	Tape/Media #:	
Purpose:	Not Known	Dia/Height:	8"
Use:	Sanitary	Material:	VCP
Drain Area:	NA	Lining:	
Category:	NA		
Comment:

Location Details:		Direction of Survey:	Upstream
US MH:	M-804-028	DS MH:	M-804-082
		Total Length Surveyed (ft):	235.4

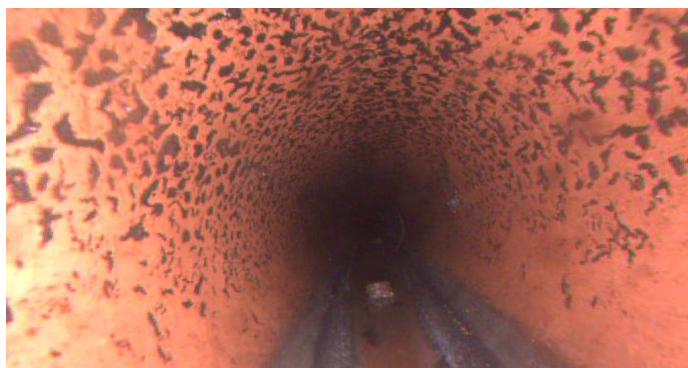
Code: **AMH**
Description: **Manhole**

Distance (ft): **.0**
Structural Grade: **0**
O&M Grade: **0**
Clock Start/From:
Clock To:
1st Value:
2nd Value:
Value Percent:
Continuous Index:
Within 8" of Joint: **NO**
Remarks: **M-804-082**

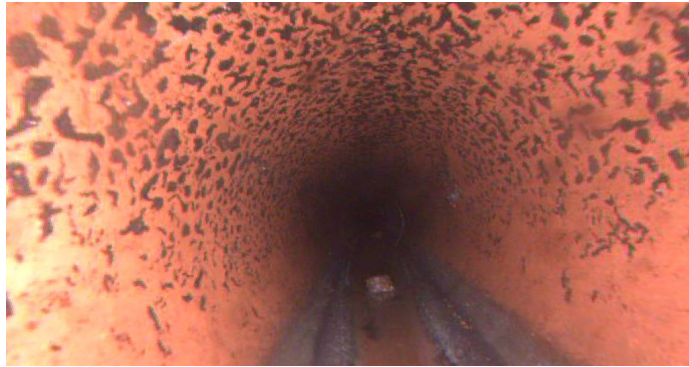
Code: **MWL**
Description: **Water Level**

Distance (ft): **.0**
Structural Grade: **0**
O&M Grade: **0**
Clock Start/From:
Clock To:
1st Value:
2nd Value:
Value Percent: **10.000**
Continuous Index:
Within 8" of Joint: **NO**
Remarks:

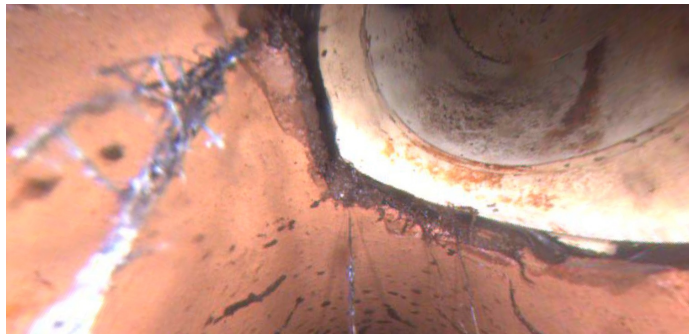
Code: **RFB**
Description: **Roots Fine Barrel**

Distance (ft): **38.1**
Structural Grade: **0**
O&M Grade: **2**
Clock Start/From: **12**
Clock To:
1st Value:
2nd Value:
Value Percent:
Continuous Index:
Within 8" of Joint: **NO**
Remarks:

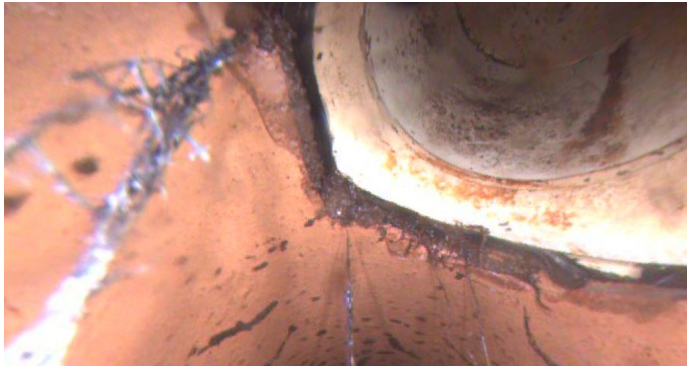
Code: **TBD**
Description: **Tap Break-in Defective**

Distance (ft): **38.1**
Structural Grade: **0**
O&M Grade: **3**
Clock Start/From: **2**
Clock To:
1st Value: **4.000**
2nd Value:
Value Percent:
Continuous Index:
Within 8" of Joint:
Remarks: **roots**

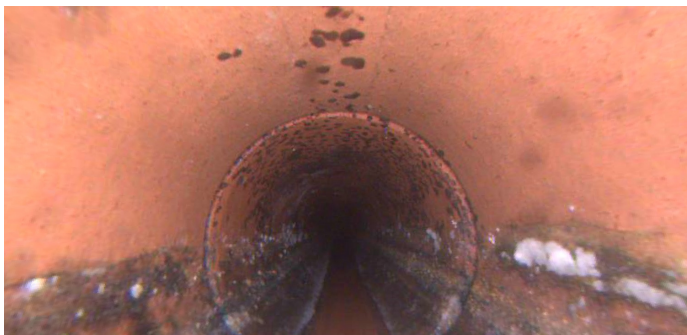
Code: **DAGS**
Description: **Deposits Attached Grease**

Distance (ft): **155.3**
Structural Grade: **0**
O&M Grade: **2**
Clock Start/From: **8**
Clock To: **4**
1st Value:
2nd Value:
Value Percent: **5.000**
Continuous Index: **S01**
Within 8" of Joint: **NO**
Remarks:

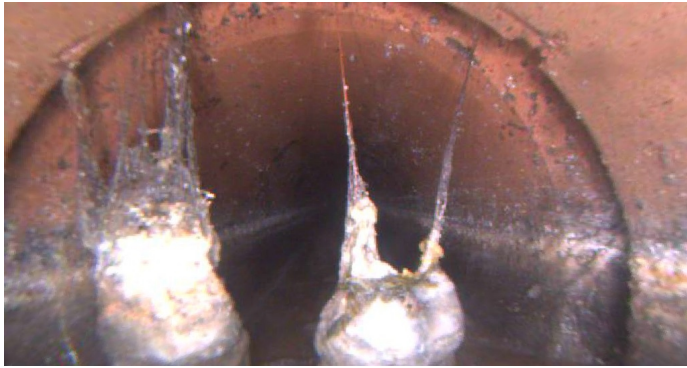
Code: **RMJ**
Description: **Roots Medium Joint**

Distance (ft): **196.0**
Structural Grade: **0**
O&M Grade: **3**
Clock Start/From: **7**
Clock To: **5**
1st Value:
2nd Value:
Value Percent: **15.000**
Continuous Index:
Within 8" of Joint: **YES**
Remarks:

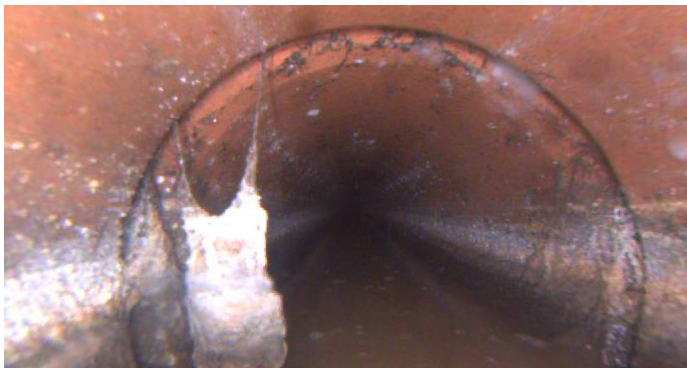
Code: **RMJ**
Description: **Roots Medium Joint**

Distance (ft): **206.1**
Structural Grade: **0**
O&M Grade: **3**
Clock Start/From: **7**
Clock To: **10**
1st Value:
2nd Value:
Value Percent: **10.000**
Continuous Index:
Within 8" of Joint: **YES**
Remarks:

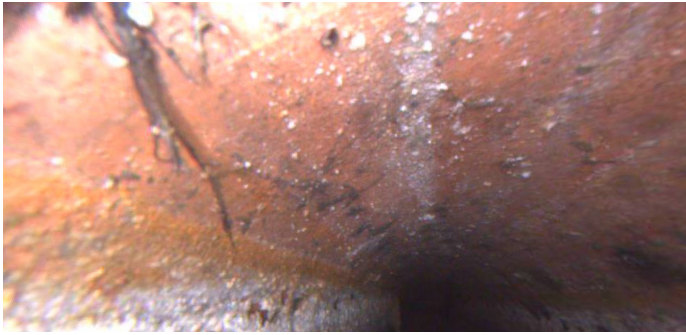
Code: **RFJ**
Description: **Roots Fine Joint**

Distance (ft): **227.0**
Structural Grade: **0**
O&M Grade: **1**
Clock Start/From: **10**
Clock To:
1st Value:
2nd Value:
Value Percent:
Continuous Index:
Within 8" of Joint: **YES**
Remarks:

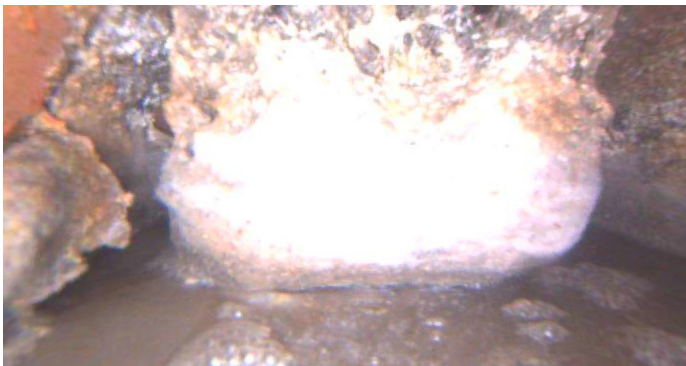
Code: **DAZ**
Description: **Deposits Attached Other**

Distance (ft): **231.7**
Structural Grade: **0**
O&M Grade: **3**
Clock Start/From: **12**
Clock To: **12**
1st Value:
2nd Value:
Value Percent: **15.000**
Continuous Index:
Within 8" of Joint: **NO**
Remarks:

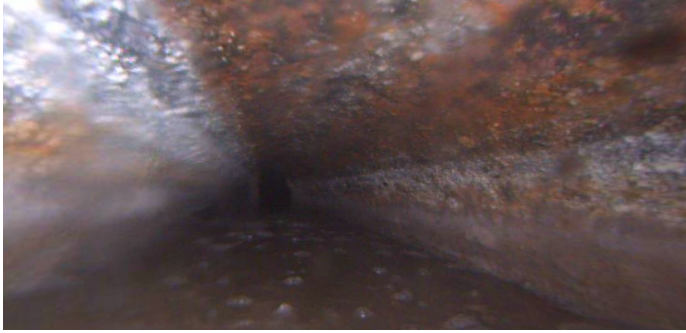
Code: **DAGS**
Description: **Deposits Attached Grease**

Distance (ft): **235.4**
Structural Grade: **0**
O&M Grade: **2**
Clock Start/From: **8**
Clock To: **4**
1st Value:
2nd Value:
Value Percent: **5.000**
Continuous Index: **F01**
Within 8" of Joint: **NO**
Remarks:

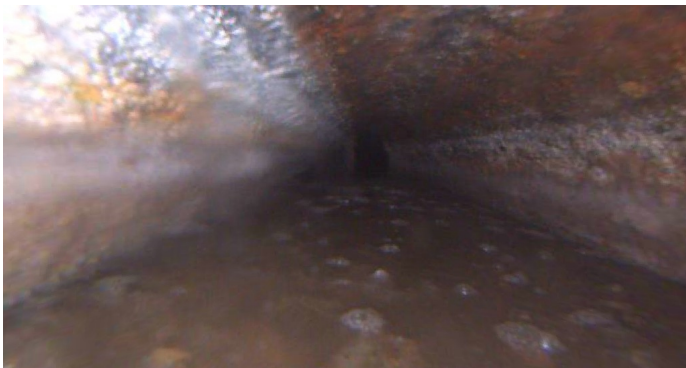
Code: **MSA**
Description: **Abandoned Survey**

Distance (ft): **235.4**
Structural Grade: **0**
O&M Grade: **0**
Clock Start/From:
Clock To:
1st Value:
2nd Value:
Value Percent:
Continuous Index:
Within 8" of Joint: **NO**
Remarks: **Debris**
