Profile/Photo Observation Report

| P.O.#: | 2004 | Surveyor: | SAN | PSR: | P-804-033-030 |

| Street: | N Hobart Rd | Flow Control: | Not Controlled |
| US MH: | M-804-033 | DS MH: | M-804-030 |

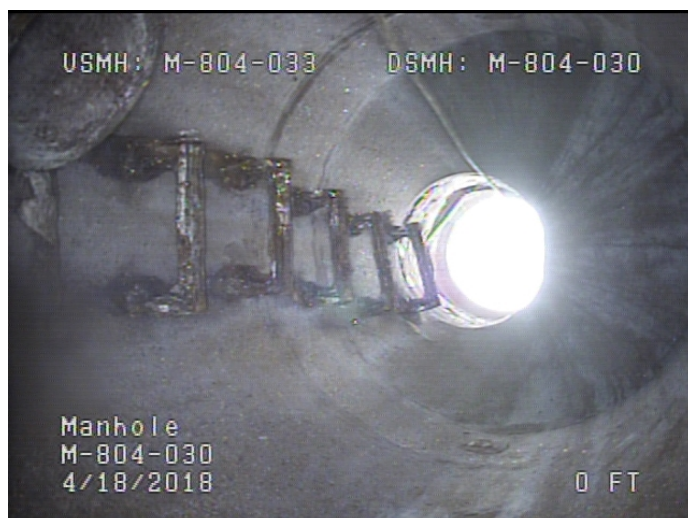
Code: **AMH**
Description: **Manhole**

Distance (ft): **.0**
Structural Grade: **0**
O&M Grade: **0**
Clock Start/From:
Clock To:
1st Value:
2nd Value:
Value Percent:
Continuous Index:
Within 8" of Joint: **NO**
Remarks: **M-804-030**

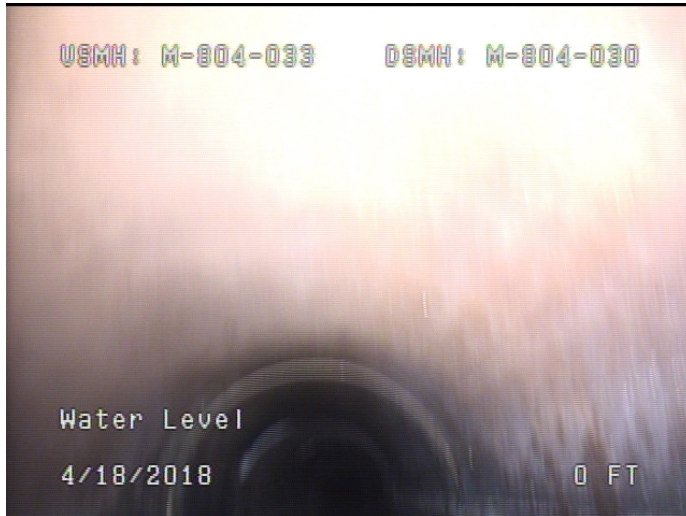
| Code: | MWL |
| Description: | Water Level |
| Distance (ft): | .0 |
| Value Percent: | 15.000 |

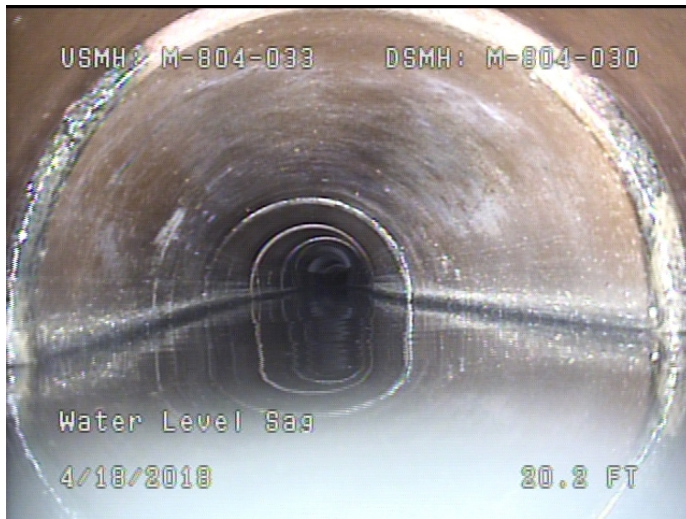
| Code: | MWLS |
| Description: | Water Level Sag |
| Distance (ft): | 20.1 |
| Structural Grade: | 3 |
| O&M Grade: | 3 |
| Value Percent: | 35.000 |

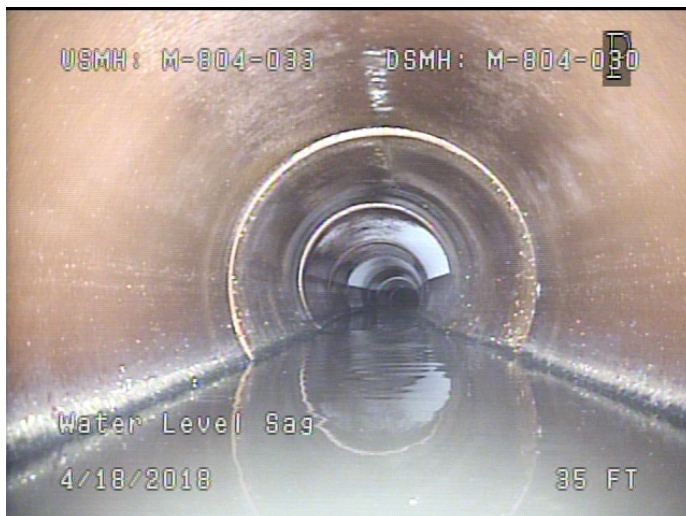
| Code: | MWLS |
| Description: | Water Level Sag |
| Distance (ft): | 35.0 |
| Structural Grade: | 3 |
| O&M Grade: | 3 |
| Value Percent: | 35.000 |

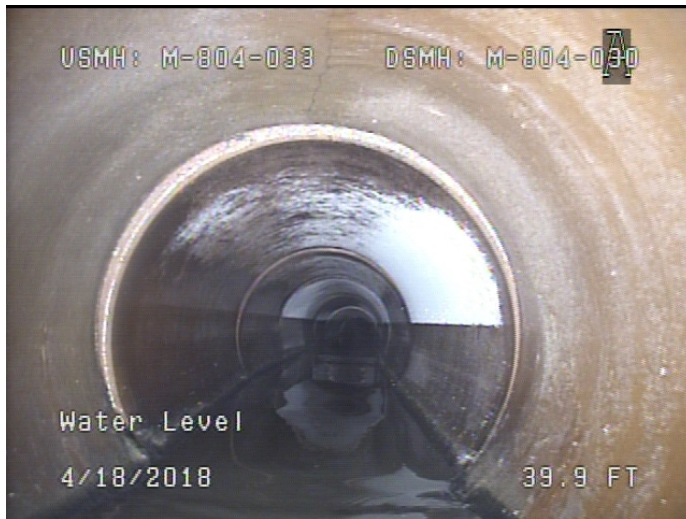
| Code: | MWL |
| Description: | Water Level |
| Distance (ft): | 39.9 |
| Value Percent: | 10.000 |

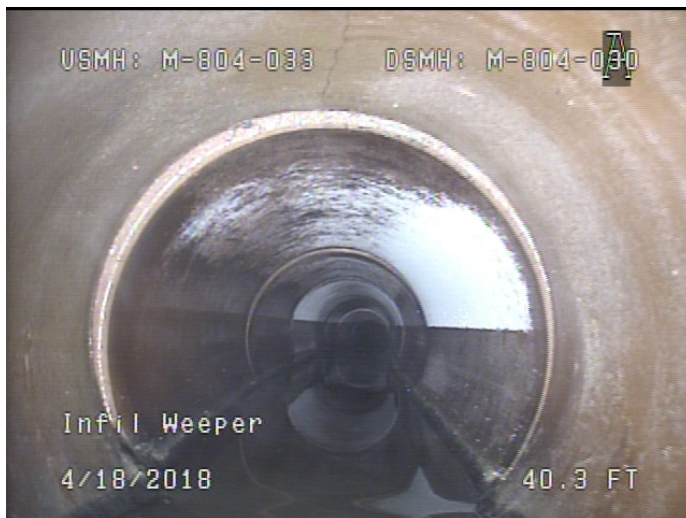
| Code: | IW |
| Description: | Infil Weeper |
| Distance (ft): | 40.3 |
| O&M Grade: | 2 |
| Within 8" of Joint: | YES |

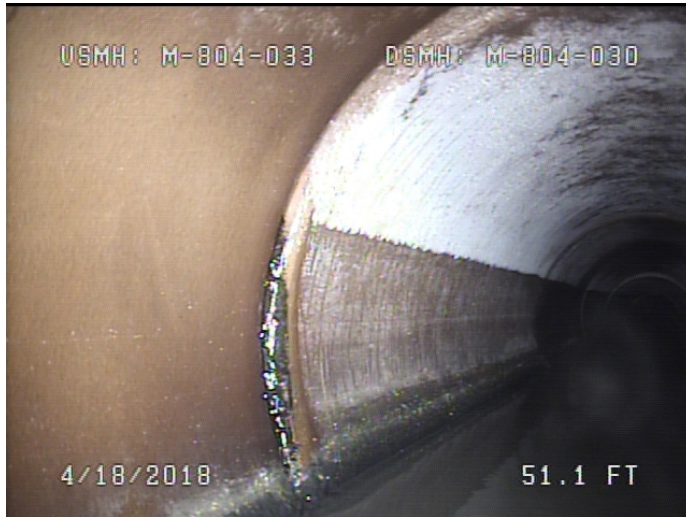
Code: **IR**
 Description: **Infil Runner**

Distance (ft): **51.1**
 Structural Grade: **0**
 O&M Grade: **4**
 Clock Start/From: **9**
 Clock To:
 1st Value:
 2nd Value:
 Value Percent:
 Continuous Index:
 Within 8" of Joint: **YES**
 Remarks:

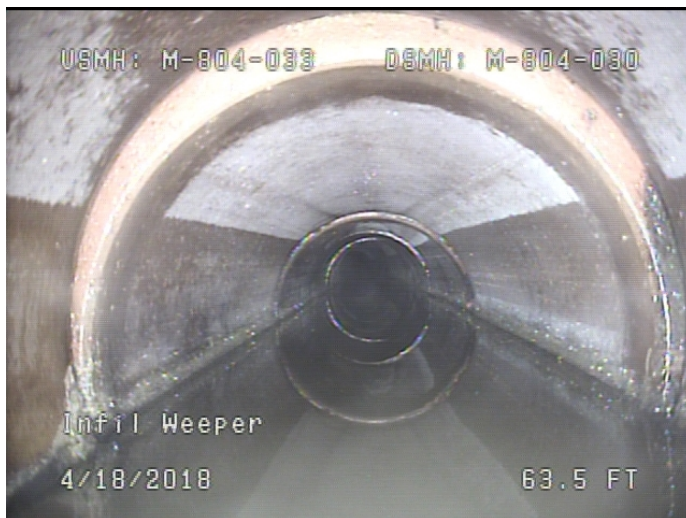
Code: **IW**
 Description: **Infil Weeper**

Distance (ft): **63.5**
 Structural Grade: **0**
 O&M Grade: **2**
 Clock Start/From: **3**
 Clock To: **8**
 1st Value:
 2nd Value:
 Value Percent:
 Continuous Index: **S03**
 Within 8" of Joint: **YES**
 Remarks:

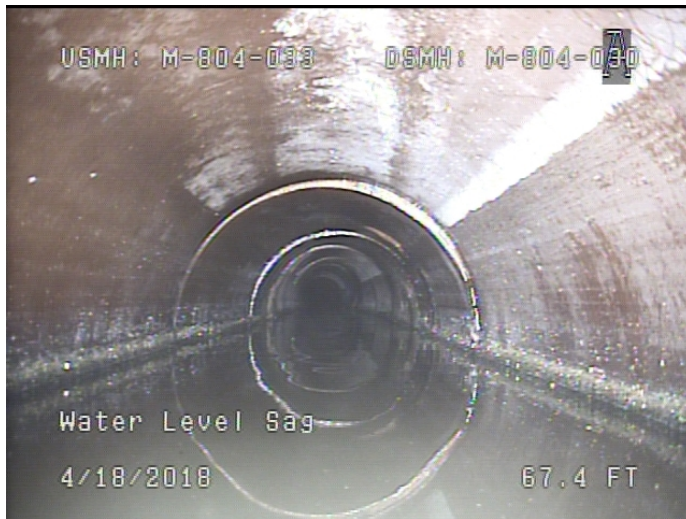
Code: **MWLS**
 Description: **Water Level Sag**

Distance (ft): **67.4**
 Structural Grade: **3**
 O&M Grade: **3**
 Clock Start/From:
 Clock To:
 1st Value:
 2nd Value:
 Value Percent: **35.000**
 Continuous Index: **S04**
 Within 8" of Joint: **NO**
 Remarks:

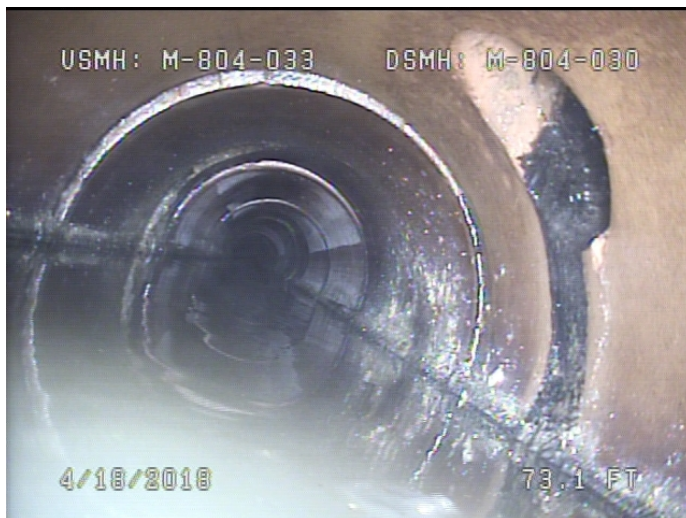
Code: **TFD**
 Description: **Tap Factory Defective**

Distance (ft): **73.1**
 Structural Grade: **0**
 O&M Grade: **2**
 Clock Start/From: **1**
 Clock To:
 1st Value: **4.000**
 2nd Value:
 Value Percent:
 Continuous Index:
 Within 8" of Joint: **NO**
 Remarks: **Defective**

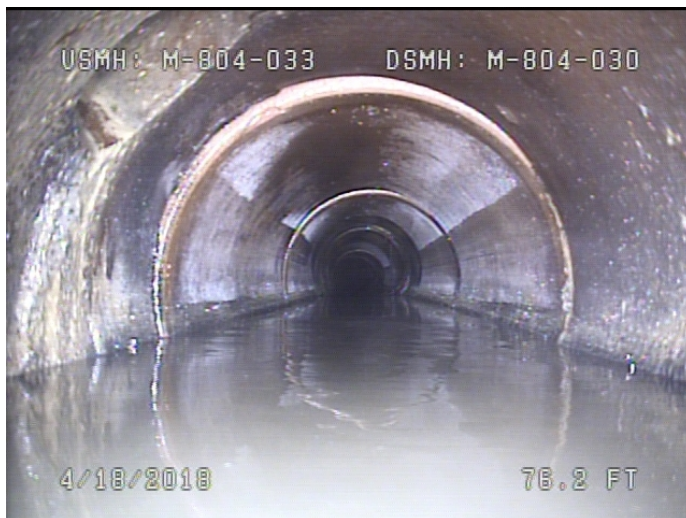
| Code: | TFD |
| Description: | Tap Factory Defective |
| Distance (ft): | 76.2 |
| O&M Grade: | 2 |
| Remarks: | hole in tap |

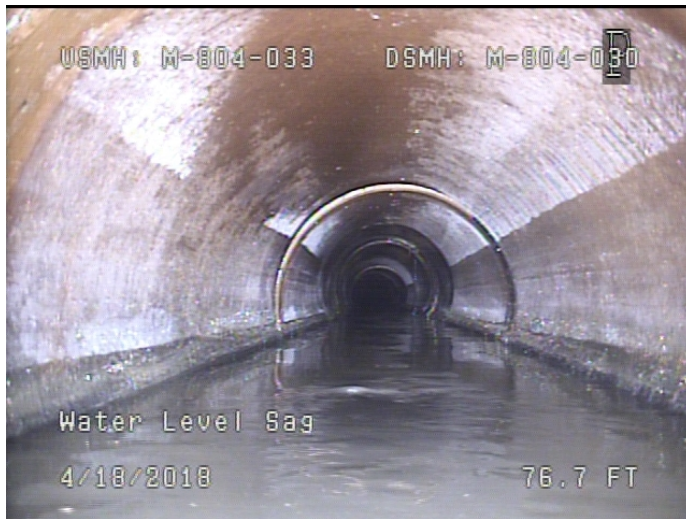
Code: **MWLS**
 Description: **Water Level Sag**

Distance (ft): **76.7**
 Structural Grade: **3**
 O&M Grade: **3**
 Clock Start/From:
 Clock To:
 1st Value:
 2nd Value:
 Value Percent: **35.000**
 Continuous Index: **F04**
 Within 8" of Joint: **NO**
 Remarks:

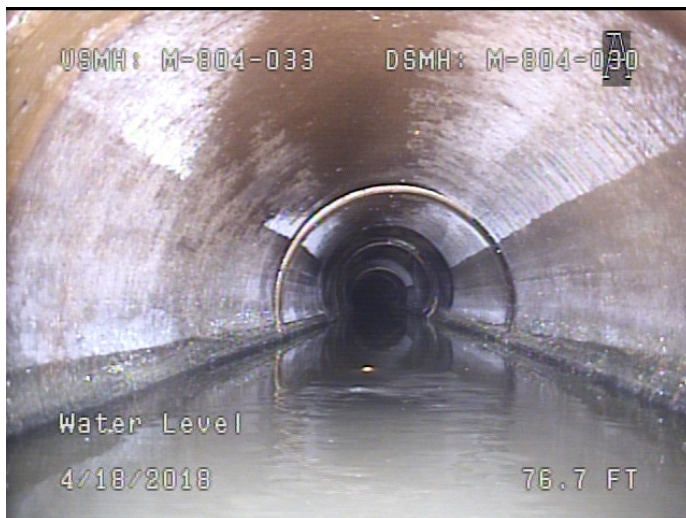
Code: **MWL**
 Description: **Water Level**

Distance (ft): **76.7**
 Structural Grade: **0**
 O&M Grade: **0**
 Clock Start/From:
 Clock To:
 1st Value:
 2nd Value:
 Value Percent: **20.000**
 Continuous Index:
 Within 8" of Joint: **NO**
 Remarks:

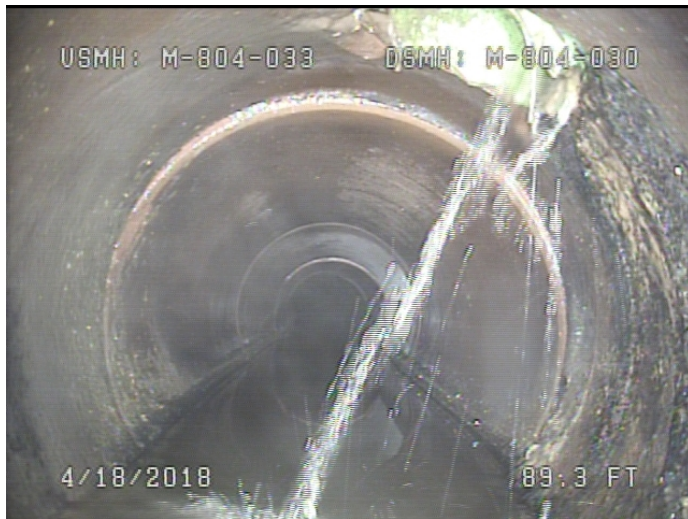
| Code: | TBD |
| Description: | Tap Break-in Defective |
| Distance (ft): | 89.3 |
| O&M Grade: | 3 |
| Remarks: | infil around tap |

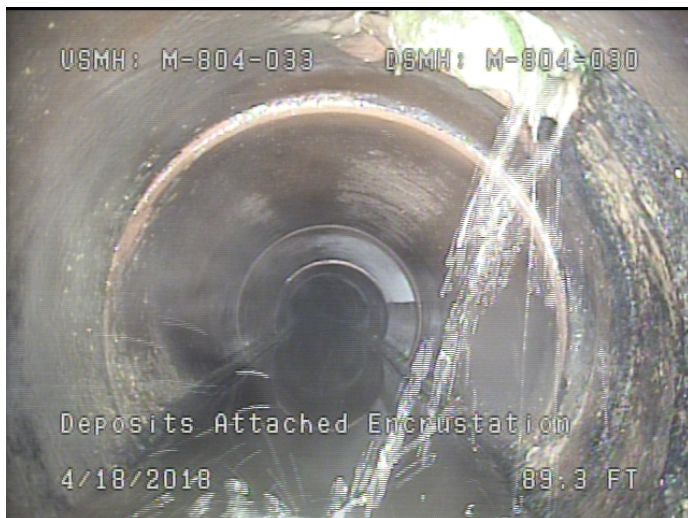
| Code: | DAE |
| Description: | Deposits Attached Encrustation |
| Distance (ft): | 89.3 |
| O&M Grade: | 2 |
| Value Percent: | 10.000 |

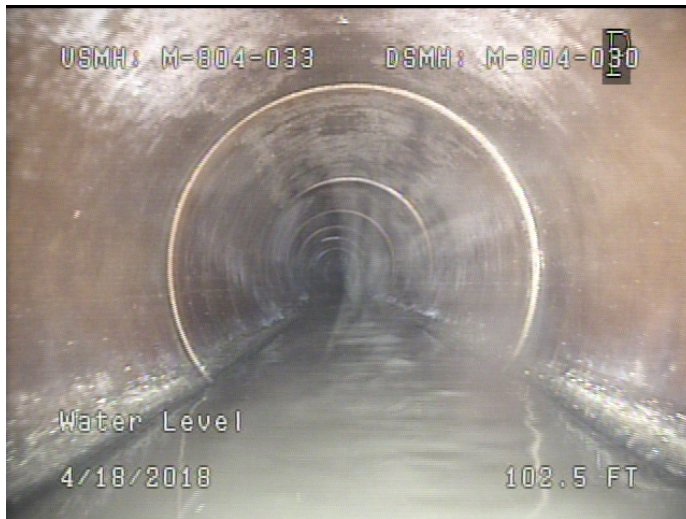
| Code: | MWL |
| Description: | Water Level |

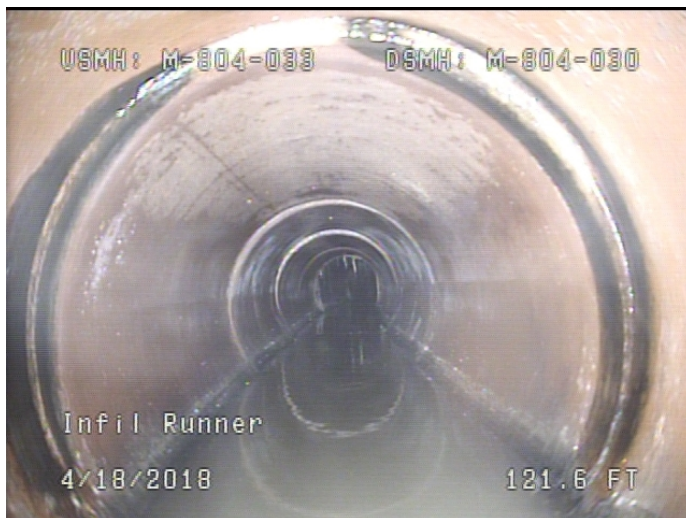
| Code: | IR |
| Description: | Infil Runner |
| Distance (ft): | 121.6 |
| O&M Grade: | 4 |
| Within 8" of Joint: | YES |

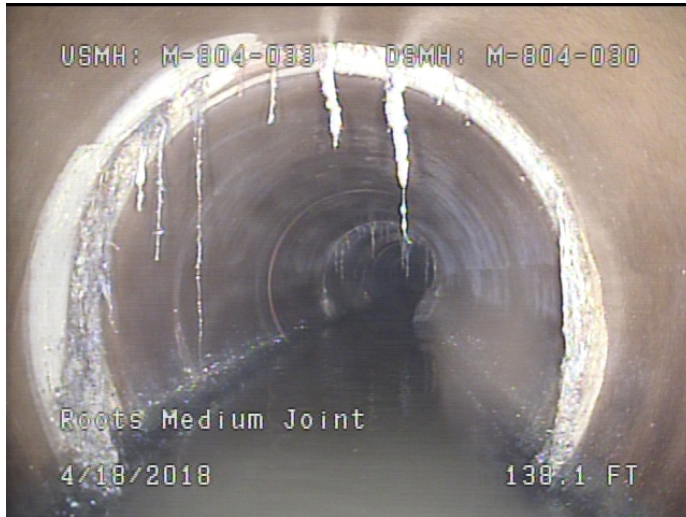
| Code: | RMJ |
| Description: | Roots Medium Joint |
| Distance (ft): | 138.1 |
| O&M Grade: | 3 |
| Value Percent: | 15.000 |

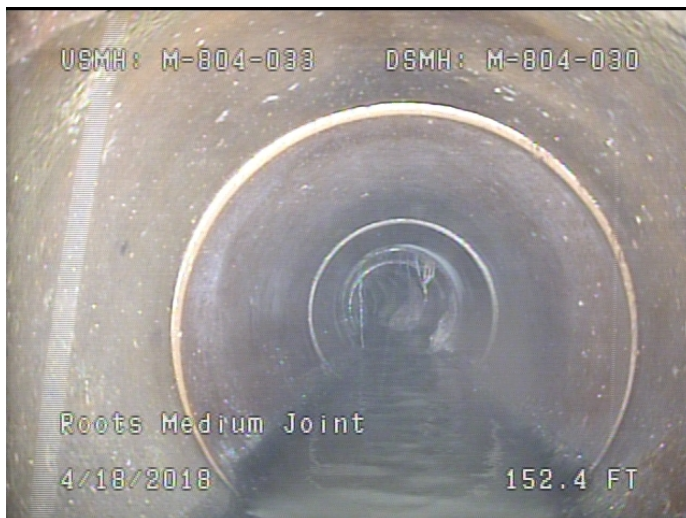
| Code: | RMJ |
| Description: | Roots Medium Joint |
| Distance (ft): | 152.4 |
| O&M Grade: | 3 |
| Value Percent: | 15.000 |

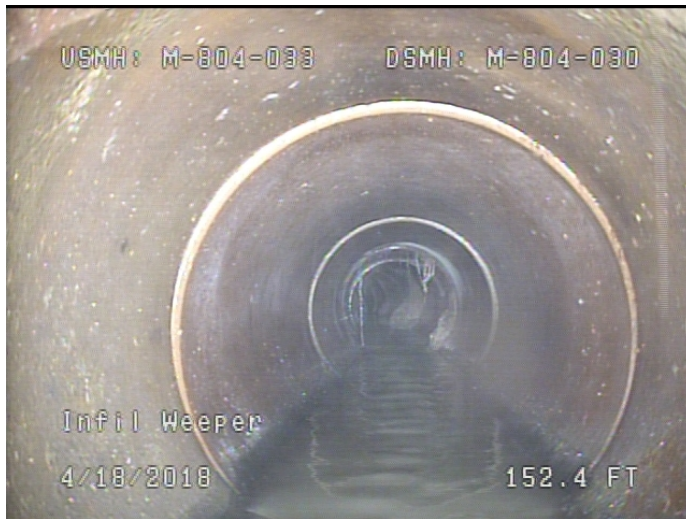
Code: **IW**
 Description: **Infil Weeper**

Distance (ft): **152.4**
 Structural Grade: **0**
 O&M Grade: **2**
 Clock Start/From: **3**
 Clock To: **8**
 1st Value:
 2nd Value:
 Value Percent:
 Continuous Index: **F03**
 Within 8" of Joint: **YES**
 Remarks:

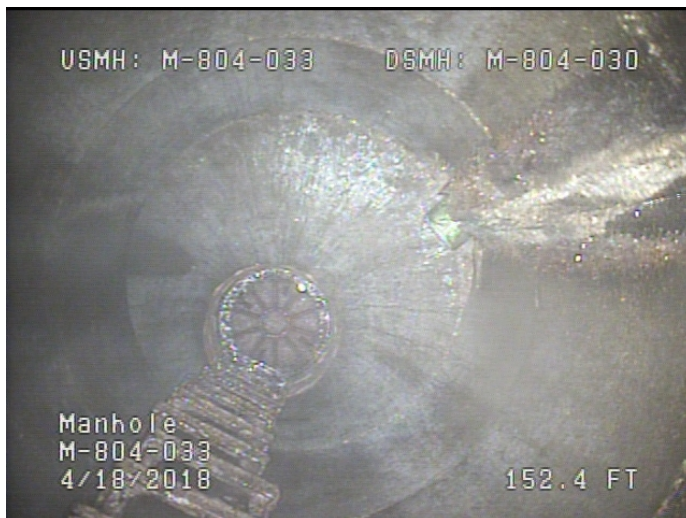
Code: **AMH**
 Description: **Manhole**

Distance (ft): **152.4**
 Structural Grade: **0**
 O&M Grade: **0**
 Clock Start/From:
 Clock To:
 1st Value:
 2nd Value:
 Value Percent:
 Continuous Index:
 Within 8" of Joint: **NO**
 Remarks: **M-804-033**
