Profile/Photo Observation Report

Street:	223 N Hobart Rd	Flow Control:	Not Controlled
City:	Hobart In	Year Renewed:	
Location:	Easement/Right of Way	Tape/Media #:	Deliverable 1
Purpose:	Routine Assessment	Dia/Height:	18"
Use:	Sanitary	Material:	VCP
Drain Area:	Northeast	Lining:	
Category:	NA		
Comment:	416-1/Reverse setup due to roots.		
Location Details:	Grass between homes	Direction of Survey:	Downstream
US MH:	M-804-034	DS MH:	M-804-033
		Total Length Surveyed (ft):	201.6

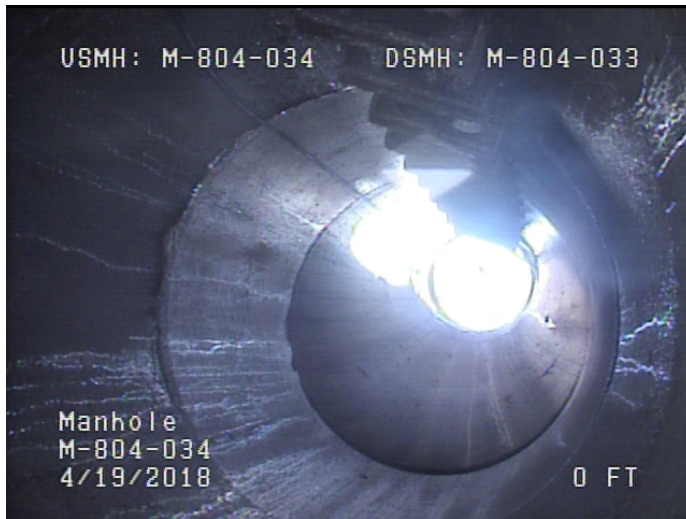
Code:	AMH
Description:	Manhole
Distance (ft):	.0
Structural Grade:	0
O&M Grade:	0
Clock Start/From:	
Clock To:	
1st Value:	
2nd Value:	
Value Percent:	
Continuous Index:	
Within 8" of Joint:	NO
Remarks:	M-804-034

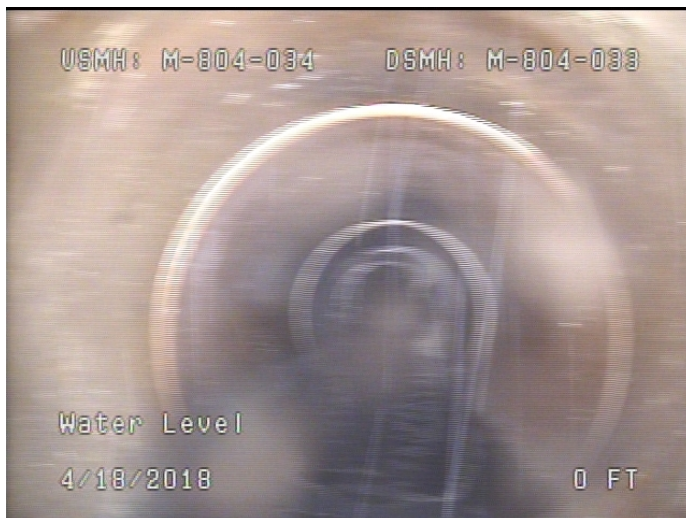
Code:	MWL
Description:	Water Level
Distance (ft):	.0
Structural Grade:	0
O&M Grade:	0
Clock Start/From:	
Clock To:	
1st Value:	
2nd Value:	
Value Percent:	15.000
Continuous Index:	
Within 8" of Joint:	NO
Remarks:

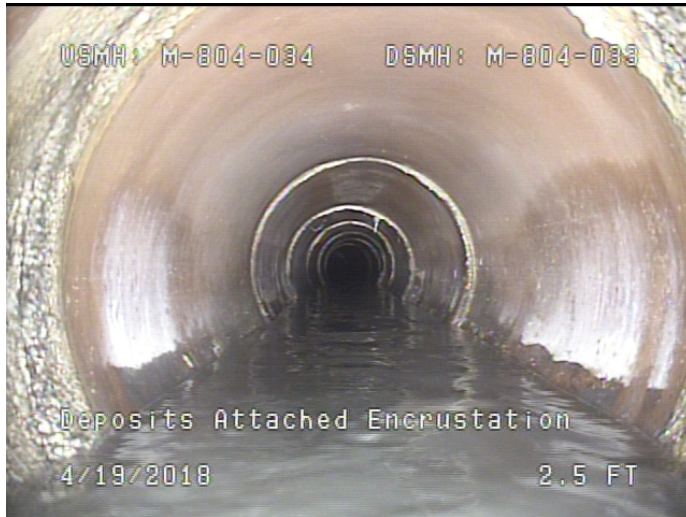
Code:	DAE
Description:	Deposits Attached Encrustation
Distance (ft):	2.5
Structural Grade:	0
O&M Grade:	2
Clock Start/From:	8
Clock To:	4
1st Value:	
2nd Value:	
Value Percent:	10.000
Continuous Index:	S01
Within 8" of Joint:	YES
Remarks:

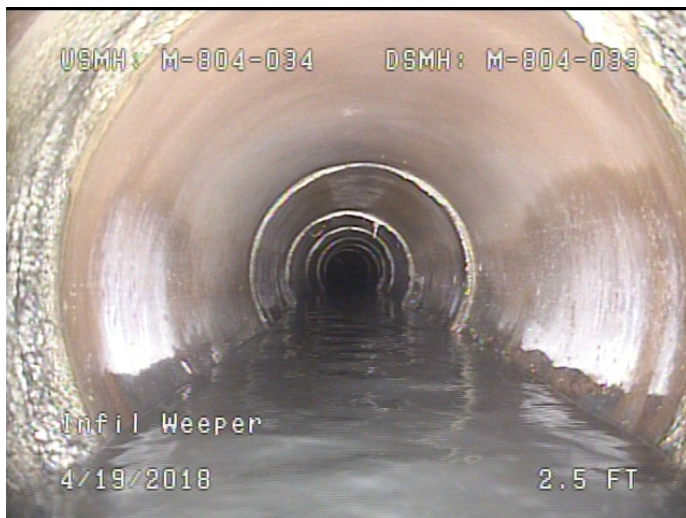
Code:	IW
Description:	Infil Weeper
Distance (ft):	2.5
Structural Grade:	0
O&M Grade:	2
Clock Start/From:	8
Clock To:	4
1st Value:	
2nd Value:	
Value Percent:	
Continuous Index:	S02
Within 8" of Joint:	YES
Remarks:

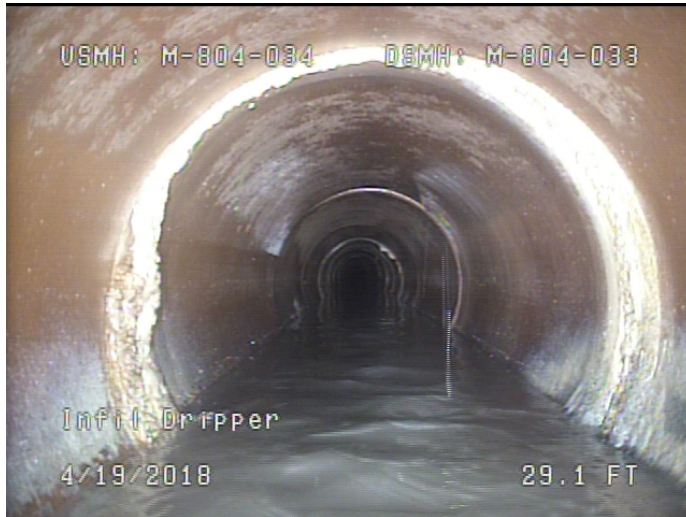
Code:	ID
Description:	Infil Dripper
Distance (ft):	29.1
Structural Grade:	0
O&M Grade:	3
Clock Start/From:	1
Clock To:	
1st Value:	
2nd Value:	
Value Percent:	
Continuous Index:	
Within 8" of Joint:	YES
Remarks:

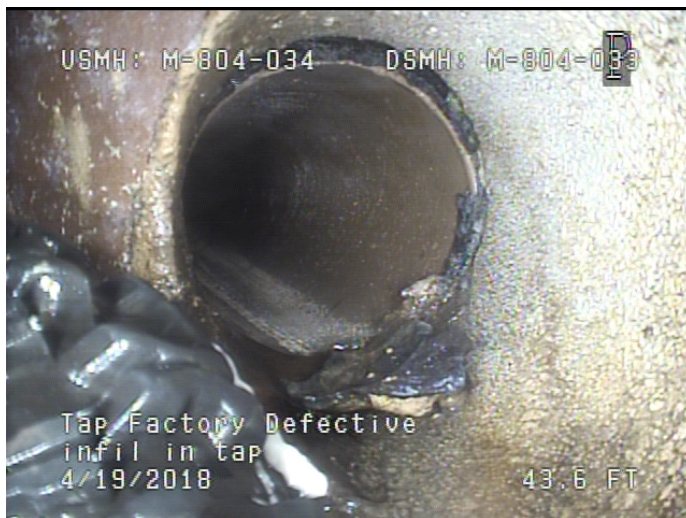
Code:	TFD
Description:	Tap Factory Defective
Distance (ft):	43.6
Structural Grade:	0
O&M Grade:	2
Clock Start/From:	10
Clock To:	
1st Value:	4.000
2nd Value:	
Value Percent:	
Continuous Index:	
Within 8" of Joint:	NO
Remarks:	infil in tap

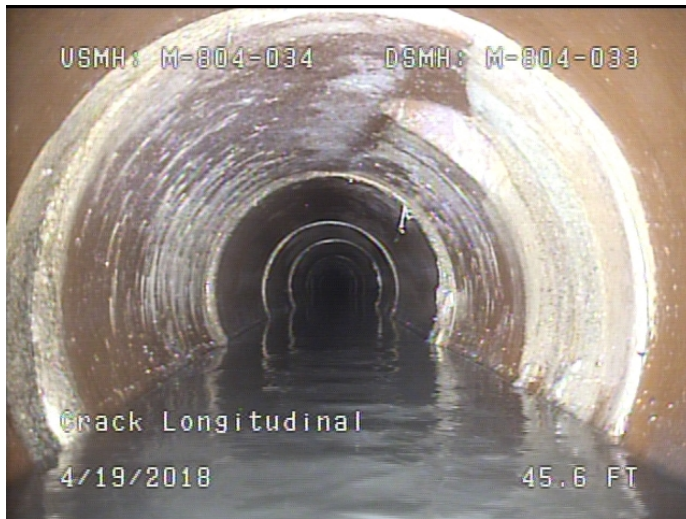
Code: **CL**
 Description: **Crack Longitudinal**

Distance (ft): **45.6**
 Structural Grade: **2**
 O&M Grade: **0**
 Clock Start/From: **1**
 Clock To:
 1st Value:
 2nd Value:
 Value Percent:
 Continuous Index:
 Within 8" of Joint: **YES**
 Remarks:

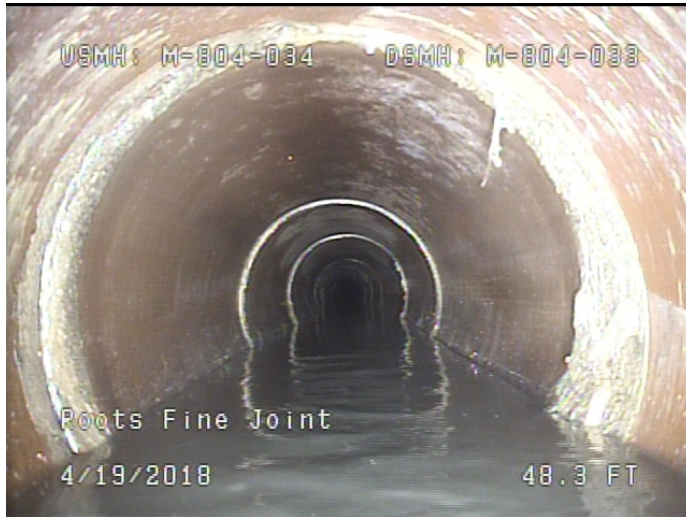
Code:	RFJ
Description:	Roots Fine Joint
Distance (ft):	48.3
Structural Grade:	0
O&M Grade:	1
Clock Start/From:	1
Clock To:	
1st Value:	
2nd Value:	
Value Percent:	
Continuous Index:	
Within 8" of Joint:	YES
Remarks:

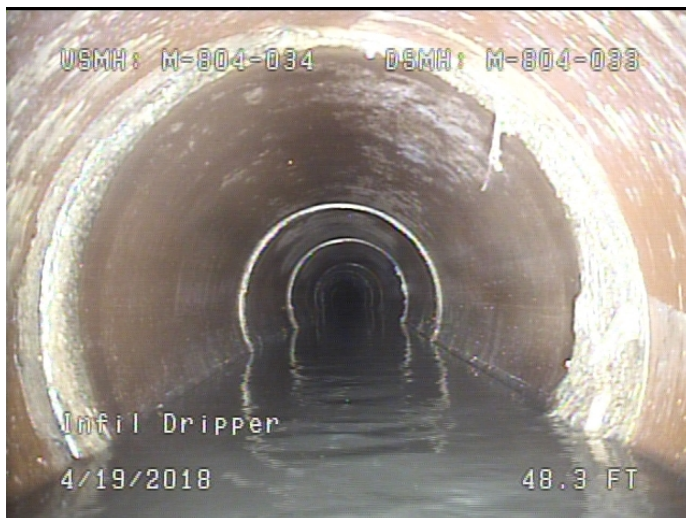
Code:	ID
Description:	Infil Dripper
Distance (ft):	48.3
Structural Grade:	0
O&M Grade:	3
Clock Start/From:	1
Clock To:	
1st Value:	
2nd Value:	
Value Percent:	
Continuous Index:	
Within 8" of Joint:	YES
Remarks:

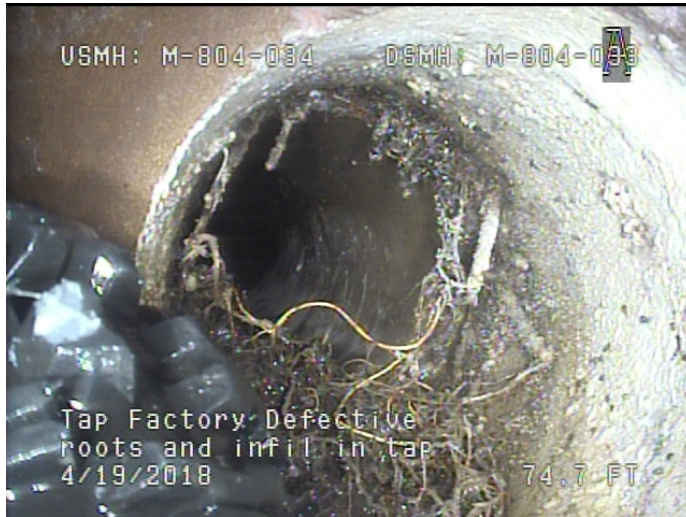
Code:	TFD
Description:	Tap Factory Defective
Distance (ft):	74.7
Structural Grade:	0
O&M Grade:	2
Clock Start/From:	10
Clock To:	
1st Value:	4.000
2nd Value:	
Value Percent:	
Continuous Index:	
Within 8" of Joint:	NO
Remarks:	roots and infill in tap

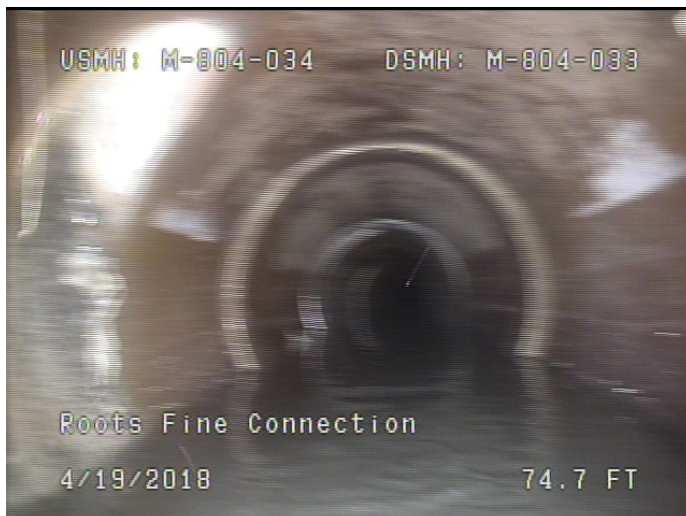
Code:	RFC
Description:	Roots Fine Connection
Distance (ft):	74.7
Structural Grade:	0
O&M Grade:	1
Clock Start/From:	9
Clock To:	
1st Value:	
2nd Value:	
Value Percent:	
Continuous Index:	
Within 8" of Joint:	NO
Remarks:

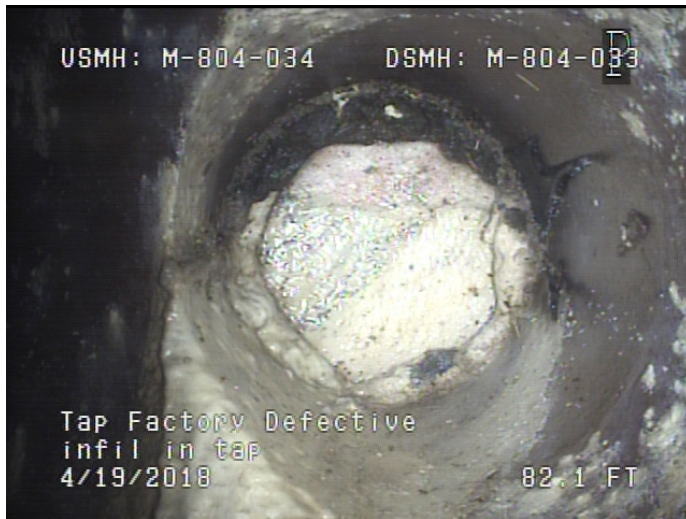
Code: TFD
Description: Tap Factory Defective

Distance (ft): 82.1
Structural Grade: 0
O&M Grade: 2
Clock Start/From: 10
Clock To:
1st Value: 4.000
2nd Value:
Value Percent:
Continuous Index:
Within 8" of Joint: NO
Remarks: infil in tap

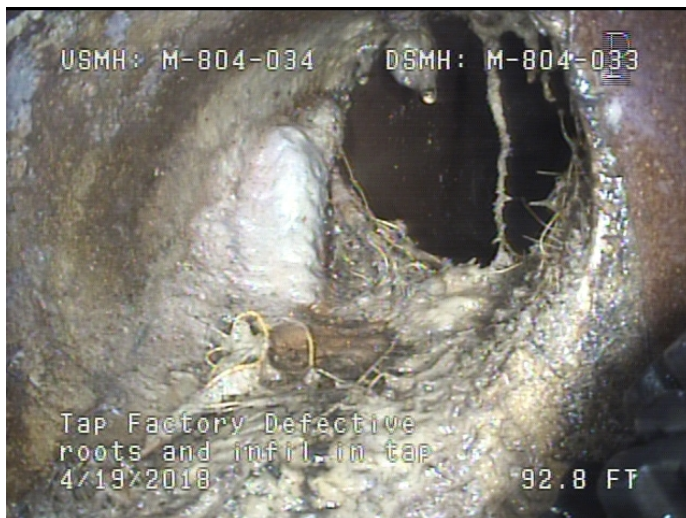
Code: TFD
Description: Tap Factory Defective

Distance (ft): 92.8
Structural Grade: 0
O&M Grade: 2
Clock Start/From: 2
Clock To:
1st Value: 4.000
2nd Value:
Value Percent:
Continuous Index:
Within 8" of Joint: NO
Remarks: roots and infil in tap

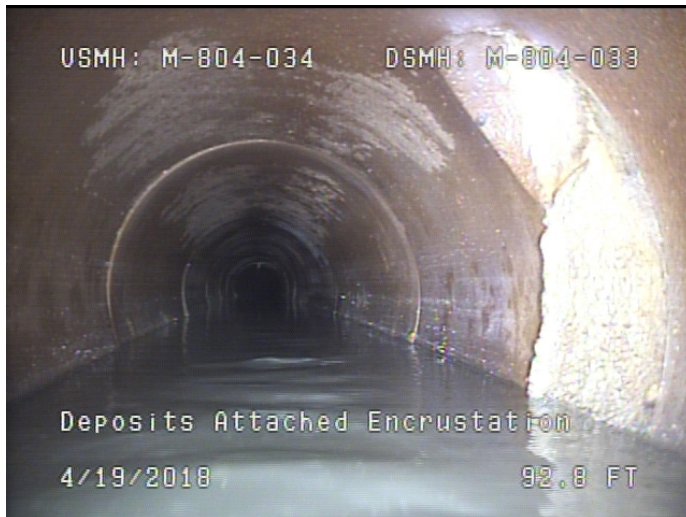
Code:	DAE
Description:	Deposits Attached Encrustation
Distance (ft):	92.8
Structural Grade:	0
O&M Grade:	3
Clock Start/From:	3
Clock To:	5
1st Value:	
2nd Value:	
Value Percent:	15.000
Continuous Index:	
Within 8" of Joint:	NO
Remarks:

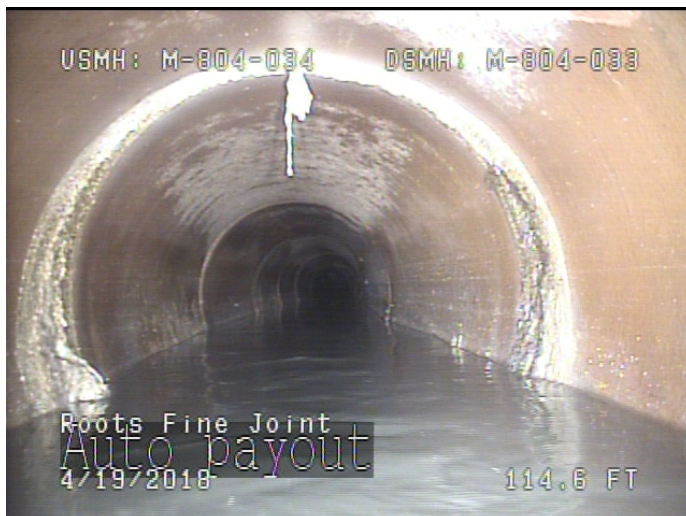
Code:	RFJ
Description:	Roots Fine Joint
Distance (ft):	114.6
Structural Grade:	0
O&M Grade:	1
Clock Start/From:	12
Clock To:	
1st Value:	
2nd Value:	
Value Percent:	
Continuous Index:	
Within 8" of Joint:	YES
Remarks:

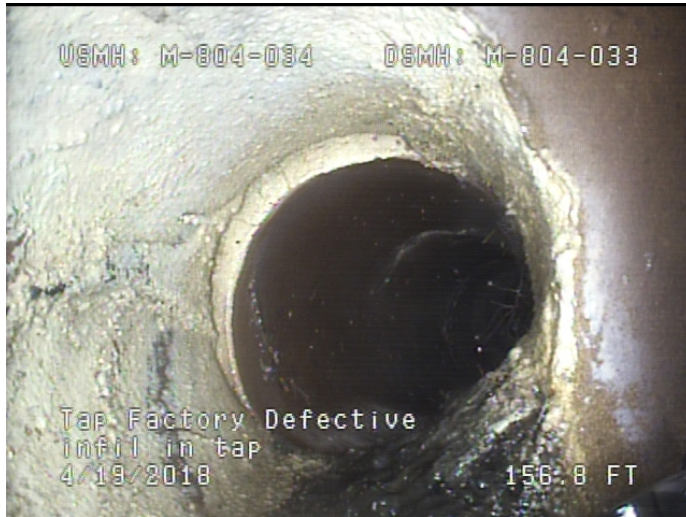
Code: **TFD**
 Description: **Tap Factory Defective**

Distance (ft): **156.8**
 Structural Grade: **0**
 O&M Grade: **2**
 Clock Start/From: **2**
 Clock To:
 1st Value: **4.000**
 2nd Value:
 Value Percent:
 Continuous Index:
 Within 8" of Joint: **NO**
 Remarks: **infil in tap**

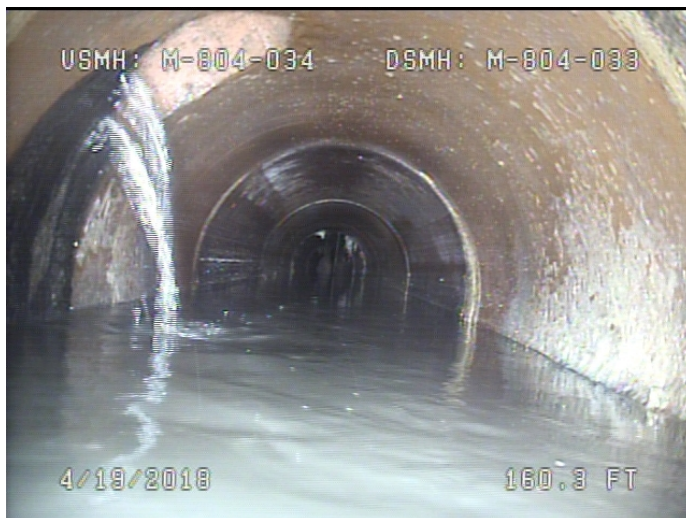
Code: **TFD**
 Description: **Tap Factory Defective**

Distance (ft): **160.3**
 Structural Grade: **0**
 O&M Grade: **2**
 Clock Start/From: **10**
 Clock To:
 1st Value: **4.000**
 2nd Value:
 Value Percent:
 Continuous Index:
 Within 8" of Joint: **NO**
 Remarks: **hole and major infil in tap**

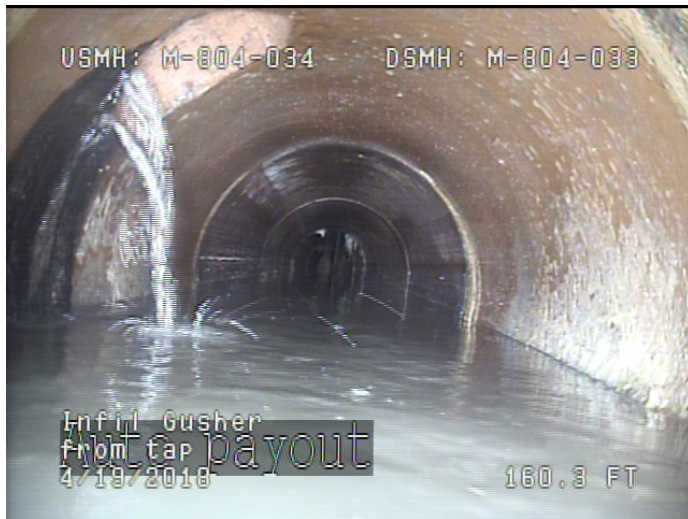
Code:	IG
Description:	Infil Gusher
Distance (ft):	160.3
Structural Grade:	0
O&M Grade:	5
Clock Start/From:	10
Clock To:	
1st Value:	
2nd Value:	
Value Percent:	
Continuous Index:	
Within 8" of Joint:	NO
Remarks:	from tap

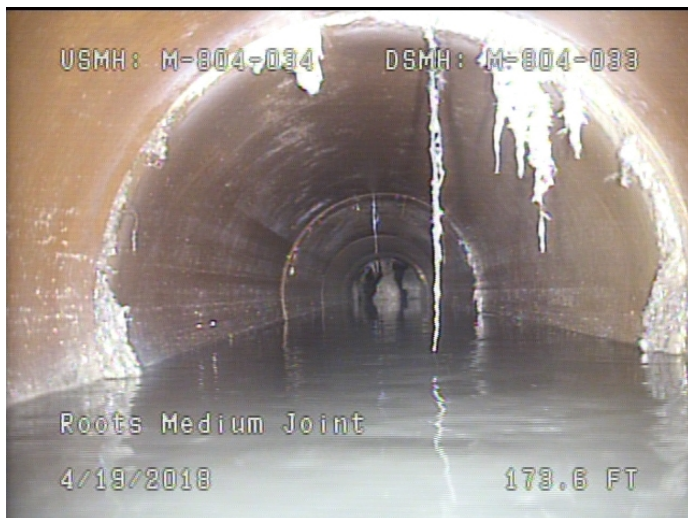
Code:	RMJ
Description:	Roots Medium Joint
Distance (ft):	173.6
Structural Grade:	0
O&M Grade:	3
Clock Start/From:	8
Clock To:	2
1st Value:	
2nd Value:	
Value Percent:	10.000
Continuous Index:	S03
Within 8" of Joint:	YES
Remarks:

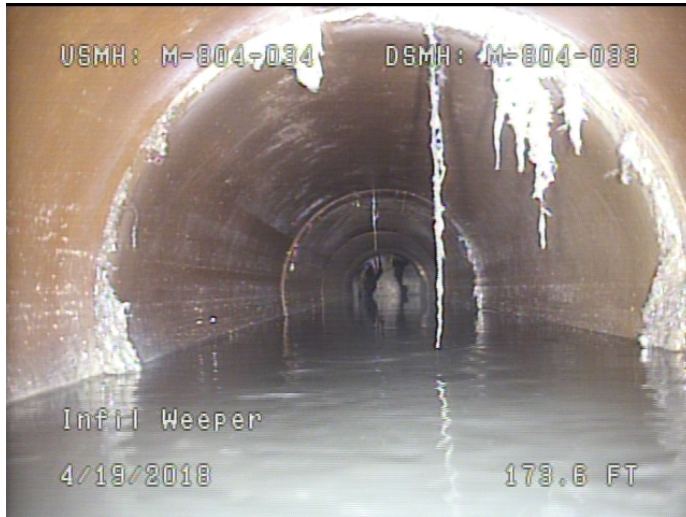
Code:	IW
Description:	Infil Weeper
Distance (ft):	173.6
Structural Grade:	0
O&M Grade:	2
Clock Start/From:	8
Clock To:	4
1st Value:	
2nd Value:	
Value Percent:	
Continuous Index:	F02
Within 8" of Joint:	YES
Remarks:

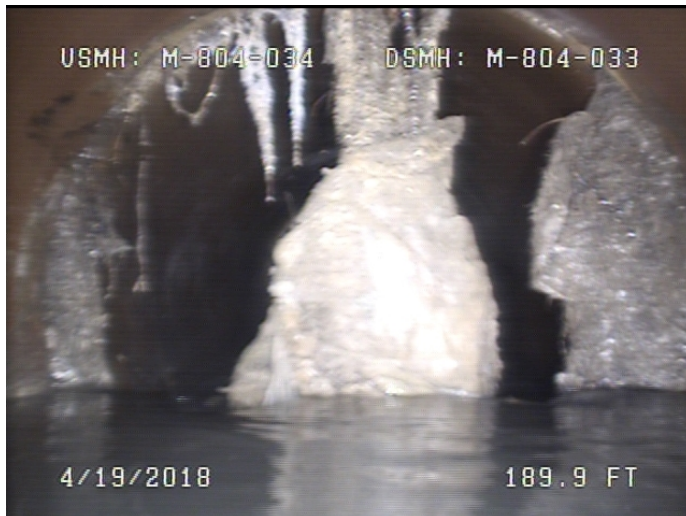
Code:	ID
Description:	Infil Dripper
Distance (ft):	173.6
Structural Grade:	0
O&M Grade:	3
Clock Start/From:	11
Clock To:	1
1st Value:	
2nd Value:	
Value Percent:	
Continuous Index:	S04
Within 8" of Joint:	YES
Remarks:

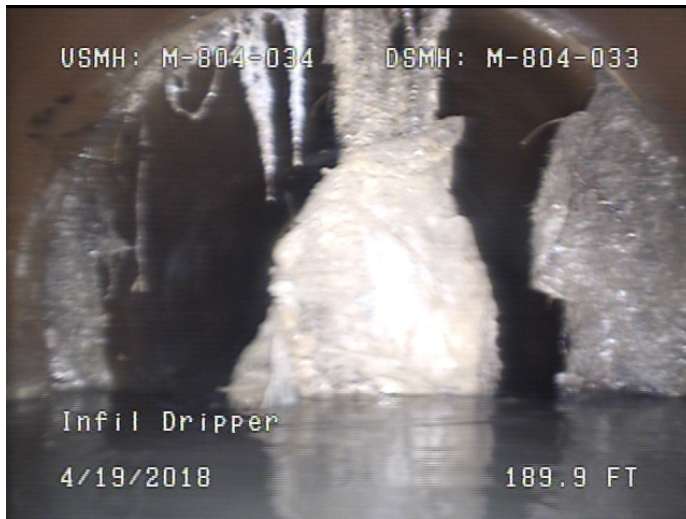
Code:	ID
Description:	Infil Dripper
Distance (ft):	189.9
Structural Grade:	0
O&M Grade:	3
Clock Start/From:	11
Clock To:	1
1st Value:	
2nd Value:	
Value Percent:	
Continuous Index:	F04
Within 8" of Joint:	YES
Remarks:

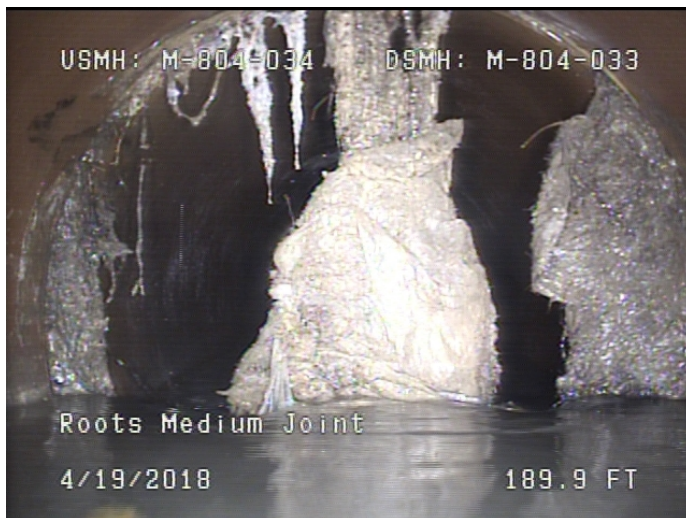
Code:	RMJ
Description:	Roots Medium Joint
Distance (ft):	189.9
Structural Grade:	0
O&M Grade:	3
Clock Start/From:	8
Clock To:	4
1st Value:	
2nd Value:	
Value Percent:	40.000
Continuous Index:	
Within 8" of Joint:	YES
Remarks:

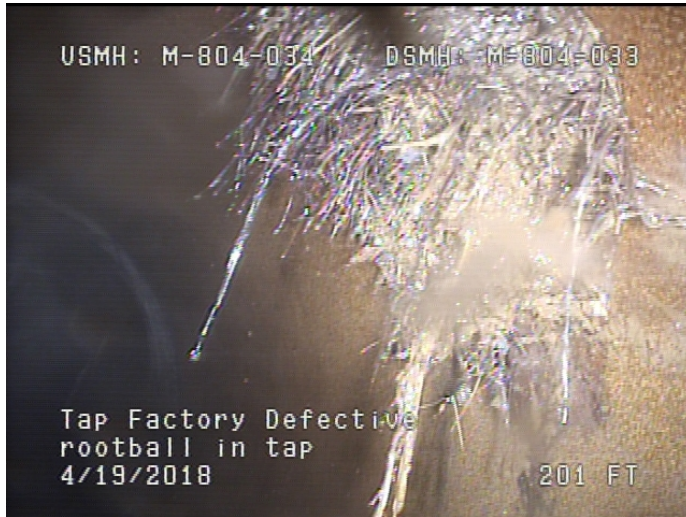
Code:	TFD
Description:	Tap Factory Defective
Distance (ft):	201.0
Structural Grade:	0
O&M Grade:	2
Clock Start/From:	2
Clock To:	
1st Value:	4.000
2nd Value:	
Value Percent:	
Continuous Index:	
Within 8" of Joint:	NO
Remarks:	rootball in tap

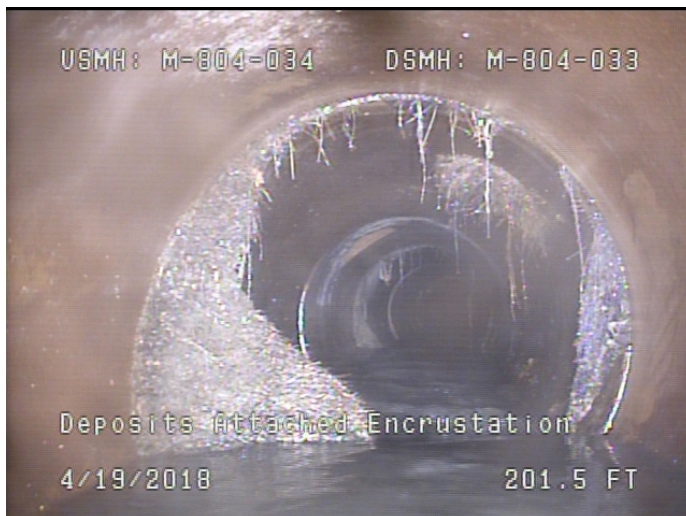
Code:	DAE
Description:	Deposits Attached Encrustation
Distance (ft):	201.5
Structural Grade:	0
O&M Grade:	2
Clock Start/From:	8
Clock To:	4
1st Value:	
2nd Value:	
Value Percent:	10.000
Continuous Index:	F01
Within 8" of Joint:	YES
Remarks:

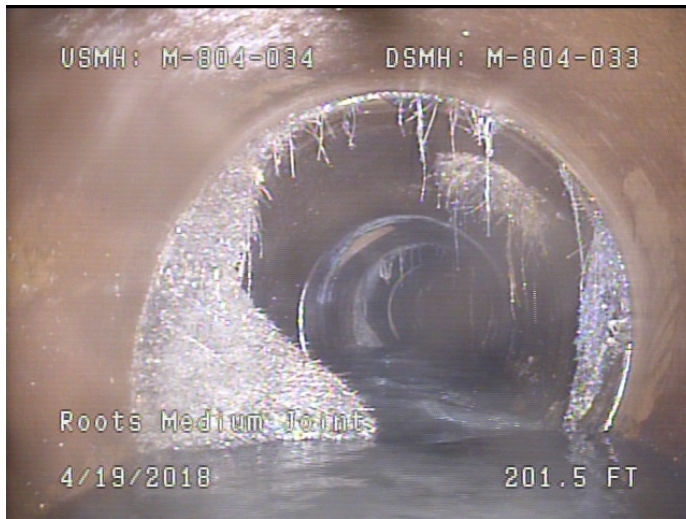
Code: **RMJ**
 Description: **Roots Medium Joint**

Distance (ft): **201.5**
 Structural Grade: **0**
 O&M Grade: **3**
 Clock Start/From: **8**
 Clock To: **2**
 1st Value:
 2nd Value:
 Value Percent: **10.000**
 Continuous Index: **F03**
 Within 8" of Joint: **YES**
 Remarks:

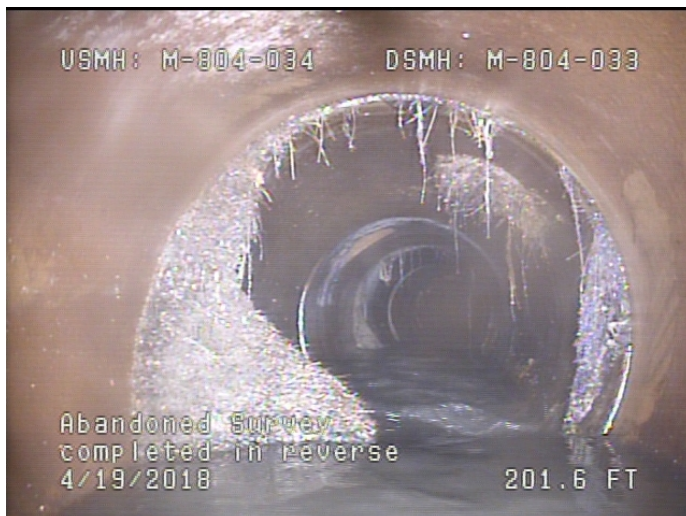
Code: **MSA**
 Description: **Abandoned Survey**

Distance (ft): **201.6**
 Structural Grade: **0**
 O&M Grade: **0**
 Clock Start/From:
 Clock To:
 1st Value:
 2nd Value:
 Value Percent:
 Continuous Index:
 Within 8" of Joint: **NO**
 Remarks: **completed in reverse**
