Date:	04/19/2018	Weather:		Coding:	PACP 4.2
Pipe Length (ft):	166.5	Owner:	City of Hobart	Pre Clean:	No Pre-Cleaning
P.O.#:	2004	Surveyor:	SAN	PSR:	P-804-035-034
Customer:	Red Zone	Clean Date:		Shape:	С
Street:	232 N Hobart Rd		Flow Control:	Not Controlled	I
City:	Hobart In		Year Renewed:		
Location:	Easement/Right of	Way	Tape/Media #:	Deliverable 1	
Purpose:	Routine Assessmen	t	Dia/Height:	18"	
Use:	Sanitary		Material:	VCP	
Drain Area:	Northeast		Lining:		
Category:	NA				
Comment:	417-1				
Location Details:	Grass between hom	nes	Direction of Surve	ey: Upstream	
US MH:	M-804-035	DS MH:	M-804-034	Total Length Surveyed (ft): 166.5
0&M Index:	1.97	O&M Quick:	2L12	O&M Rating:	134.00
Structural Index:	0.00	 Structural Qu	uick: 0000	Structural Rating:	0.00
Overall Index:	1.97	Overall Quick	. 2L12	Overall Rating:	134.00

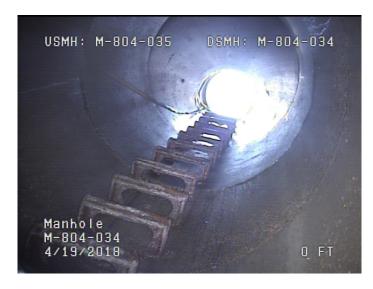
Code: Description:	AMH Manhole
Distance (ft):	.0
Structural Grade:	0
O&M Grade:	0
Clock Start/From:	
Clock To:	
1st Value:	
2nd Value:	
Value Percent:	
Continuous Index:	
Within 8" of Joint:	NO
Remarks:	M-804-034

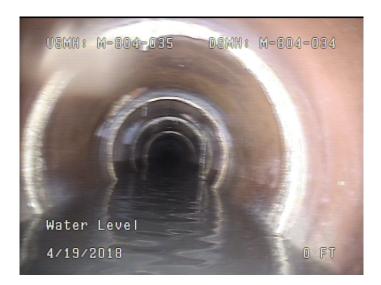
Code:	MWL
Description:	Water Level
	_
Distance (ft):	.0
Structural Grade:	0
O&M Grade:	0
Clock Start/From:	
Clock To:	
1st Value:	
2nd Value:	
Value Percent:	15.000
Continuous Index:	
Within 8" of Joint:	NO
Remarks:

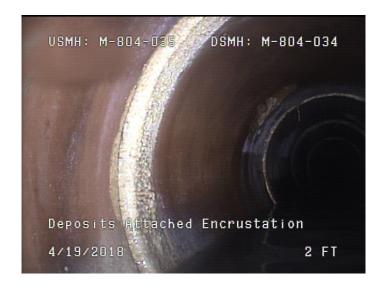
Code: Description:	DAE Deposits Attached Encrustation
Distance (ft): Structural Grade: O&M Grade: Clock Start/From: Clock To: 1st Value: 2nd Value: Value Percent: Continuous Index: Within 8" of Joint: Remarks:	2.0 0 2 8 4 10.000 S01 YES

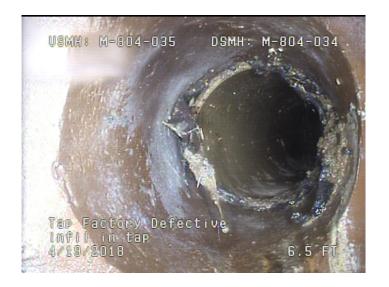
Code: Description:	TFD Tap Factory Defective
Distance (ft):	6.5
Structural Grade:	0
O&M Grade:	2
Clock Start/From:	10
Clock To:	
1st Value:	4.000
2nd Value:	
Value Percent:	
Continuous Index:	
Within 8" of Joint:	NO
Remarks:	infil in tap

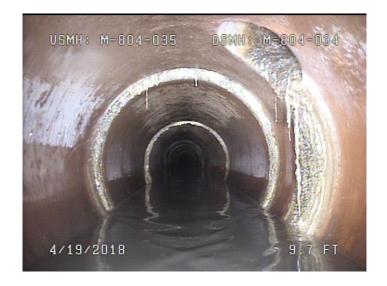
Code:	TFD
Description:	Tap Factory Defective
Distance (ft):	9.7
Structural Grade:	0
O&M Grade:	2
Clock Start/From: Clock To: 1st Value:	2 4.000
2nd Value: Value Percent: Continuous Index:	
Within 8" of Joint:	NO
Remarks:	roots and offset in tap

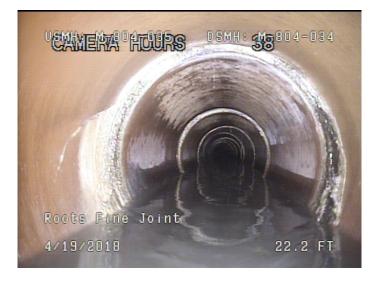
Code: Description:	RFJ Roots Fine Joint
Distance (ft):	22.2
Structural Grade:	0
O&M Grade:	1
Clock Start/From:	10
Clock To:	
1st Value:	
2nd Value:	
Value Percent:	
Continuous Index:	
Within 8" of Joint:	YES
Remarks:

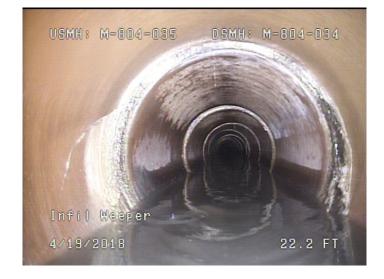
Code: Description:	IW Infil Weeper
Distance (ft): Structural Grade: O&M Grade: Clock Start/From: Clock To: 1st Value: 2nd Value: Value Percent: Continuous Index:	22.2 0 2 8 4 S02
Within 8" of Joint: Remarks:	YES

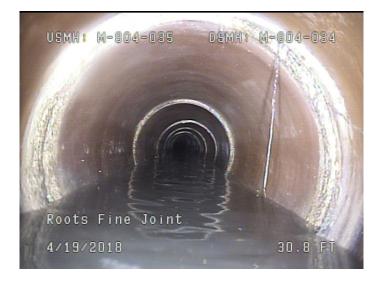
Code: Description:	RFJ Roots Fine Joint
Distance (ft):	30.8
Structural Grade:	0
O&M Grade:	1
Clock Start/From:	1
Clock To:	
1st Value:	
2nd Value:	
Value Percent:	
Continuous Index:	
Within 8" of Joint:	YES
Remarks:

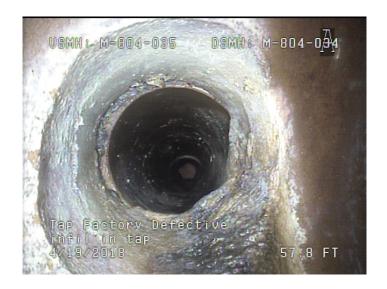
Code: Description:	TFD Tap Factory Defective
Distance (ft):	57.8
Structural Grade:	0
O&M Grade:	2
Clock Start/From:	10
Clock To:	
1st Value:	4.000
2nd Value:	
Value Percent:	
Continuous Index:	
Within 8" of Joint:	NO
Remarks:	infil in tap

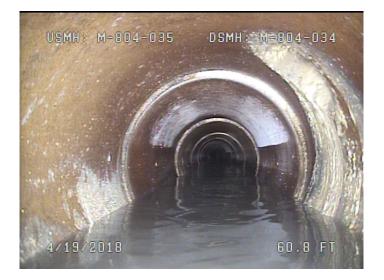
Code: Description:	TFD Tap Factory Defective
Distance (ft):	60.8
Structural Grade:	0
O&M Grade:	2
Clock Start/From:	2
Clock To:	
1st Value:	4.000
2nd Value:	
Value Percent:	
Continuous Index:	
Within 8" of Joint:	NO
Remarks:	infil in tap

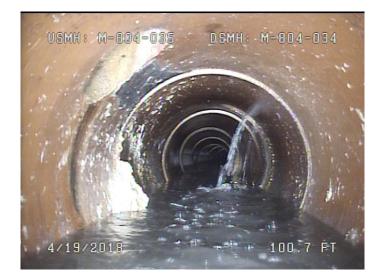
Code: Description:	TFD Tap Factory Defective
Distance (ft): Structural Grade:	100.7 0
O&M Grade:	2
Clock Start/From:	10
Clock To:	
1st Value:	4.000
2nd Value:	
Value Percent:	
Continuous Index:	
Within 8" of Joint:	NO
Remarks:	infil in tap

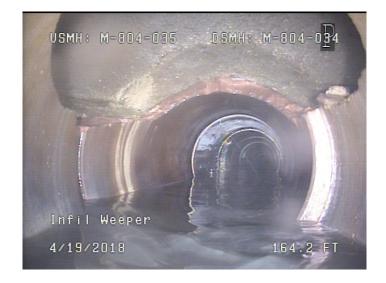
Code: Description:	IW Infil Weeper
Distance (ft): Structural Grade: O&M Grade: Clock Start/From: Clock To: 1st Value: 2nd Value: Value Percent: Continuous Index: Within 8" of Joint: Remarks:	164.2 0 2 8 4 F02 YES

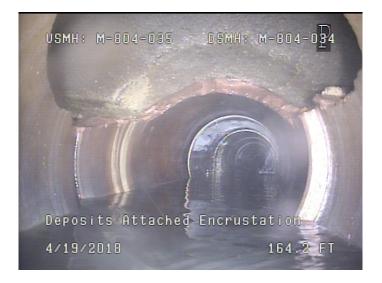
Code:DAEDescription:Deposits Attached Encrustation

Distance (ft):	164.2
Structural Grade:	0
O&M Grade:	2
Clock Start/From:	8
Clock To:	4
1st Value:	
2nd Value:	
Value Percent:	10.000
Continuous Index:	F01
Within 8" of Joint:	YES
Remarks:

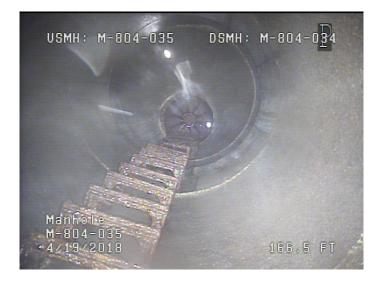
AMH Manhole
166.5
0
0
NO
M-804-035
