## Profile/Photo Observation Report

Street:	<b>OFF N HOBART RD</b>	Flow Control:	<b>Not Controlled</b>
City:	<b>Hobart, IN</b>	Year Renewed:	
Location:	<b>Other</b>	Tape/Media #:	
Purpose:	<b>Not Known</b>	Dia/Height:	<b>12"</b>
Use:	<b>Sanitary</b>	Material:	<b>VCP</b>
Drain Area:	<b>NA</b>	Lining:	
Category:	<b>NA</b>		
Comment:

Location Details:		Direction of Survey:	<b>Downstream</b>
US MH:	<b>M-804-038</b>	DS MH:	<b>M-804-037</b>
		Total Length Surveyed (ft):	<b>185.2</b>

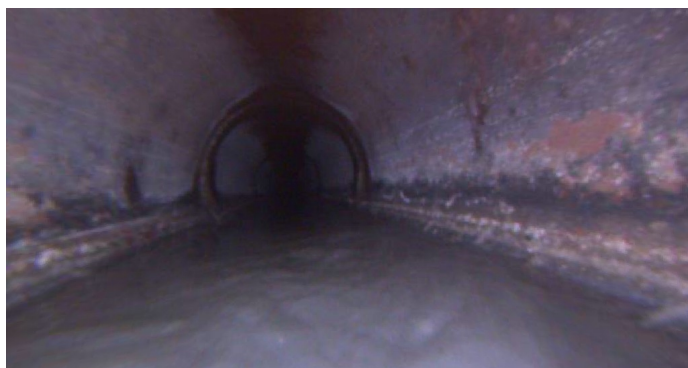
Code: **AMH**  
 Description: **Manhole**

Distance (ft): **.0**  
 Structural Grade: **0**  
 O&M Grade: **0**  
 Clock Start/From:  
 Clock To:  
 1st Value:  
 2nd Value:  
 Value Percent:  
 Continuous Index:  
 Within 8" of Joint: **NO**  
 Remarks: **M-804-038**

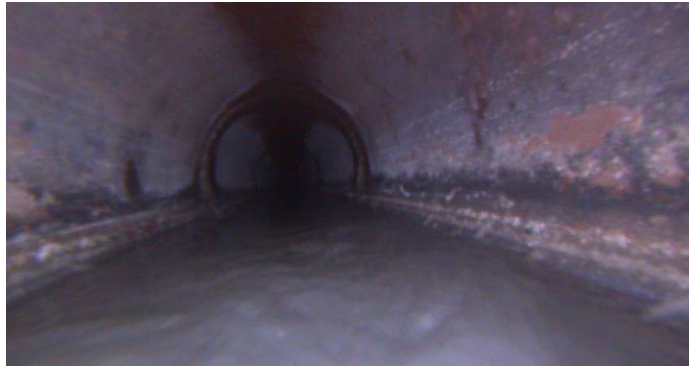
Code:	<b>MWL</b>
Description:	<b>Water Level</b>
Distance (ft):	<b>.0</b>
Structural Grade:	<b>0</b>
O&M Grade:	<b>0</b>
Clock Start/From:	
Clock To:	
1st Value:	
2nd Value:	
Value Percent:	<b>10.000</b>
Continuous Index:	
Within 8" of Joint:	<b>NO</b>
Remarks:

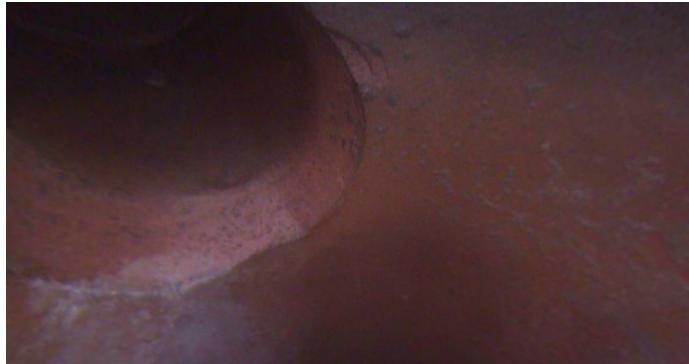
Code:	<b>TF</b>
Description:	<b>Tap Factory</b>
Distance (ft):	<b>15.1</b>
Structural Grade:	<b>0</b>
O&M Grade:	<b>0</b>
Clock Start/From:	<b>10</b>
Clock To:	
1st Value:	<b>4.000</b>
2nd Value:	
Value Percent:	
Continuous Index:	
Within 8" of Joint:	
Remarks:

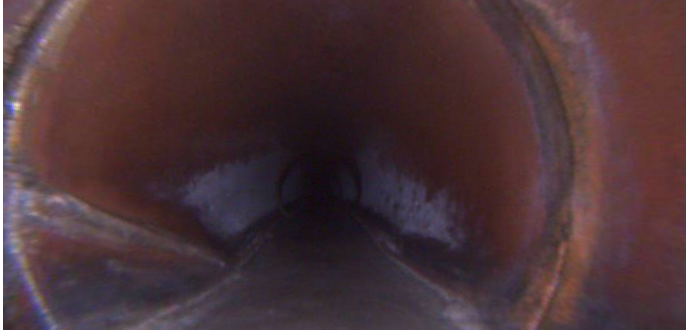
Code: **IS**  
Description: **Infil Stain**

Distance (ft): **34.9**  
Structural Grade: **0**  
O&M Grade: **0**  
Clock Start/From: **1**  
Clock To: **4**  
1st Value:  
2nd Value:  
Value Percent:  
Continuous Index:  
Within 8" of Joint: **YES**  
Remarks:

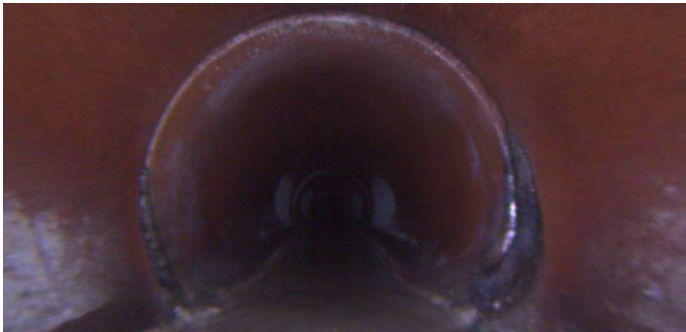
Code: **IW**  
Description: **Infil Weeper**

Distance (ft): **49.5**  
Structural Grade: **0**  
O&M Grade: **2**  
Clock Start/From: **8**  
Clock To: **4**  
1st Value:  
2nd Value:  
Value Percent:  
Continuous Index: **S01**  
Within 8" of Joint: **YES**  
Remarks:

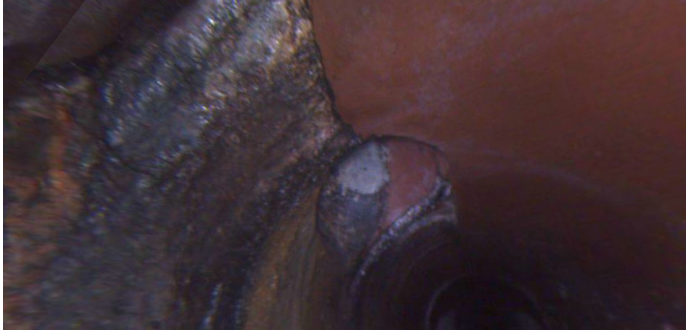
Code: **DAE**  
Description: **Deposits Attached Encrustation**

Distance (ft): **56.1**  
Structural Grade: **0**  
O&M Grade: **2**  
Clock Start/From: **7**  
Clock To: **11**  
1st Value:  
2nd Value:  
Value Percent: **5.000**  
Continuous Index:  
Within 8" of Joint: **NO**  
Remarks:

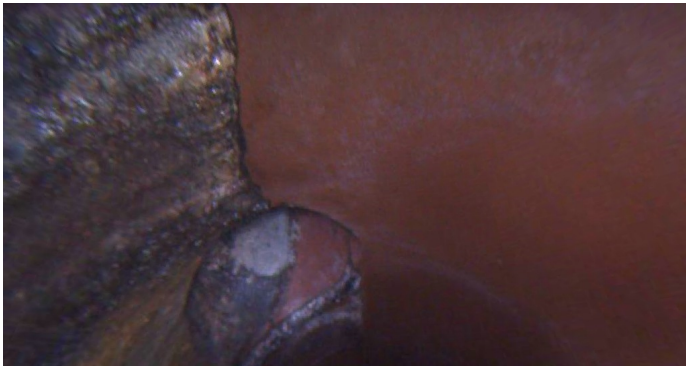
Code: **CL**  
Description: **Crack Longitudinal**

Distance (ft): **56.1**  
Structural Grade: **2**  
O&M Grade: **0**  
Clock Start/From: **11**  
Clock To:  
1st Value:  
2nd Value:  
Value Percent:  
Continuous Index:  
Within 8" of Joint:  
Remarks:

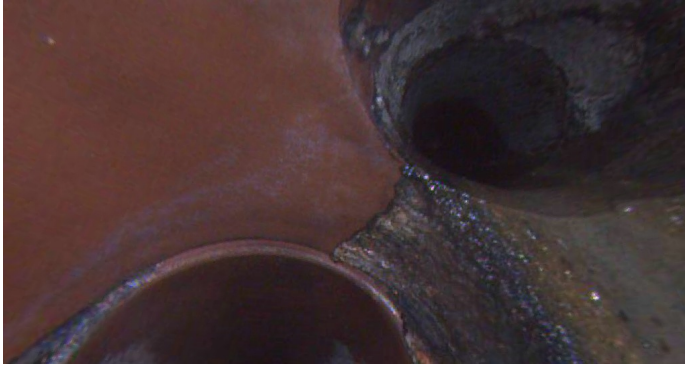
Code: **TF**  
Description: **Tap Factory**

Distance (ft): **57.2**  
Structural Grade: **0**  
O&M Grade: **0**  
Clock Start/From: **10**  
Clock To:  
1st Value: **4.000**  
2nd Value:  
Value Percent:  
Continuous Index:  
Within 8" of Joint:  
Remarks:

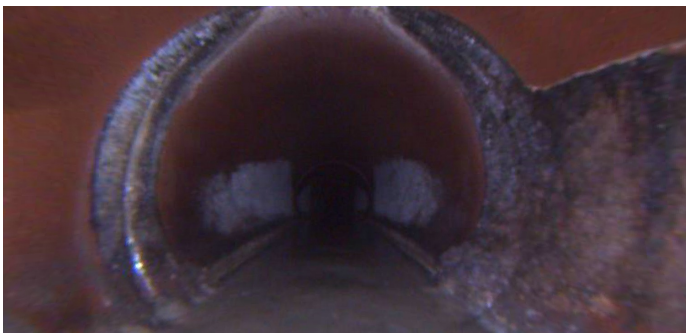
Code: **IW**  
Description: **Infil Weeper**

Distance (ft): **58.5**  
Structural Grade: **0**  
O&M Grade: **2**  
Clock Start/From: **8**  
Clock To: **4**  
1st Value:  
2nd Value:  
Value Percent:  
Continuous Index:  
Within 8" of Joint: **YES**  
Remarks:

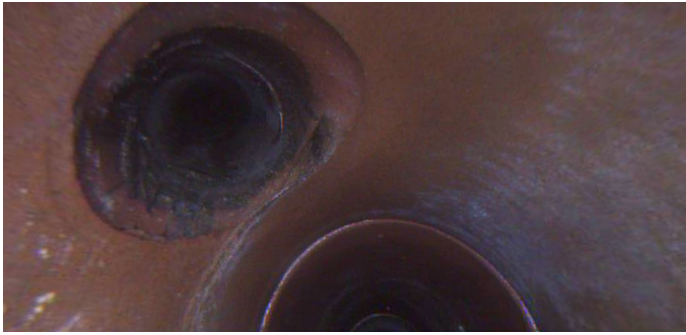
Code: **TF**  
Description: **Tap Factory**

Distance (ft): **111.1**  
Structural Grade: **0**  
O&M Grade: **0**  
Clock Start/From: **2**  
Clock To:  
1st Value: **4.000**  
2nd Value:  
Value Percent:  
Continuous Index:  
Within 8" of Joint:  
Remarks:

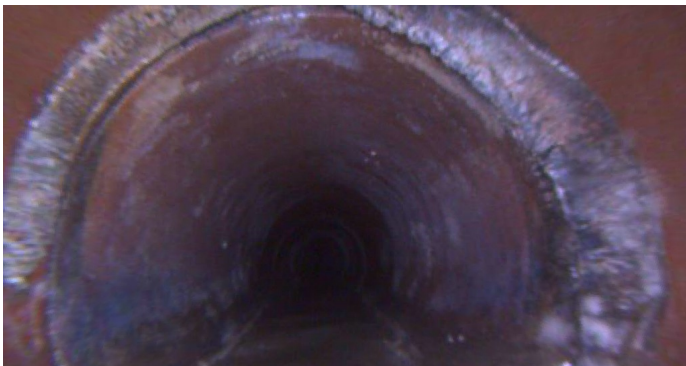
Code: **DAE**  
Description: **Deposits Attached Encrustation**

Distance (ft): **124.0**  
Structural Grade: **0**  
O&M Grade: **2**  
Clock Start/From: **7**  
Clock To: **5**  
1st Value:  
2nd Value:  
Value Percent: **10.000**  
Continuous Index: **S02**  
Within 8" of Joint: **YES**  
Remarks:

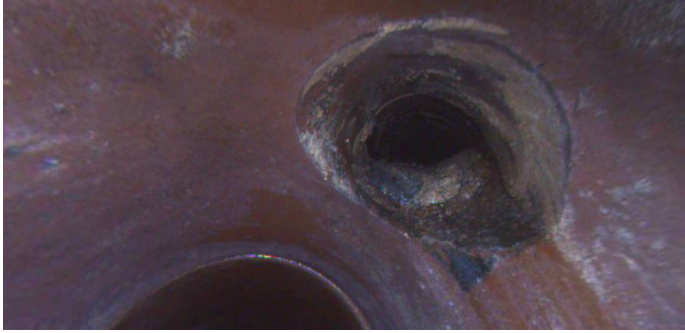
Code: **TF**  
Description: **Tap Factory**

Distance (ft): **146.7**  
Structural Grade: **0**  
O&M Grade: **0**  
Clock Start/From: **2**  
Clock To:  
1st Value: **4.000**  
2nd Value:  
Value Percent:  
Continuous Index:  
Within 8" of Joint:  
Remarks:

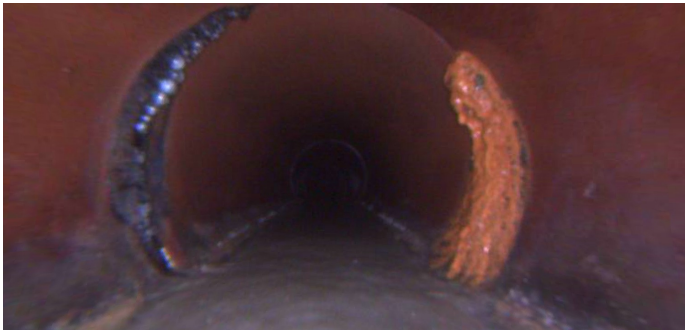
Code: **IW**  
Description: **Infil Weeper**

Distance (ft): **171.7**  
Structural Grade: **0**  
O&M Grade: **2**  
Clock Start/From: **8**  
Clock To: **4**  
1st Value:  
2nd Value:  
Value Percent:  
Continuous Index:  
Within 8" of Joint: **YES**  
Remarks:

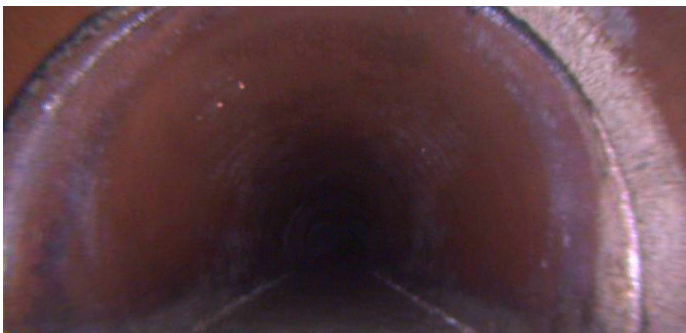
Code: **DAE**  
Description: **Deposits Attached Encrustation**

Distance (ft): **181.0**  
Structural Grade: **0**  
O&M Grade: **2**  
Clock Start/From: **7**  
Clock To: **5**  
1st Value:  
2nd Value:  
Value Percent: **10.000**  
Continuous Index: **F02**  
Within 8" of Joint: **YES**  
Remarks:

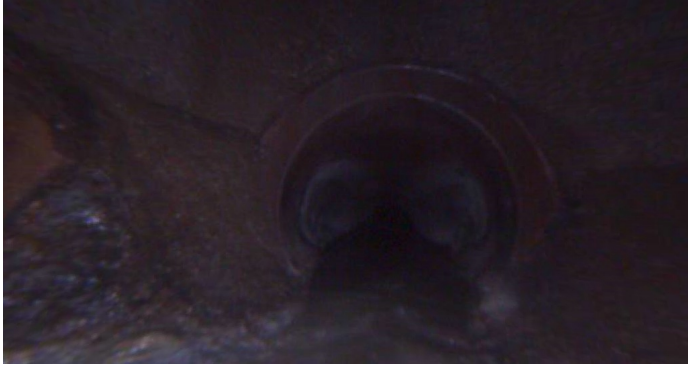
Code:	AMH
Description:	Manhole
Distance (ft):	185.2
Structural Grade:	0
O&M Grade:	0
Clock Start/From:	
Clock To:	
1st Value:	
2nd Value:	
Value Percent:	
Continuous Index:	
Within 8" of Joint:	NO
Remarks:	M-804-037
