Profile/Photo Observation Report

Street:	N Liberty St.	Flow Control:	Not Controlled
City:	Hobart, IN	Year Renewed:	
Location:	Other	Tape/Media #:	
Purpose:	Not Known	Dia/Height:	12"
Use:	Sanitary	Material:	VCP
Drain Area:	NA	Lining:	
Category:	NA		
Comment:

Location Details:		Direction of Survey:	Downstream
US MH:	M-804-038	DS MH:	M-804-037
		Total Length Surveyed (ft):	185.2

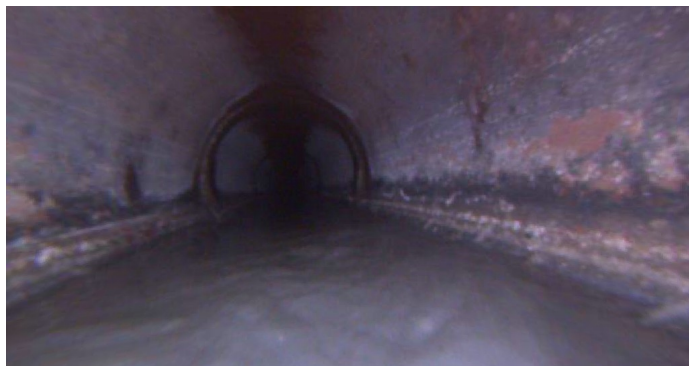
Code: **AMH**
Description: **Manhole**

Distance (ft): **.0**
Structural Grade: **0**
O&M Grade: **0**
Clock Start/From:
Clock To:
1st Value:
2nd Value:
Value Percent:
Continuous Index:
Within 8" of Joint: **NO**
Remarks: **M-804-038**

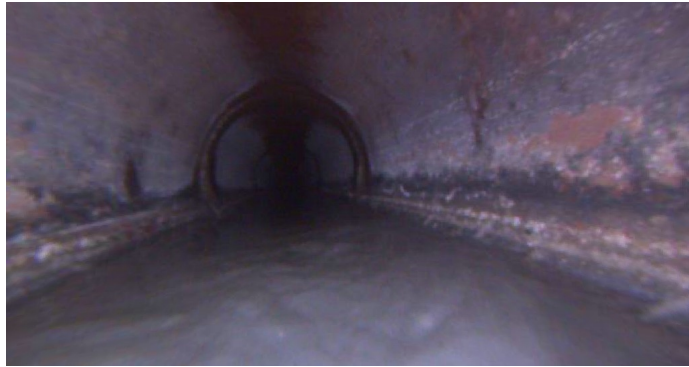
Code:	MWL
Description:	Water Level
Distance (ft):	.0
Structural Grade:	0
O&M Grade:	0
Clock Start/From:	
Clock To:	
1st Value:	
2nd Value:	
Value Percent:	10.000
Continuous Index:	
Within 8" of Joint:	NO
Remarks:

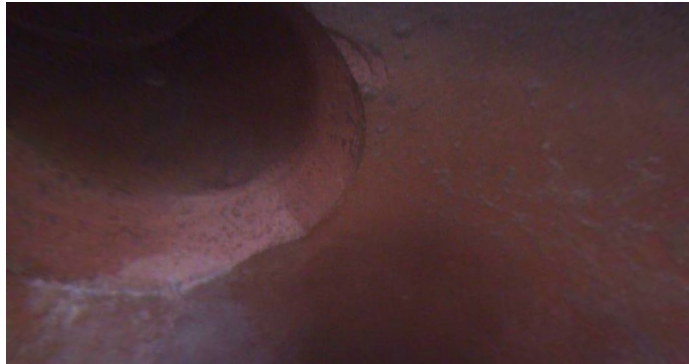
Code:	TF
Description:	Tap Factory
Distance (ft):	15.1
Structural Grade:	0
O&M Grade:	0
Clock Start/From:	10
Clock To:	
1st Value:	4.000
2nd Value:	
Value Percent:	
Continuous Index:	
Within 8" of Joint:	
Remarks:

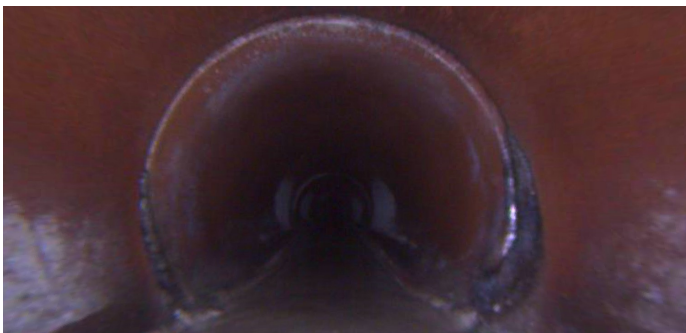
Code: **IW**
Description: **Infil Weeper**

Distance (ft): **49.5**
Structural Grade: **0**
O&M Grade: **2**
Clock Start/From: **8**
Clock To: **4**
1st Value:
2nd Value:
Value Percent:
Continuous Index: **S01**
Within 8" of Joint: **YES**
Remarks:

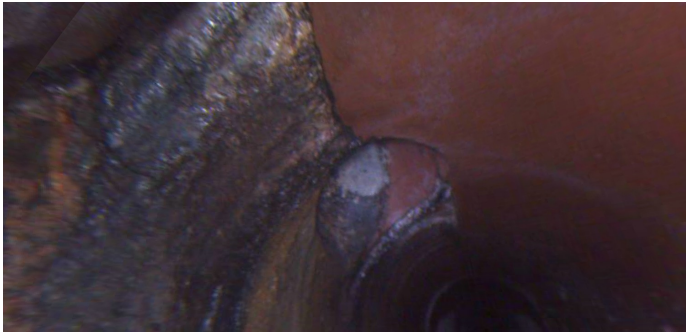
Code: **DAE**
Description: **Deposits Attached Encrustation**

Distance (ft): **56.1**
Structural Grade: **0**
O&M Grade: **2**
Clock Start/From: **7**
Clock To: **11**
1st Value:
2nd Value:
Value Percent: **5.000**
Continuous Index:
Within 8" of Joint: **NO**
Remarks:

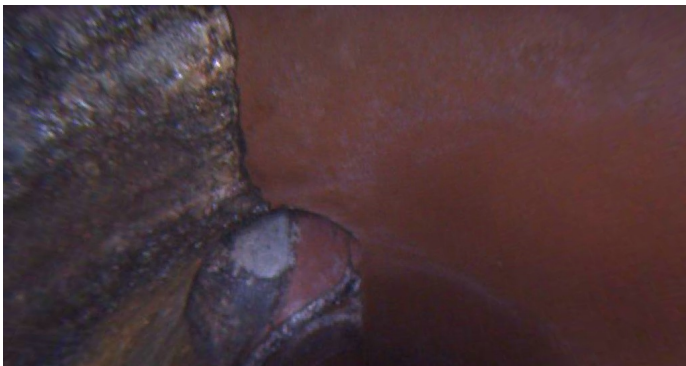
Code: **CL**
Description: **Crack Longitudinal**

Distance (ft): **56.1**
Structural Grade: **2**
O&M Grade: **0**
Clock Start/From: **11**
Clock To:
1st Value:
2nd Value:
Value Percent:
Continuous Index:
Within 8" of Joint:
Remarks:

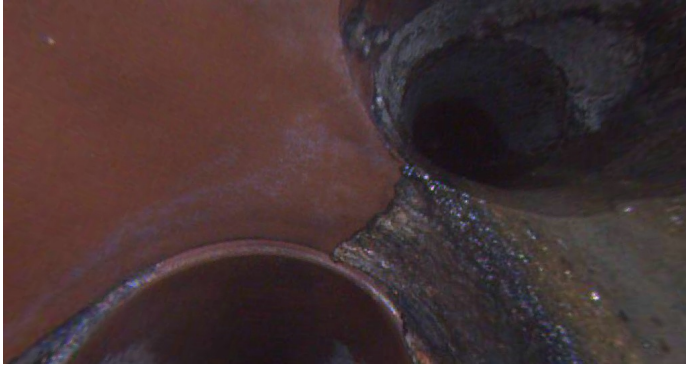
Code: **TF**
Description: **Tap Factory**

Distance (ft): **57.2**
Structural Grade: **0**
O&M Grade: **0**
Clock Start/From: **10**
Clock To:
1st Value: **4.000**
2nd Value:
Value Percent:
Continuous Index:
Within 8" of Joint:
Remarks:

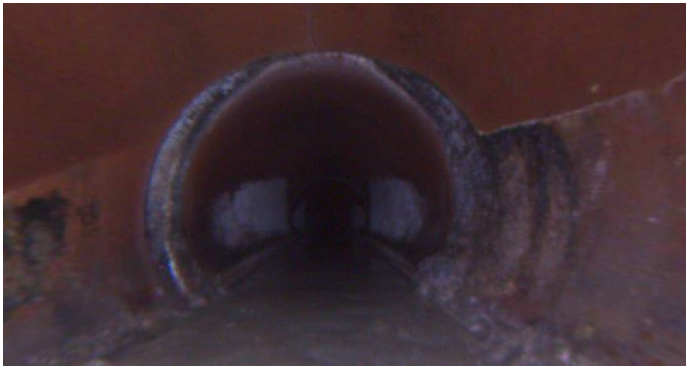
Code: **CM**
Description: **Crack Multiple**

Distance (ft): **58.2**
Structural Grade: **3**
O&M Grade: **0**
Clock Start/From: **7**
Clock To: **5**
1st Value:
2nd Value:
Value Percent:
Continuous Index:
Within 8" of Joint:
Remarks:

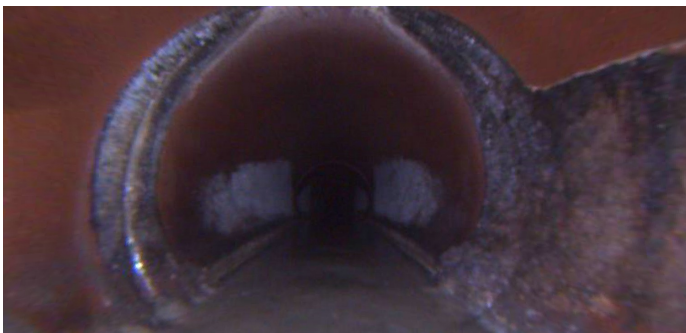
Code: **IW**
Description: **Infil Weeper**

Distance (ft): **58.5**
Structural Grade: **0**
O&M Grade: **2**
Clock Start/From: **8**
Clock To: **4**
1st Value:
2nd Value:
Value Percent:
Continuous Index:
Within 8" of Joint: **YES**
Remarks:

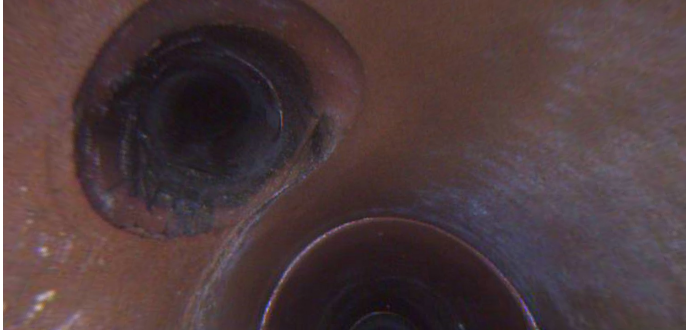
Code: **TF**
Description: **Tap Factory**

Distance (ft): **111.1**
Structural Grade: **0**
O&M Grade: **0**
Clock Start/From: **2**
Clock To:
1st Value: **4.000**
2nd Value:
Value Percent:
Continuous Index:
Within 8" of Joint:
Remarks:

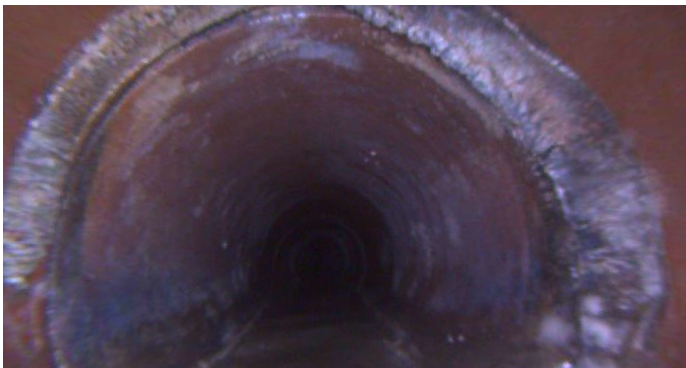
Code: **DAE**
Description: **Deposits Attached Encrustation**

Distance (ft): **124.0**
Structural Grade: **0**
O&M Grade: **2**
Clock Start/From: **7**
Clock To: **5**
1st Value:
2nd Value:
Value Percent: **10.000**
Continuous Index: **S02**
Within 8" of Joint: **YES**
Remarks:

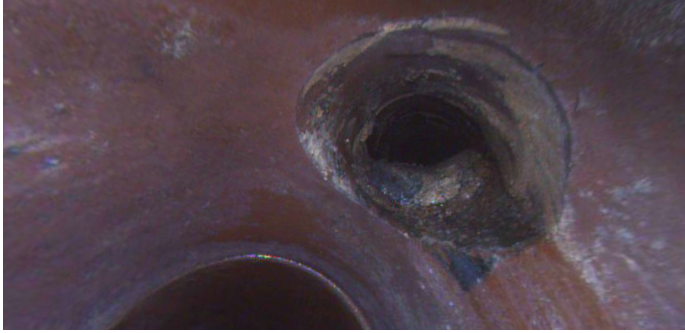
Code: **TF**
Description: **Tap Factory**

Distance (ft): **146.7**
Structural Grade: **0**
O&M Grade: **0**
Clock Start/From: **2**
Clock To:
1st Value: **4.000**
2nd Value:
Value Percent:
Continuous Index:
Within 8" of Joint:
Remarks:

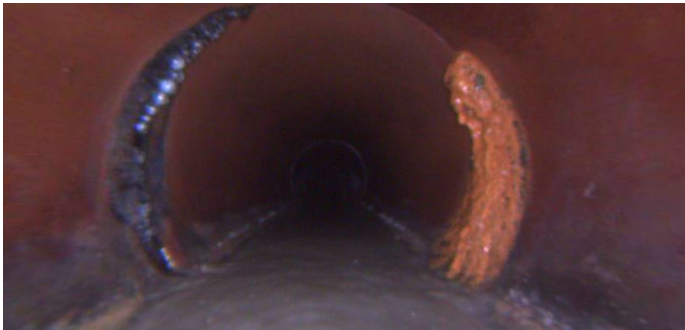
Code: **IW**
Description: **Infil Weeper**

Distance (ft): **171.7**
Structural Grade: **0**
O&M Grade: **2**
Clock Start/From: **8**
Clock To: **4**
1st Value:
2nd Value:
Value Percent:
Continuous Index:
Within 8" of Joint: **YES**
Remarks:

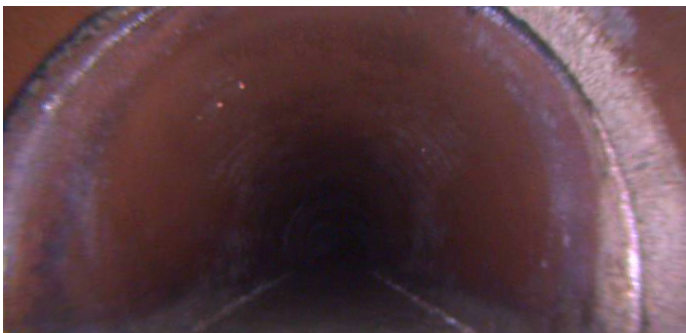
Code: **DAE**
Description: **Deposits Attached Encrustation**

Distance (ft): **181.0**
Structural Grade: **0**
O&M Grade: **2**
Clock Start/From: **7**
Clock To: **5**
1st Value:
2nd Value:
Value Percent: **10.000**
Continuous Index: **F02**
Within 8" of Joint: **YES**
Remarks:

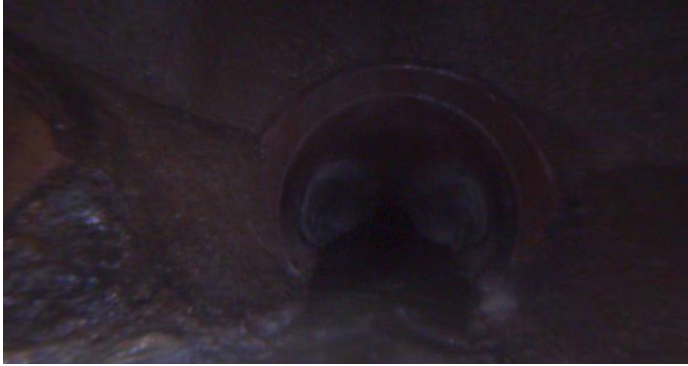
Code:	AMH
Description:	Manhole
Distance (ft):	185.2
Structural Grade:	0
O&M Grade:	0
Clock Start/From:	
Clock To:	
1st Value:	
2nd Value:	
Value Percent:	
Continuous Index:	
Within 8" of Joint:	NO
Remarks:	M-804-037
