Profile/Photo Observation Report

| Street: | North Liberty Street | Flow Control: | Not Controlled |
| US MH: | M-804-071 | DS MH: | M-804-040 |

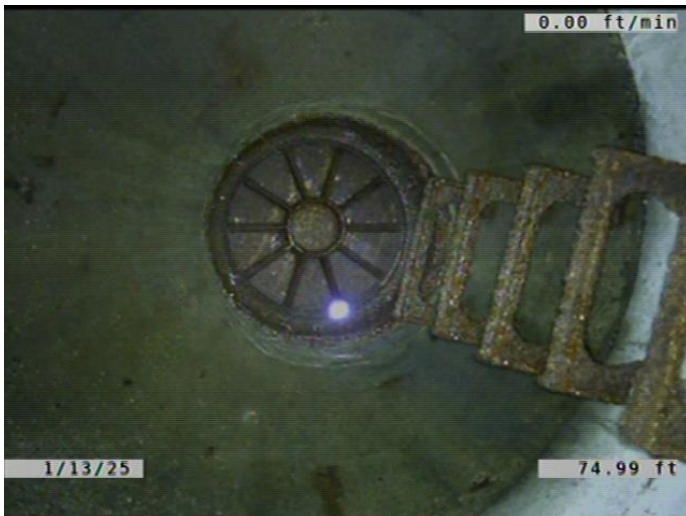
Code: **AMH**
 Description: **Manhole**

Distance (ft): **75.0**
 Structural Grade: **0**
 O&M Grade: **0**
 Clock Start/From:
 Clock To:
 1st Value:
 2nd Value:
 Value Percent:
 Continuous Index:
 Within 8" of Joint: **NO**
 Remarks: **M-804-040**
