## Profile/Photo Observation Report

Street:	<b>OFF N HOBART RD</b>	Flow Control:	<b>Not Controlled</b>
City:	<b>Hobart, IN</b>	Year Renewed:	
Location:	<b>Other</b>	Tape/Media #:	
Purpose:	<b>Not Known</b>	Dia/Height:	<b>12"</b>
Use:	<b>Sanitary</b>	Material:	<b>VCP</b>
Drain Area:	<b>NA</b>	Lining:	
Category:	<b>NA</b>		
Comment:

Location Details:		Direction of Survey:	<b>Downstream</b>
US MH:	<b>M-804-041</b>	DS MH:	<b>M-804-038</b>
		Total Length Surveyed (ft):	<b>304.2</b>

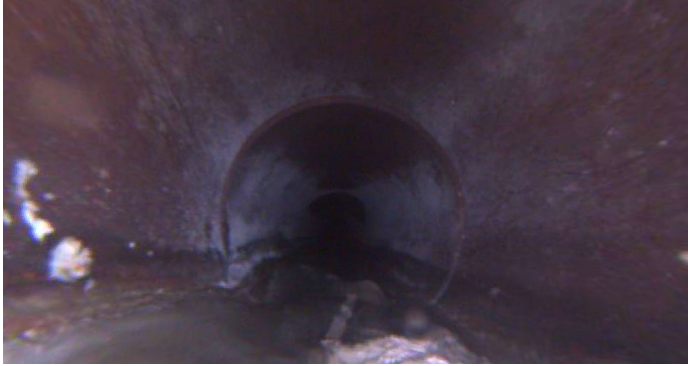
Code: **AMH**  
Description: **Manhole**

Distance (ft): **.0**  
Structural Grade: **0**  
O&M Grade: **0**  
Clock Start/From:  
Clock To:  
1st Value:  
2nd Value:  
Value Percent:  
Continuous Index:  
Within 8" of Joint: **NO**  
Remarks: **M-804-041**

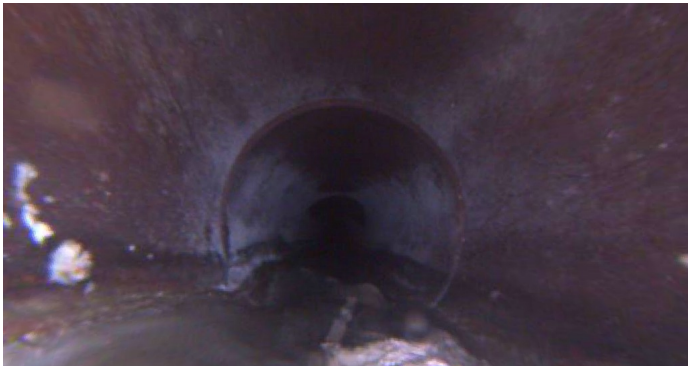
Code: **MWL**  
Description: **Water Level**

Distance (ft): **.0**  
Structural Grade: **0**  
O&M Grade: **0**  
Clock Start/From:  
Clock To:  
1st Value:  
2nd Value:  
Value Percent: **10.000**  
Continuous Index:  
Within 8" of Joint: **NO**  
Remarks:

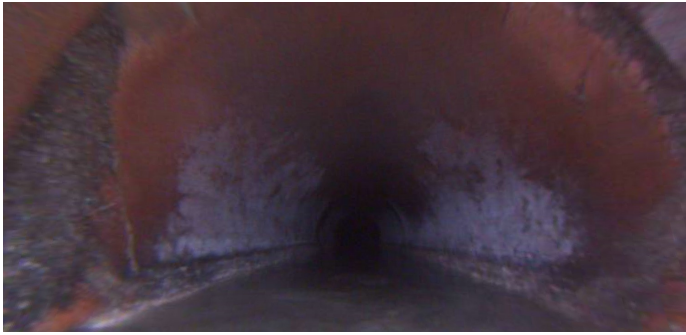
Code: **RFJ**  
Description: **Roots Fine Joint**

Distance (ft): **14.0**  
Structural Grade: **0**  
O&M Grade: **1**  
Clock Start/From: **8**  
Clock To: **4**  
1st Value:  
2nd Value:  
Value Percent:  
Continuous Index: **S01**  
Within 8" of Joint: **YES**  
Remarks:

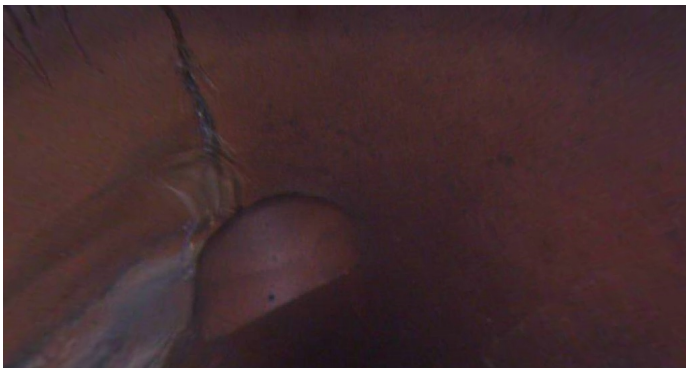
Code: **FM**  
Description: **Fracture Multiple**

Distance (ft): **56.7**  
Structural Grade: **4**  
O&M Grade: **0**  
Clock Start/From: **8**  
Clock To: **4**  
1st Value:  
2nd Value:  
Value Percent:  
Continuous Index:  
Within 8" of Joint:  
Remarks:

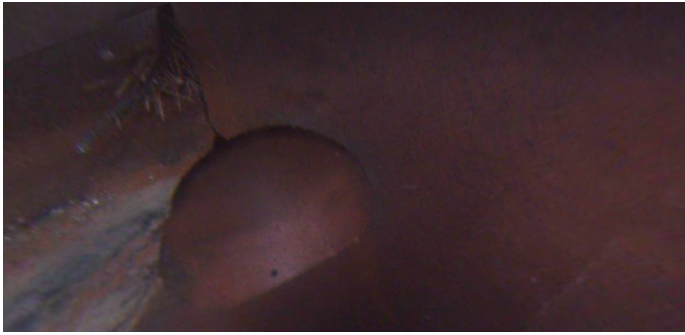
Code: **RFB**  
Description: **Roots Fine Barrel**

Distance (ft): **56.9**  
Structural Grade: **0**  
O&M Grade: **2**  
Clock Start/From: **11**  
Clock To:  
1st Value:  
2nd Value:  
Value Percent:  
Continuous Index:  
Within 8" of Joint: **NO**  
Remarks:

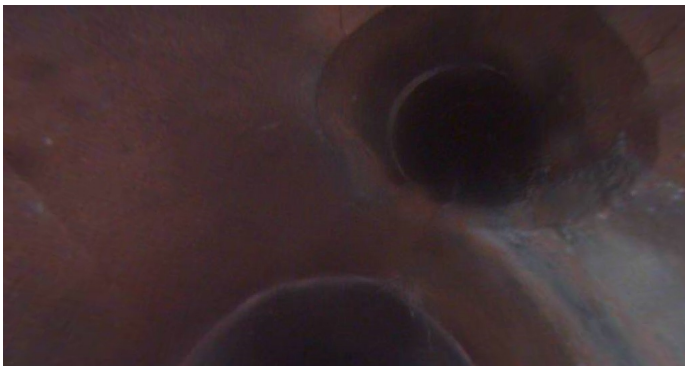
Code: **TF**  
Description: **Tap Factory**

Distance (ft): **57.9**  
Structural Grade: **0**  
O&M Grade: **0**  
Clock Start/From: **10**  
Clock To:  
1st Value: **4.000**  
2nd Value:  
Value Percent:  
Continuous Index:  
Within 8" of Joint:  
Remarks: **Photo taken from rear camera.**

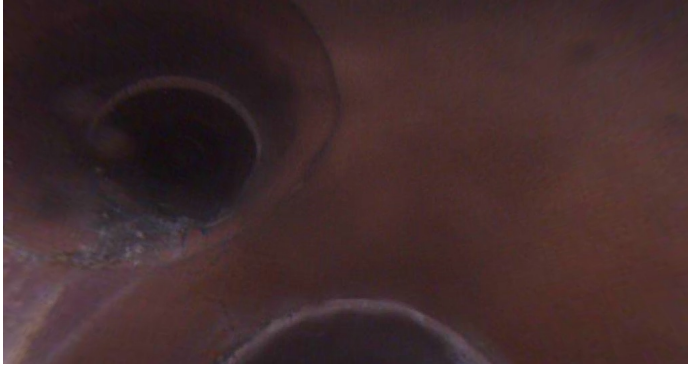
Code: **TF**  
Description: **Tap Factory**

Distance (ft): **82.1**  
Structural Grade: **0**  
O&M Grade: **0**  
Clock Start/From: **2**  
Clock To:  
1st Value: **4.000**  
2nd Value:  
Value Percent:  
Continuous Index:  
Within 8" of Joint:  
Remarks: **Photo taken from rear camera.**

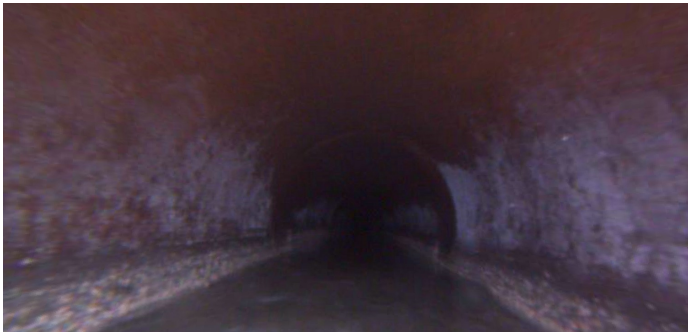
Code: **RFJ**  
Description: **Roots Fine Joint**

Distance (ft): **82.4**  
Structural Grade: **0**  
O&M Grade: **1**  
Clock Start/From: **8**  
Clock To: **4**  
1st Value:  
2nd Value:  
Value Percent:  
Continuous Index: **F01**  
Within 8" of Joint: **YES**  
Remarks:

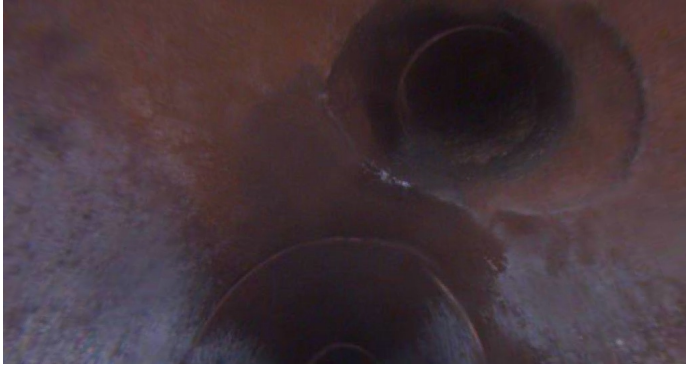
Code: **TF**  
Description: **Tap Factory**

Distance (ft): **97.3**  
Structural Grade: **0**  
O&M Grade: **0**  
Clock Start/From: **2**  
Clock To:  
1st Value: **4.000**  
2nd Value:  
Value Percent:  
Continuous Index:  
Within 8" of Joint:  
Remarks: **Photo taken from rear camera.**

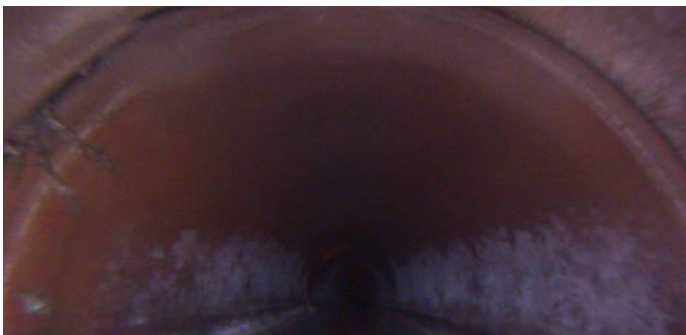
Code: **RFJ**  
Description: **Roots Fine Joint**

Distance (ft): **123.0**  
Structural Grade: **0**  
O&M Grade: **1**  
Clock Start/From: **8**  
Clock To: **4**  
1st Value:  
2nd Value:  
Value Percent:  
Continuous Index: **S02**  
Within 8" of Joint: **YES**  
Remarks:

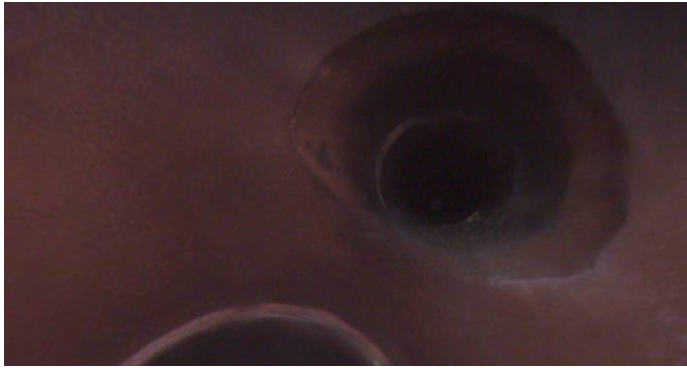
Code: **TF**  
Description: **Tap Factory**

Distance (ft): **127.6**  
Structural Grade: **0**  
O&M Grade: **0**  
Clock Start/From: **10**  
Clock To:  
1st Value: **4.000**  
2nd Value:  
Value Percent:  
Continuous Index:  
Within 8" of Joint:  
Remarks: **Photo taken from rear camera.**

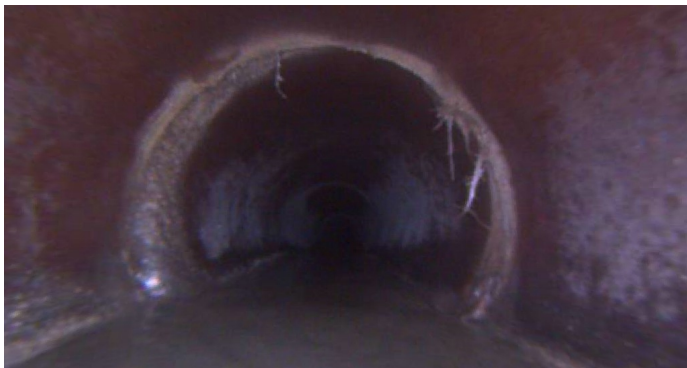
Code: **RFJ**  
Description: **Roots Fine Joint**

Distance (ft): **158.9**  
Structural Grade: **0**  
O&M Grade: **1**  
Clock Start/From: **11**  
Clock To: **4**  
1st Value:  
2nd Value:  
Value Percent:  
Continuous Index:  
Within 8" of Joint: **YES**  
Remarks:

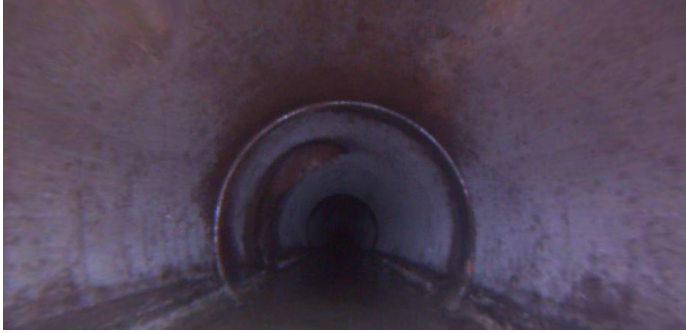
Code: **RFJ**  
Description: **Roots Fine Joint**

Distance (ft): **188.9**  
Structural Grade: **0**  
O&M Grade: **1**  
Clock Start/From: **8**  
Clock To: **4**  
1st Value:  
2nd Value:  
Value Percent:  
Continuous Index: **F02**  
Within 8" of Joint: **YES**  
Remarks:

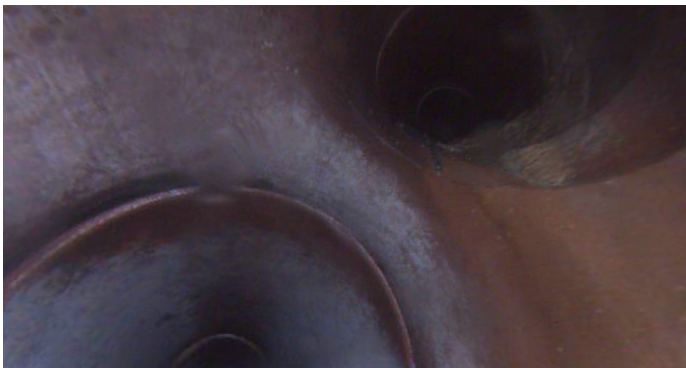
Code: **TF**  
Description: **Tap Factory**

Distance (ft): **191.0**  
Structural Grade: **0**  
O&M Grade: **0**  
Clock Start/From: **10**  
Clock To:  
1st Value: **4.000**  
2nd Value:  
Value Percent:  
Continuous Index:  
Within 8" of Joint:  
Remarks: **Photo taken from rear camera.**

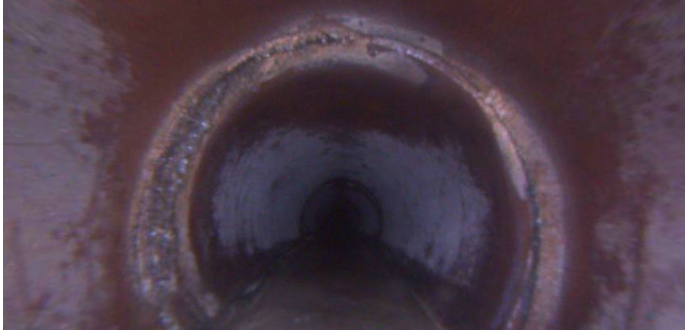
Code: **IW**  
Description: **Infil Weeper**

Distance (ft): **195.2**  
Structural Grade: **0**  
O&M Grade: **2**  
Clock Start/From: **8**  
Clock To: **4**  
1st Value:  
2nd Value:  
Value Percent:  
Continuous Index: **S03**  
Within 8" of Joint: **YES**  
Remarks:

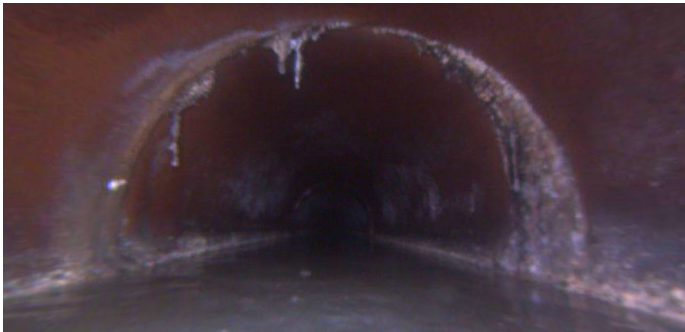
Code: **RFJ**  
Description: **Roots Fine Joint**

Distance (ft): **207.3**  
Structural Grade: **0**  
O&M Grade: **1**  
Clock Start/From: **8**  
Clock To: **4**  
1st Value:  
2nd Value:  
Value Percent:  
Continuous Index:  
Within 8" of Joint: **YES**  
Remarks:

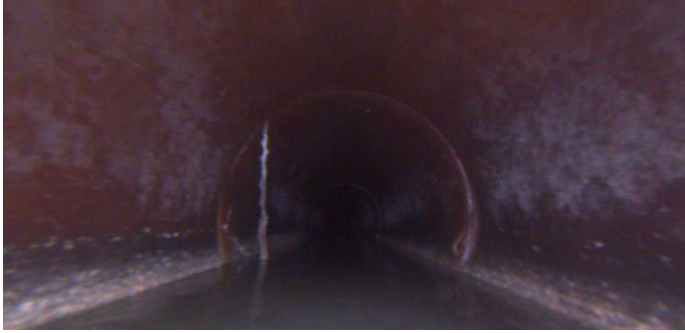
Code: **RFJ**  
Description: **Roots Fine Joint**

Distance (ft): **222.1**  
Structural Grade: **0**  
O&M Grade: **1**  
Clock Start/From: **8**  
Clock To: **4**  
1st Value:  
2nd Value:  
Value Percent:  
Continuous Index:  
Within 8" of Joint: **YES**  
Remarks:

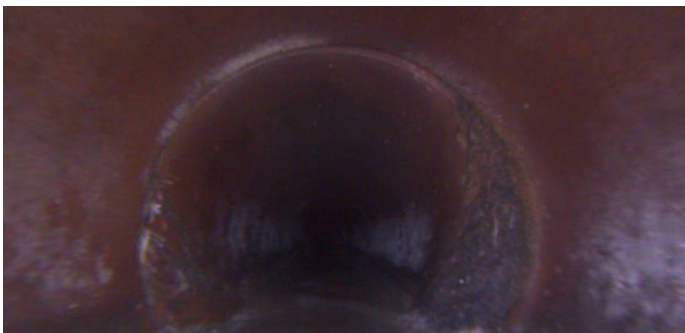
Code: **RMJ**  
Description: **Roots Medium Joint**

Distance (ft): **228.5**  
Structural Grade: **0**  
O&M Grade: **3**  
Clock Start/From: **8**  
Clock To: **4**  
1st Value:  
2nd Value:  
Value Percent: **5.000**  
Continuous Index:  
Within 8" of Joint: **YES**  
Remarks:

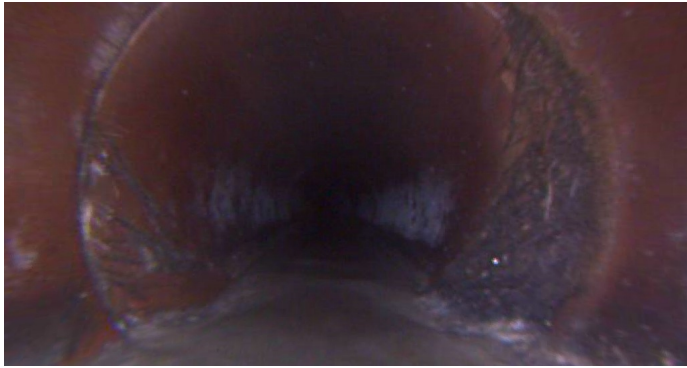
Code:	<b>RMJ</b>
Description:	<b>Roots Medium Joint</b>
Distance (ft):	<b>228.6</b>
Structural Grade:	<b>0</b>
O&M Grade:	<b>3</b>
Clock Start/From:	<b>7</b>
Clock To:	<b>5</b>
1st Value:	
2nd Value:	
Value Percent:	<b>5.000</b>
Continuous Index:	
Within 8" of Joint:	<b>YES</b>
Remarks:

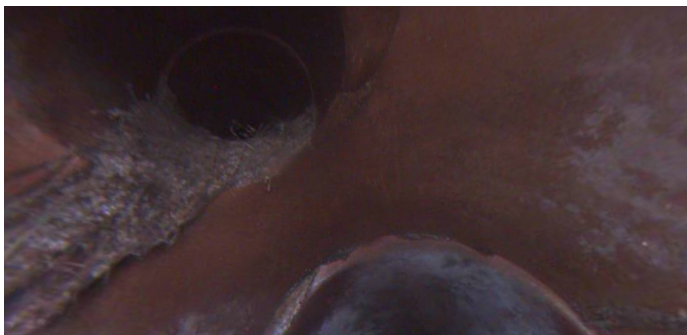
Code:	<b>RML</b>
Description:	<b>Roots Medium Lateral</b>
Distance (ft):	<b>239.4</b>
Structural Grade:	<b>0</b>
O&M Grade:	<b>3</b>
Clock Start/From:	<b>10</b>
Clock To:	
1st Value:	
2nd Value:	
Value Percent:	<b>5.000</b>
Continuous Index:	
Within 8" of Joint:	<b>NO</b>
Remarks:

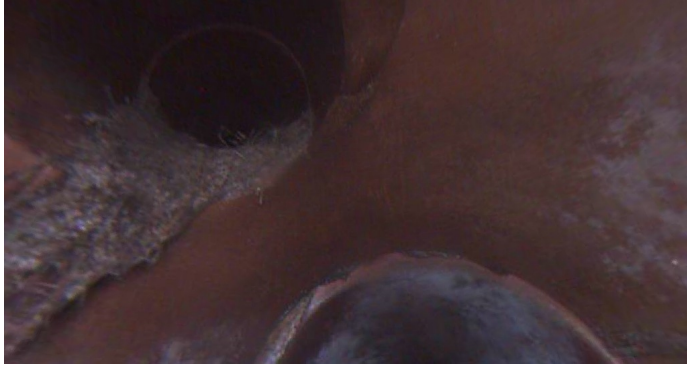
Code: **TFD**  
Description: **Tap Factory Defective**

Distance (ft): **239.4**  
Structural Grade: **0**  
O&M Grade: **2**  
Clock Start/From: **2**  
Clock To:  
1st Value: **4.000**  
2nd Value:  
Value Percent:  
Continuous Index:  
Within 8" of Joint:  
Remarks: **Roots, Photo taken from rear camera.**

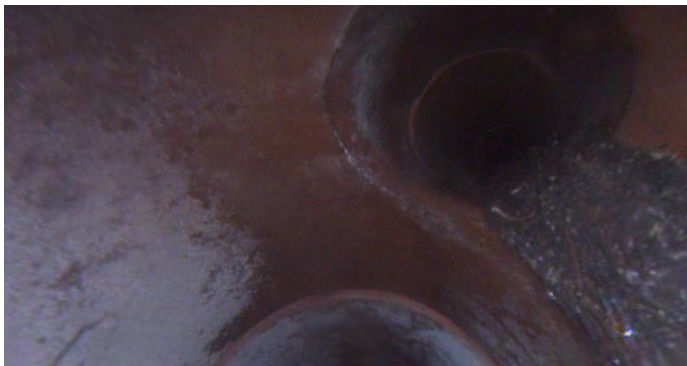
Code: **TFD**  
Description: **Tap Factory Defective**

Distance (ft): **245.7**  
Structural Grade: **0**  
O&M Grade: **2**  
Clock Start/From: **2**  
Clock To:  
1st Value: **4.000**  
2nd Value:  
Value Percent:  
Continuous Index:  
Within 8" of Joint:  
Remarks: **Roots, Photo taken from rear camera.**

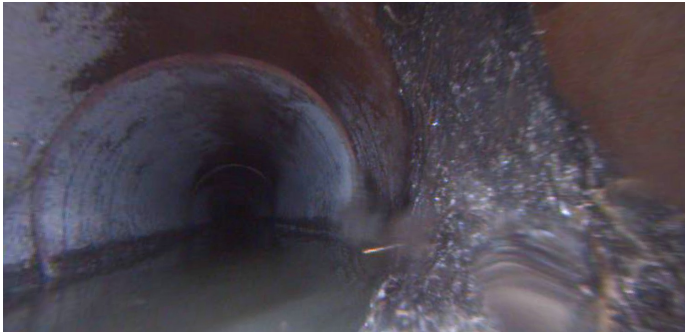
Code: **RML**  
Description: **Roots Medium Lateral**

Distance (ft): **245.8**  
Structural Grade: **0**  
O&M Grade: **3**  
Clock Start/From: **1**  
Clock To: **4**  
1st Value:  
2nd Value:  
Value Percent: **10.000**  
Continuous Index:  
Within 8" of Joint: **NO**  
Remarks:

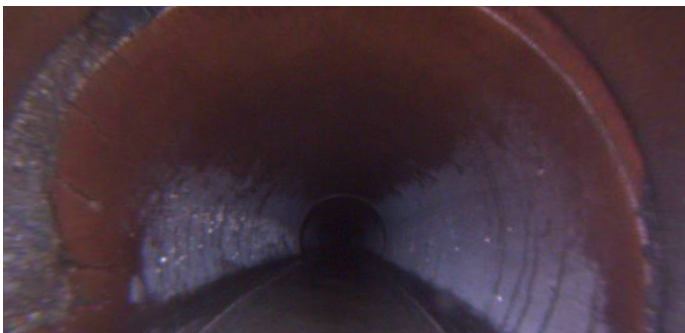
Code: **RFJ**  
Description: **Roots Fine Joint**

Distance (ft): **250.2**  
Structural Grade: **0**  
O&M Grade: **1**  
Clock Start/From: **8**  
Clock To: **9**  
1st Value:  
2nd Value:  
Value Percent:  
Continuous Index:  
Within 8" of Joint: **YES**  
Remarks:

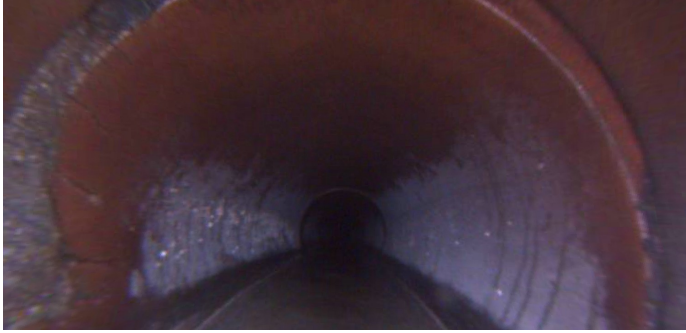
Code: **IW**  
Description: **Infil Weeper**

Distance (ft): **250.2**  
Structural Grade: **0**  
O&M Grade: **2**  
Clock Start/From: **8**  
Clock To: **4**  
1st Value:  
2nd Value:  
Value Percent:  
Continuous Index: **F03**  
Within 8" of Joint: **YES**  
Remarks:

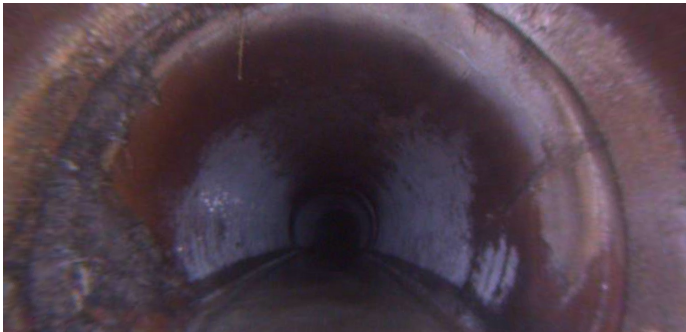
Code: **RFJ**  
Description: **Roots Fine Joint**

Distance (ft): **265.2**  
Structural Grade: **0**  
O&M Grade: **1**  
Clock Start/From: **8**  
Clock To: **4**  
1st Value:  
2nd Value:  
Value Percent:  
Continuous Index: **S04**  
Within 8" of Joint: **YES**  
Remarks:

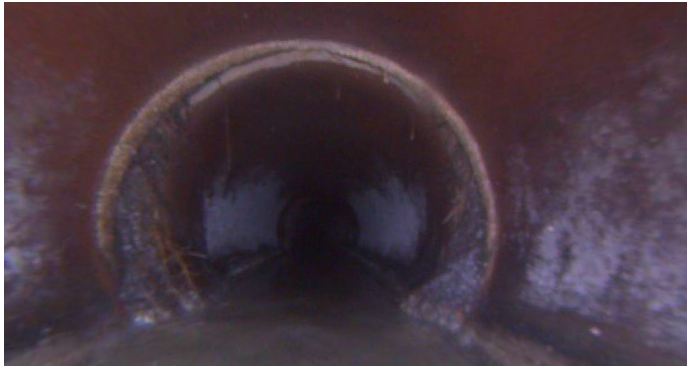
Code: **RMJ**  
Description: **Roots Medium Joint**

Distance (ft): **282.9**  
Structural Grade: **0**  
O&M Grade: **3**  
Clock Start/From: **7**  
Clock To: **5**  
1st Value:  
2nd Value:  
Value Percent: **5.000**  
Continuous Index:  
Within 8" of Joint: **YES**  
Remarks:

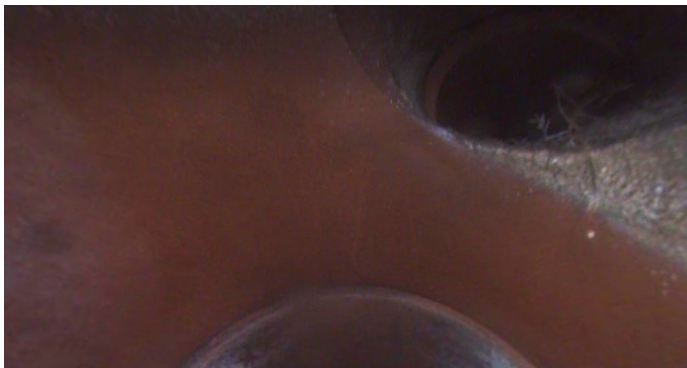
Code: **TFD**  
Description: **Tap Factory Defective**

Distance (ft): **287.8**  
Structural Grade: **0**  
O&M Grade: **2**  
Clock Start/From: **11**  
Clock To:  
1st Value: **4.000**  
2nd Value:  
Value Percent:  
Continuous Index:  
Within 8" of Joint:  
Remarks: **Photo taken from rear camera.**

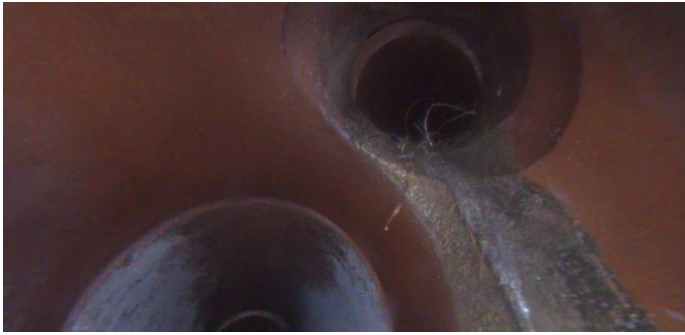
Code: **RFL**  
Description: **Roots Fine Lateral**

Distance (ft): **288.2**  
Structural Grade: **0**  
O&M Grade: **1**  
Clock Start/From: **11**  
Clock To:  
1st Value:  
2nd Value:  
Value Percent:  
Continuous Index:  
Within 8" of Joint: **NO**  
Remarks:

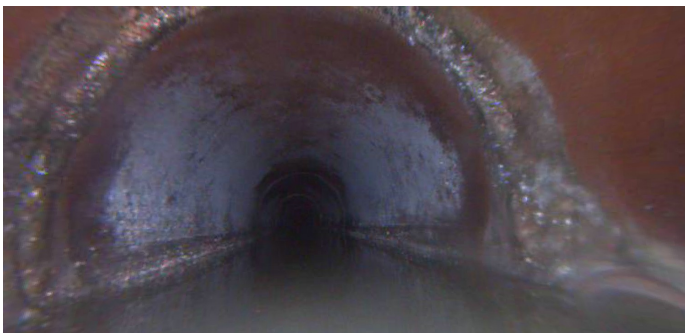
Code: **RFJ**  
Description: **Roots Fine Joint**

Distance (ft): **296.7**  
Structural Grade: **0**  
O&M Grade: **1**  
Clock Start/From: **8**  
Clock To: **4**  
1st Value:  
2nd Value:  
Value Percent:  
Continuous Index: **F04**  
Within 8" of Joint: **YES**  
Remarks:

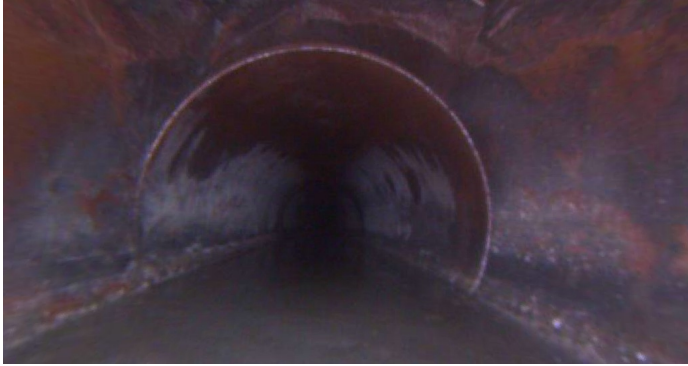
Code:	<b>AMH</b>
Description:	<b>Manhole</b>
Distance (ft):	<b>304.2</b>
Structural Grade:	<b>0</b>
O&M Grade:	<b>0</b>
Clock Start/From:	
Clock To:	
1st Value:	
2nd Value:	
Value Percent:	
Continuous Index:	
Within 8" of Joint:	<b>NO</b>
Remarks:	<b>M-804-038</b>
